RRT 3

Case Study:

M/V DALI

HAZARDOUS MATERIALS SALVAGE PLAN AND
OVERVIEW

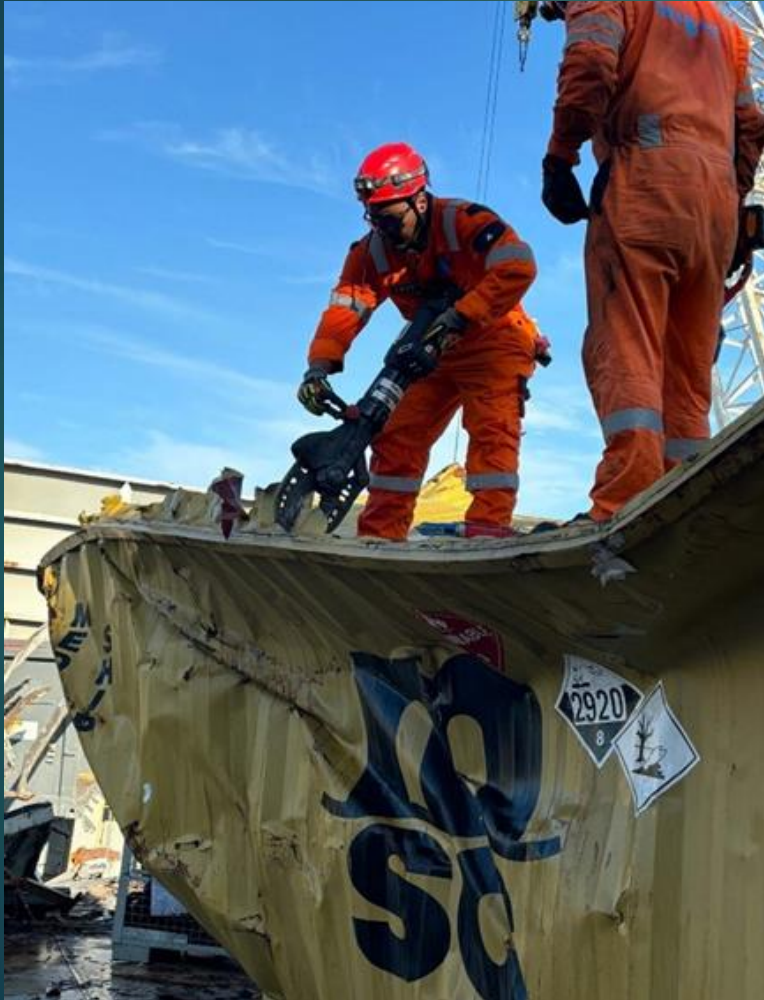
Chemical Disinfectants, Cleaners, and Fungicides

- Various Cleaners
- Stainless Steel / Furniture Polishes
- BARDAC 205-M (Fungicide)
Flammable. Harmful in contact with skin and if swallowed. Causes burns, very toxic to aquatic organisms (per SDS).

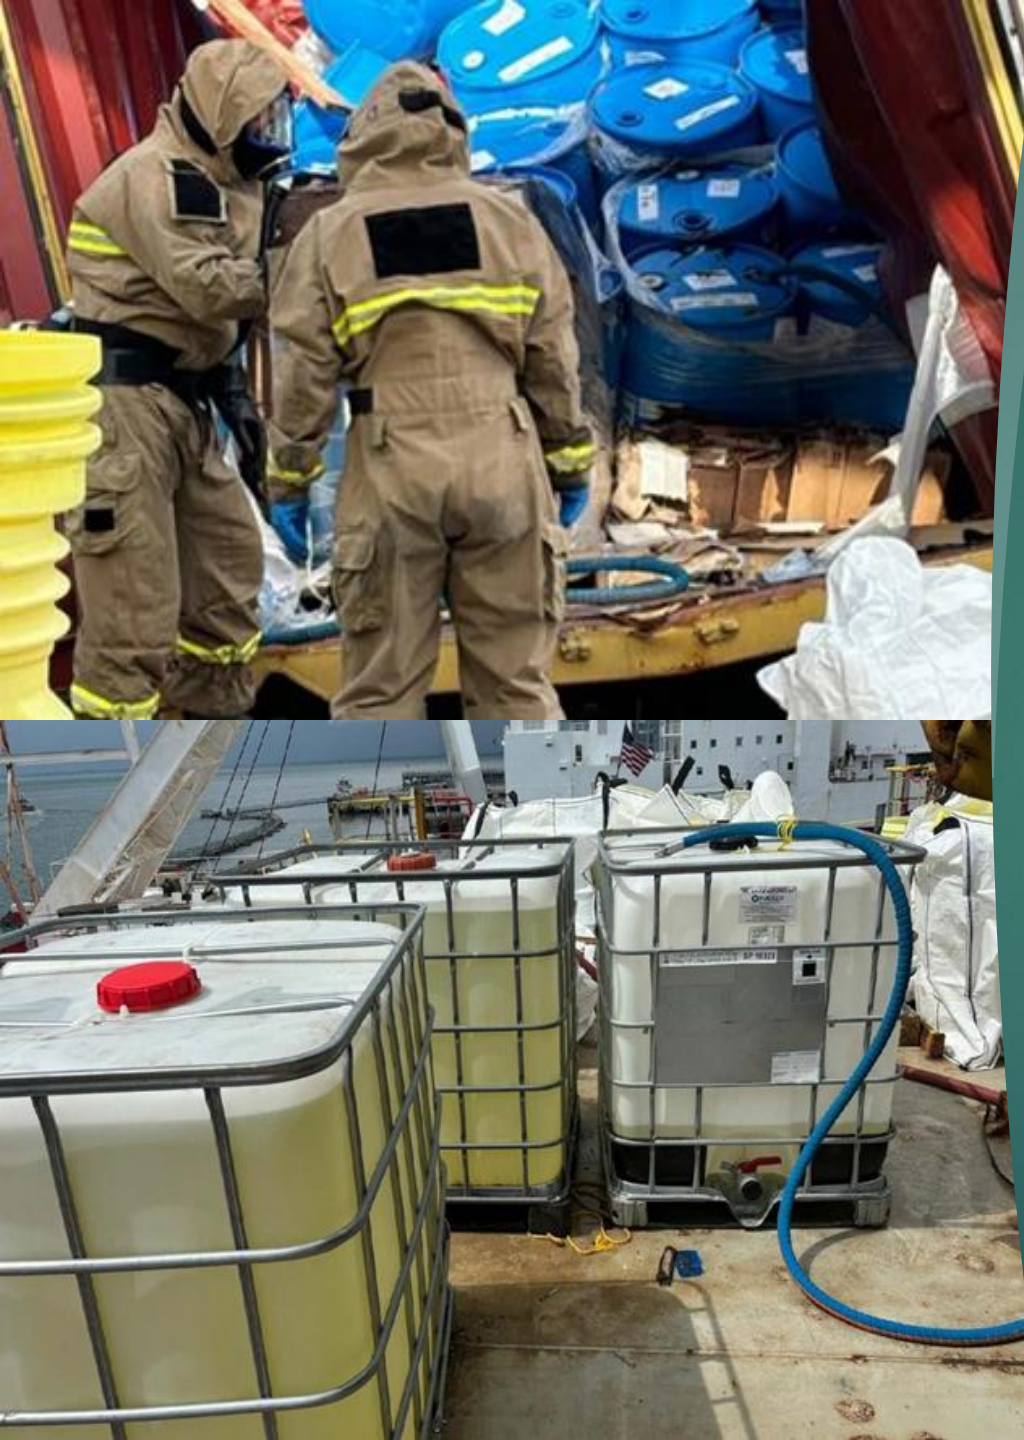
Due to container damage, access to approximately (20) 55-gallon drums of BARDAC 205-M was not possible without cutting the container in place.

Once gaining access, the hazmat crews pumped the contents of the drums into tote tanks for removal.

Totals: Bardac 205 count: (2) 275 gal. totes, 4 overpacks with 55-gallon drums, 2 supersacks of debris with bardac 205 on it.

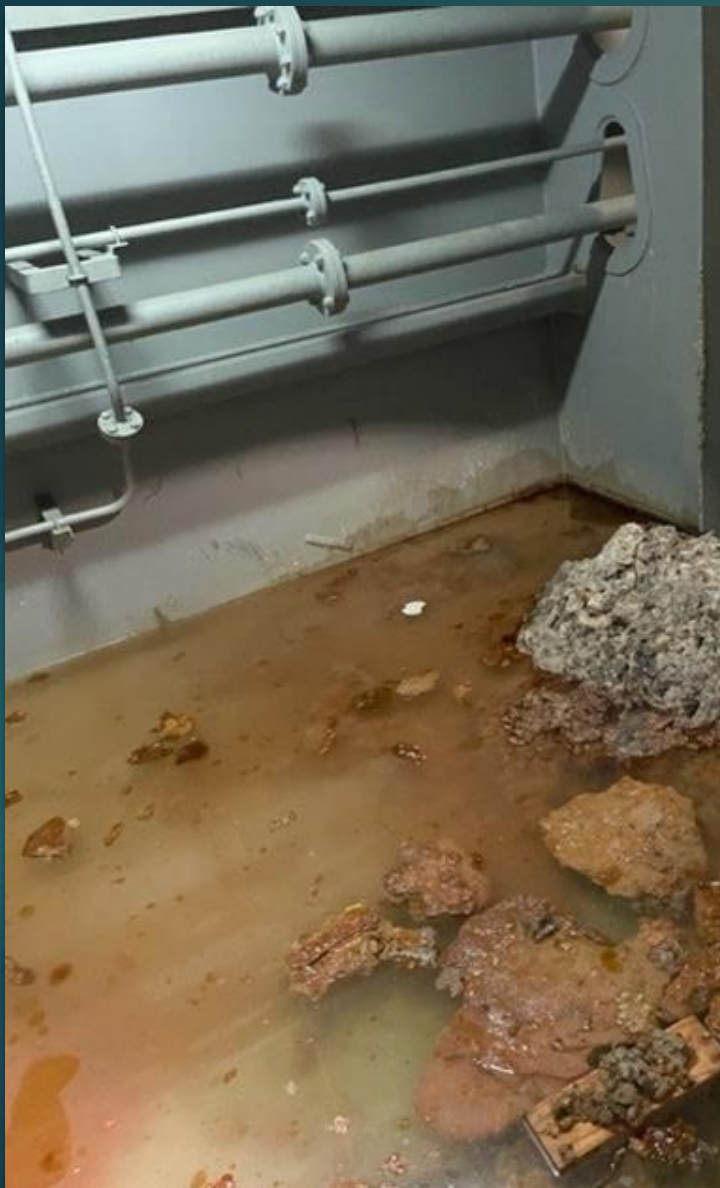
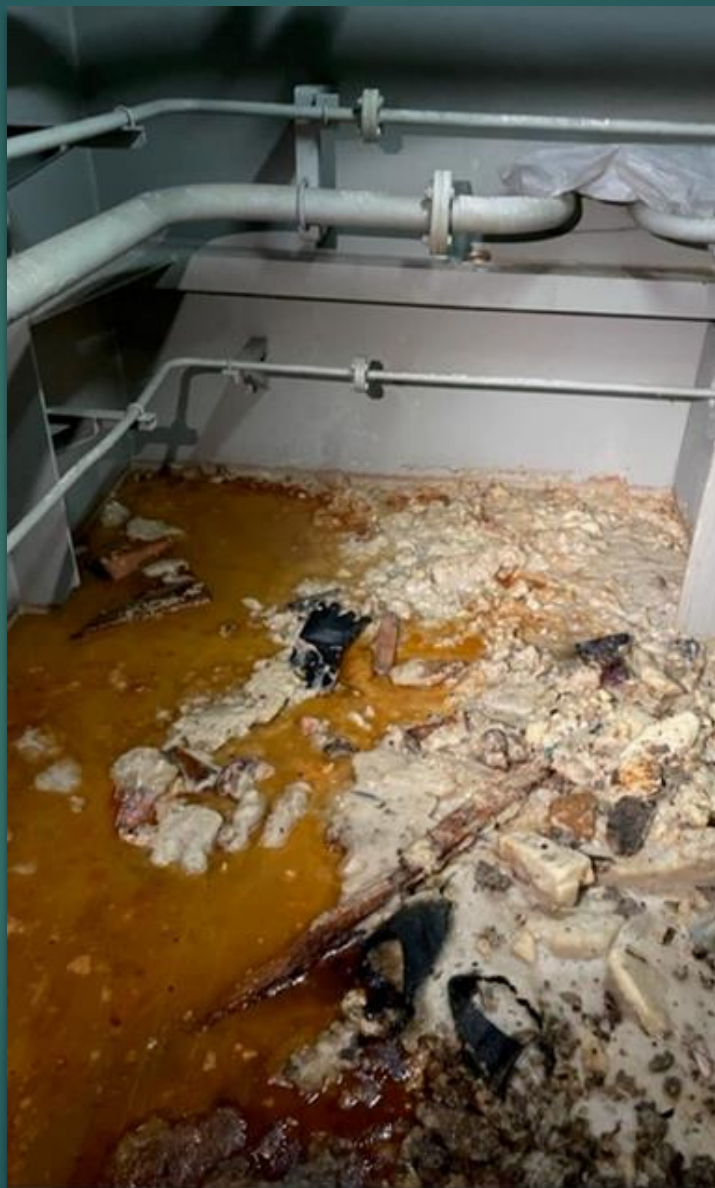
WESTON 705T

Base component of adhesives

Not classed as HAZMAT, but crews experienced skin and respiratory tract irritation.

Solidified waste had to be shoveled into supersacks

Contaminated water pumped into totes

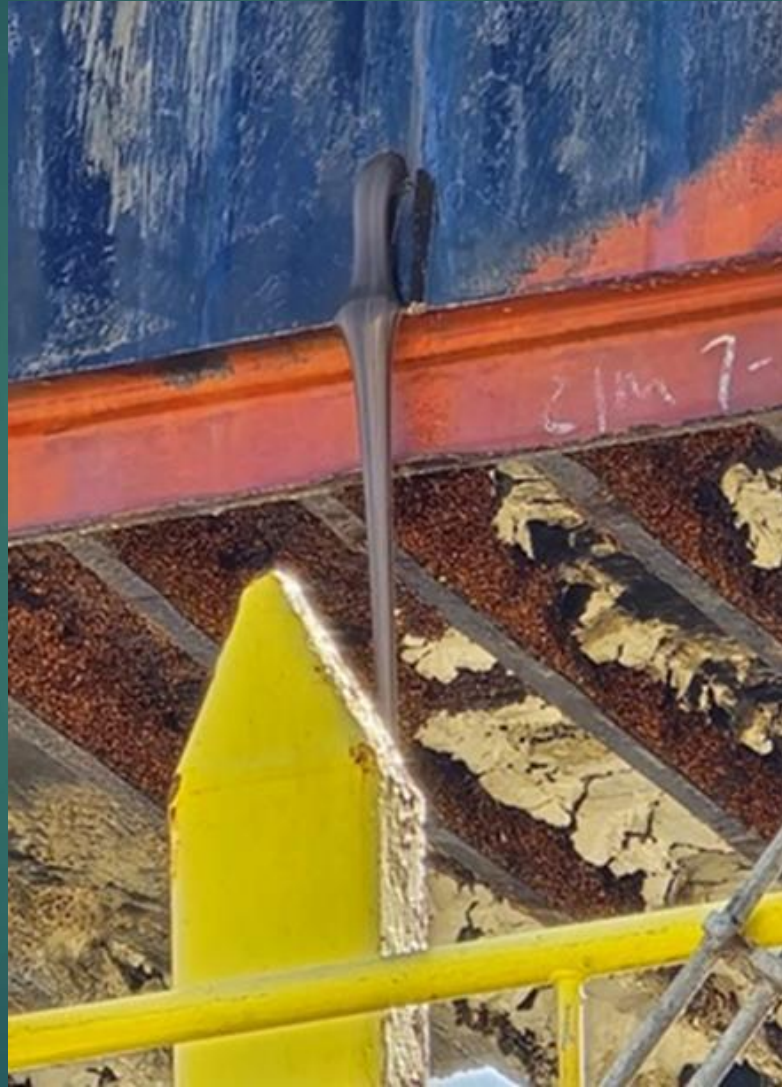
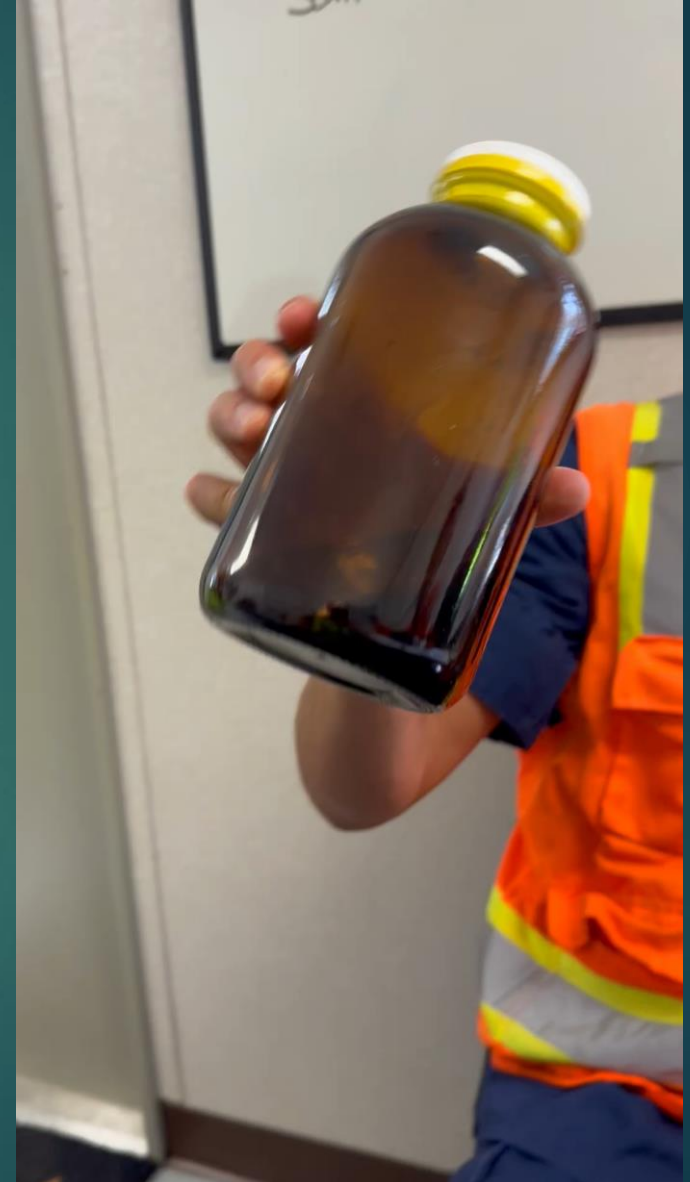
The Sludge

- Field testing revealed that the sludge is heavier than water and sinks readily.
- It will also emulsify upon agitation. Lab samples do not ignite when exposed to flame

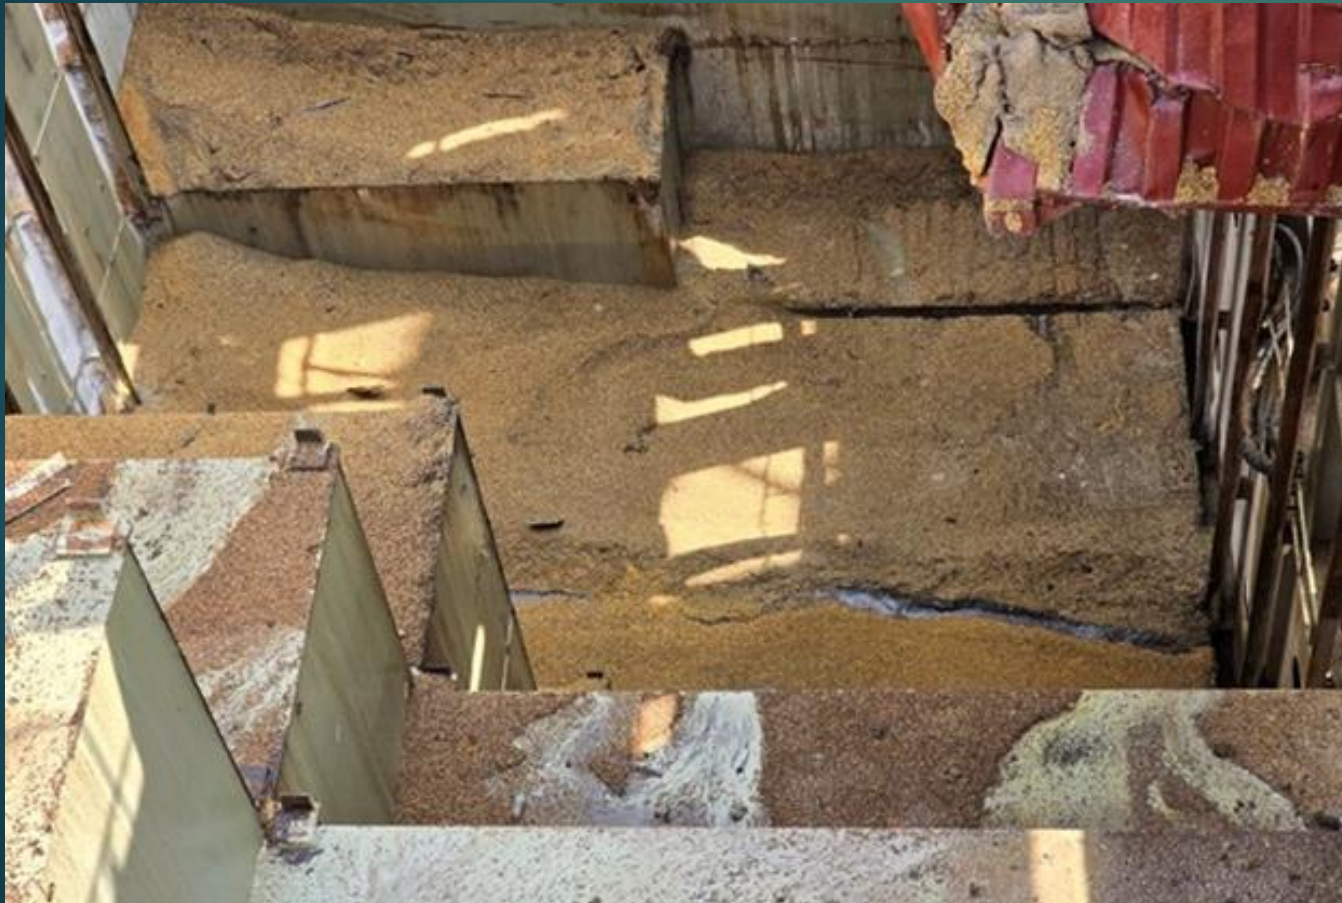
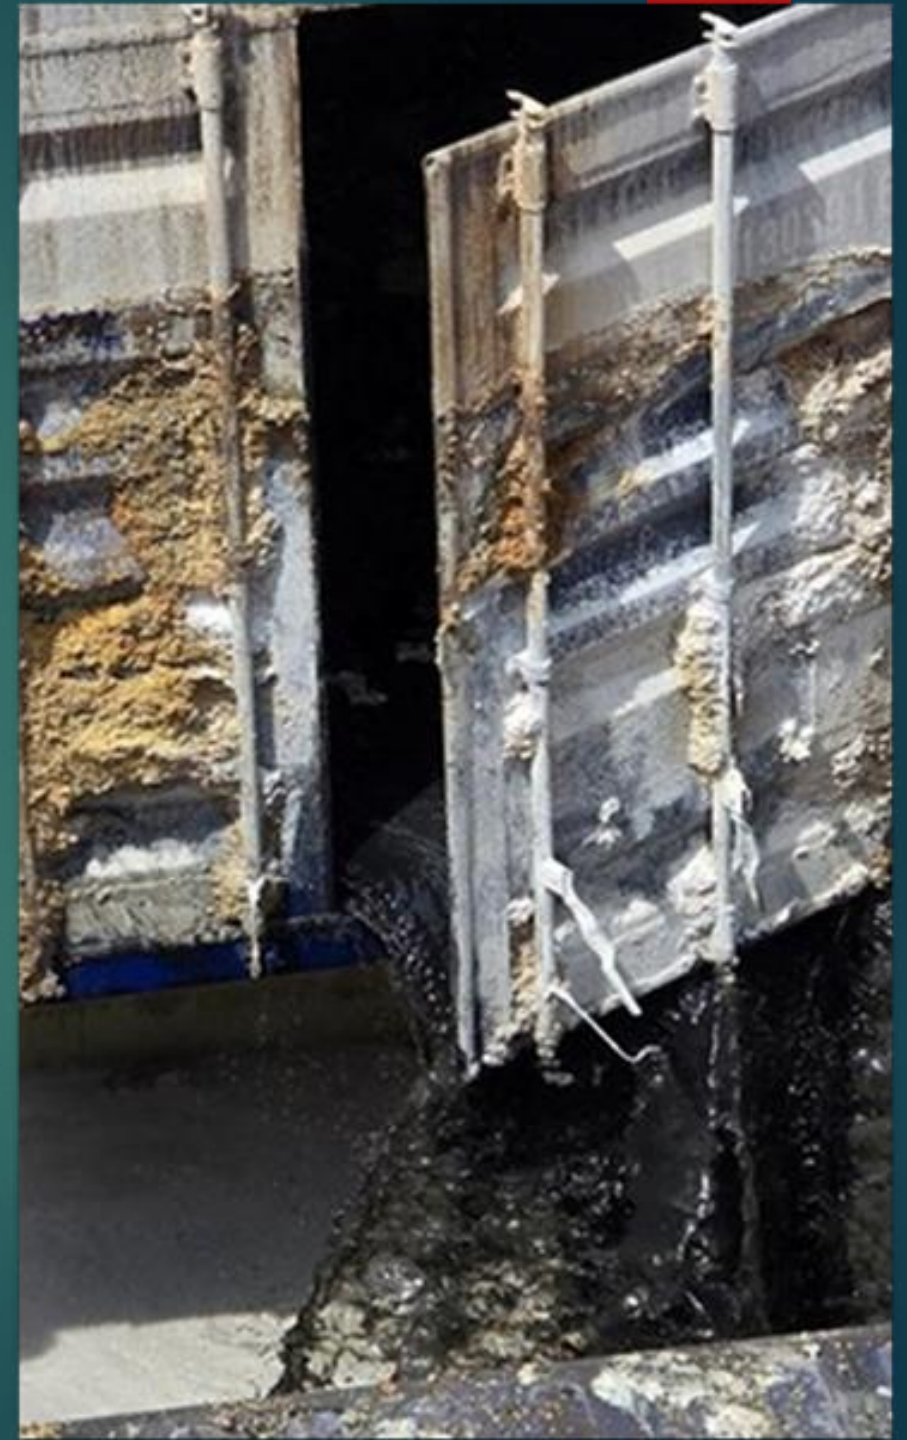
Once debris was cleared from the top, Liquid sludge was revealed underneath piles of soybeans

Several containers were completely submerged

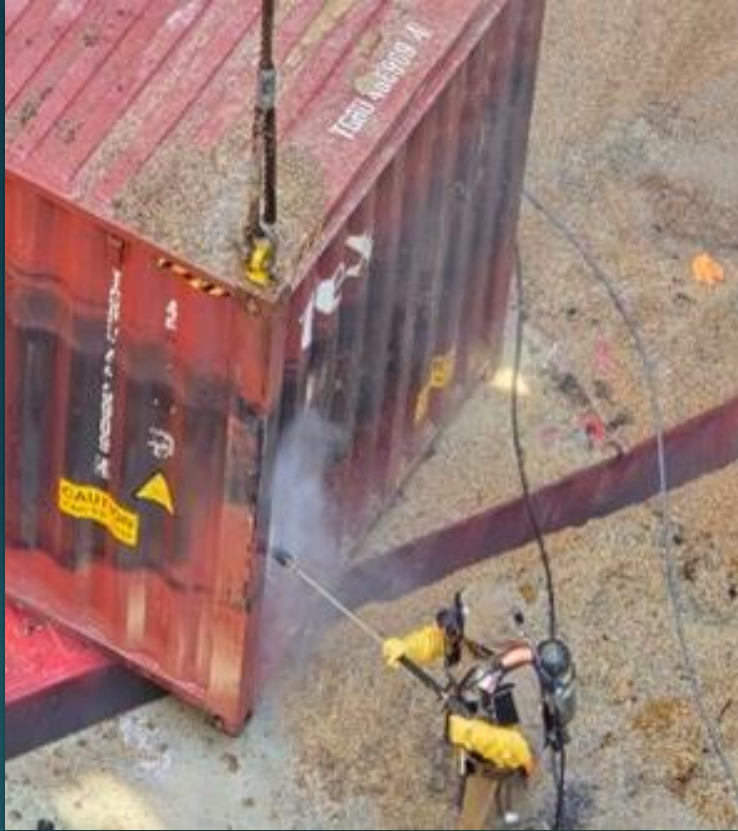
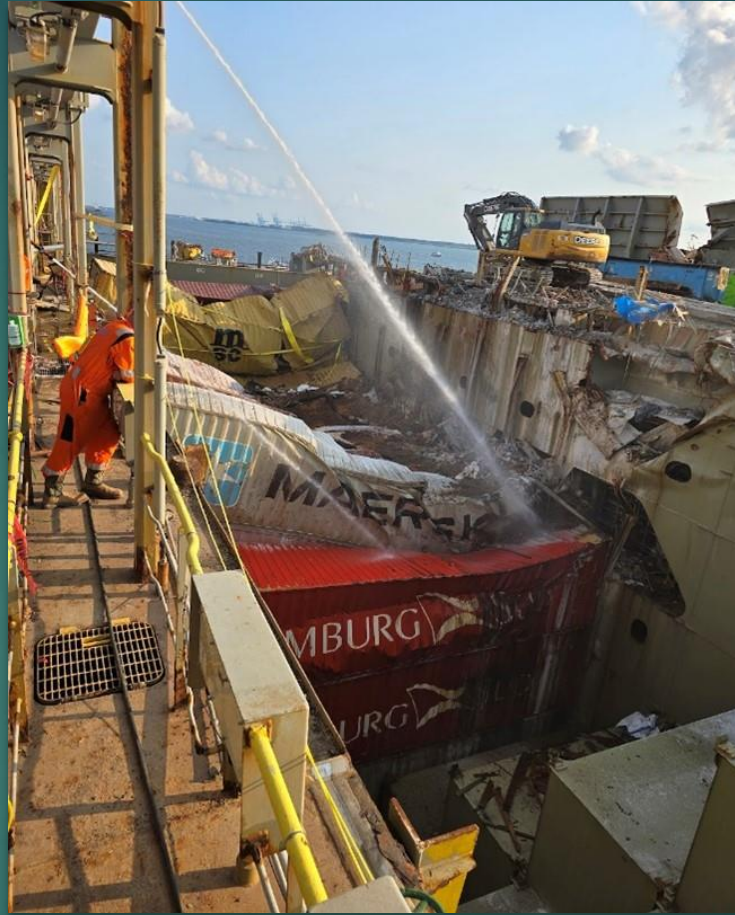
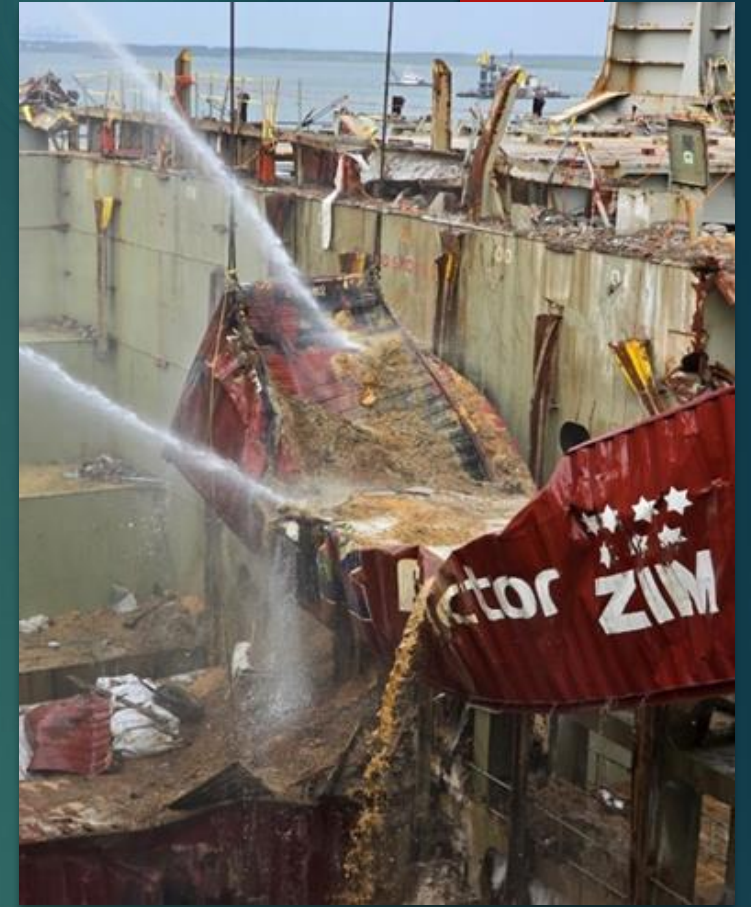
Level B
responders
deconned
containers in
place before
being
offloaded

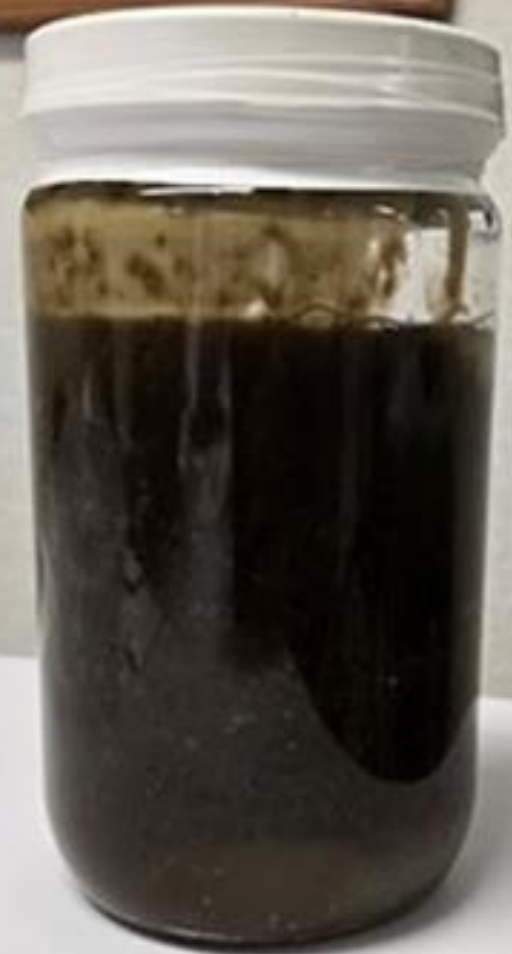
- ▶ Since product sinks in water, boom not effective
- ▶ 50' hose lengths left possibility of connection points mid-air
- ▶ Product not tested for sorbent pad clean up

- ▶ 100' hose length purchased- 6-inch, bolted flange
- ▶ Operate at 150 psi vice 200 MAWP
- ▶ 12' corrugated pipe purchased to act as secondary hose containment
- ▶ Sorbent material tests conducted on sludge
- ▶ (20) 50-lb bags of saw dust ordered for on-deck spills

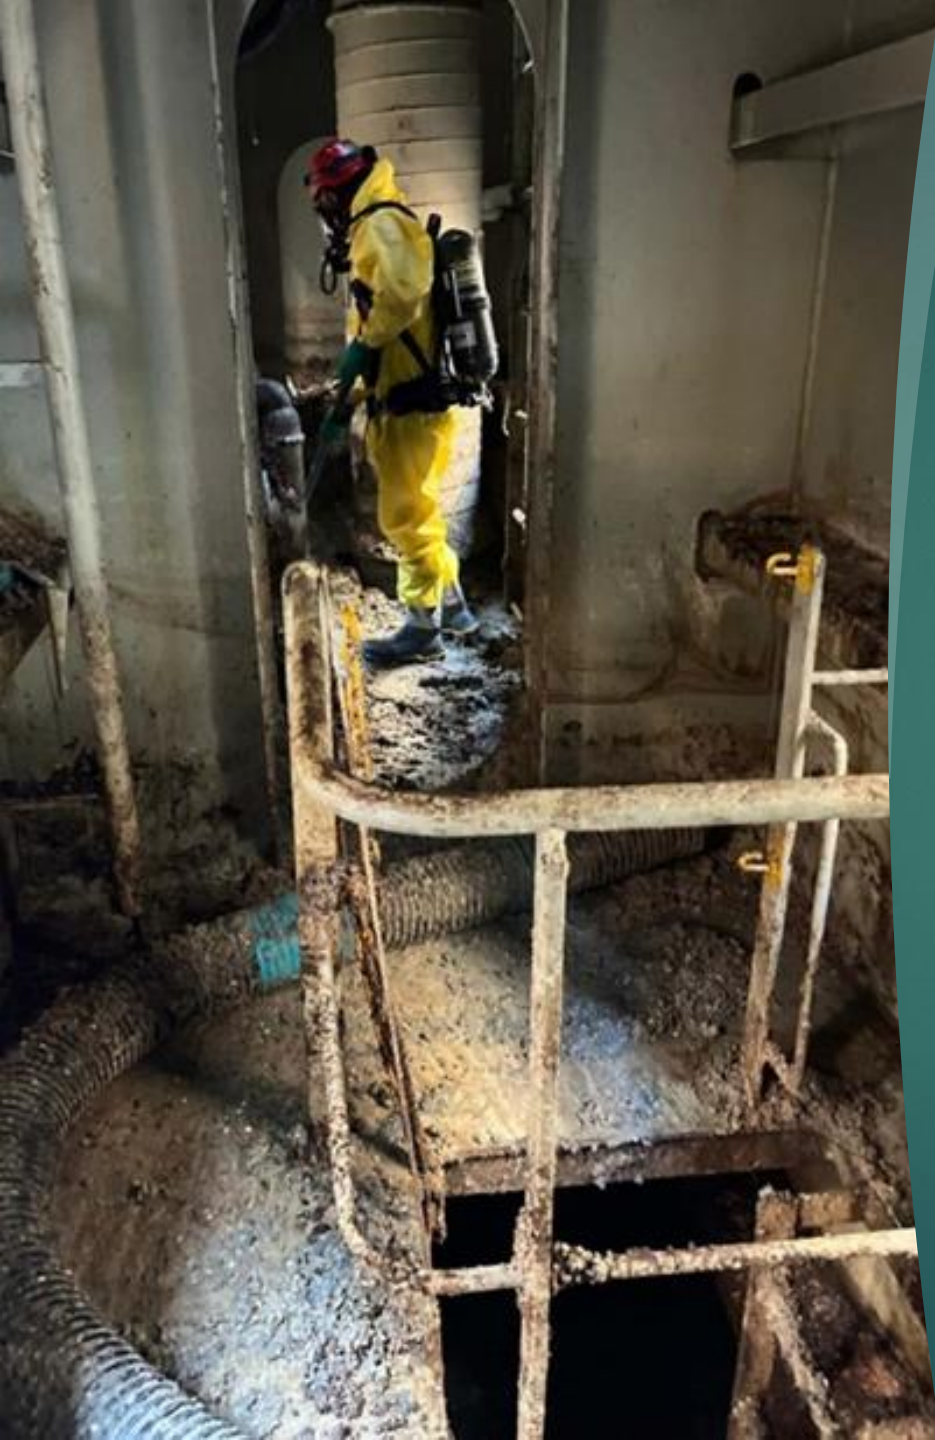
Underdeck Passageway at Tier 04 Level (second from bottom). Shoveling sludge/soybean mixture to bottom of cargo hold and towards pump. Level B primarily for high H₂S readings.

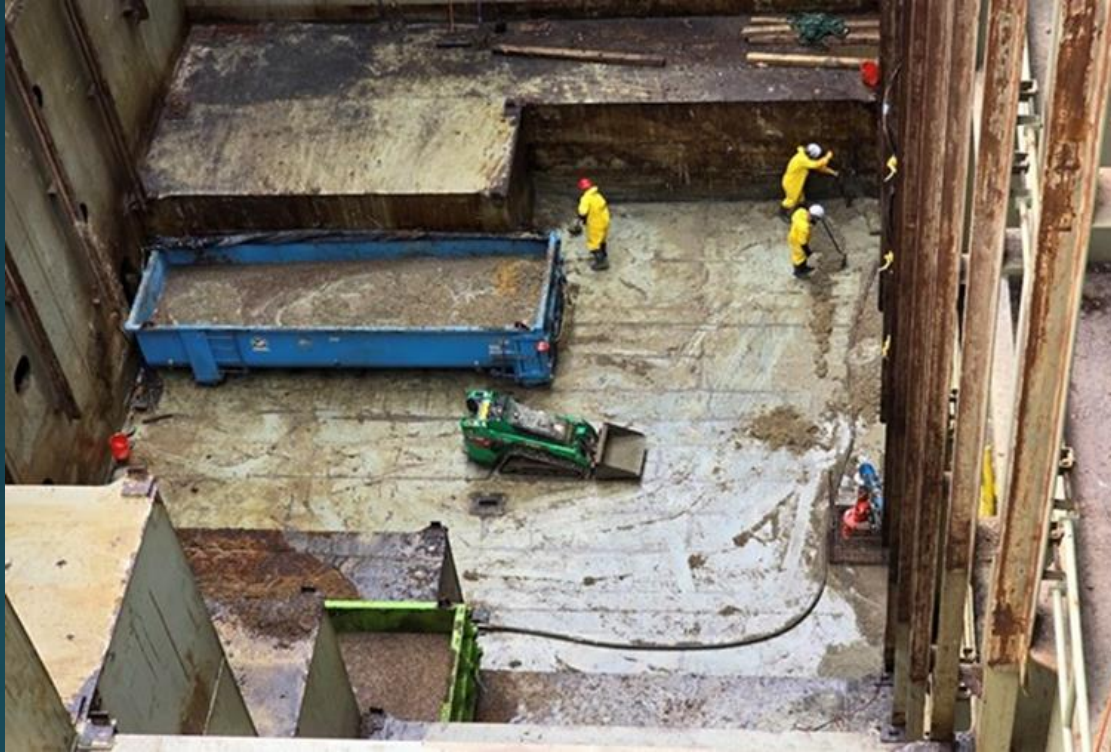
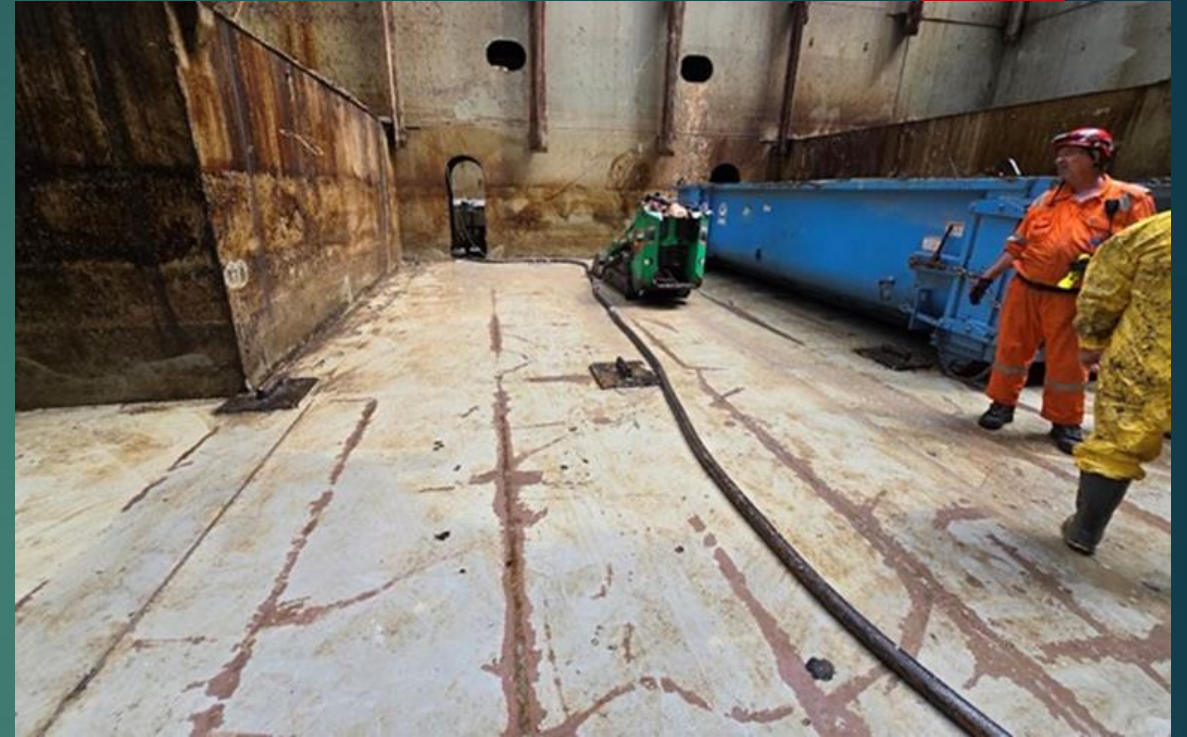
02SEP24: Hold 01 was tested by the Marine Chemist and observed by WOB, Resolve Salvage Master, and the Chief Mate. It was determined that the hold is safe and clean.
