# Barge MM 46 Response Natchez, MS Lower Mississippi River Mile Marker 363

# Barge MM 46 Response, Natchez, MS

<b>RRT Activation:</b>	None
<b>Type of Product &amp; Amount spilled:</b>	Catalytic Cracked Clarified Oil (CCFB) Pends Final Investigation ~ 3,150 gallons
<b>Cause of Spill:</b>	UTV AMY FRANCES struck Natchez Highway 84 Bridge, #1 Port tank of lead port Barge MM 46 damaged
<b>Date of Spill:</b>	21 January 2016
<b>Responsible Party:</b>	Magnolia Marine Transport (MMT)
<b>Agencies Involved:</b>	MS DEQ, LA DEQ, NOAA, USACE, USFWS, MS SHPO, US EPA (R4 & R6)
<b>Key Operational Activities:</b>	Recovery of spilled oil Ongoing SCAT Barge lightering Transit of barge for final repairs
<b>Major Lessons Learned:</b>	River conditions affected ability to locate spilled CCFB; Use of USACE Side Scan Sonar equipment Consultation with SHPO & USFWS
<b>Other:</b>	USCG IMAT and GST assisted

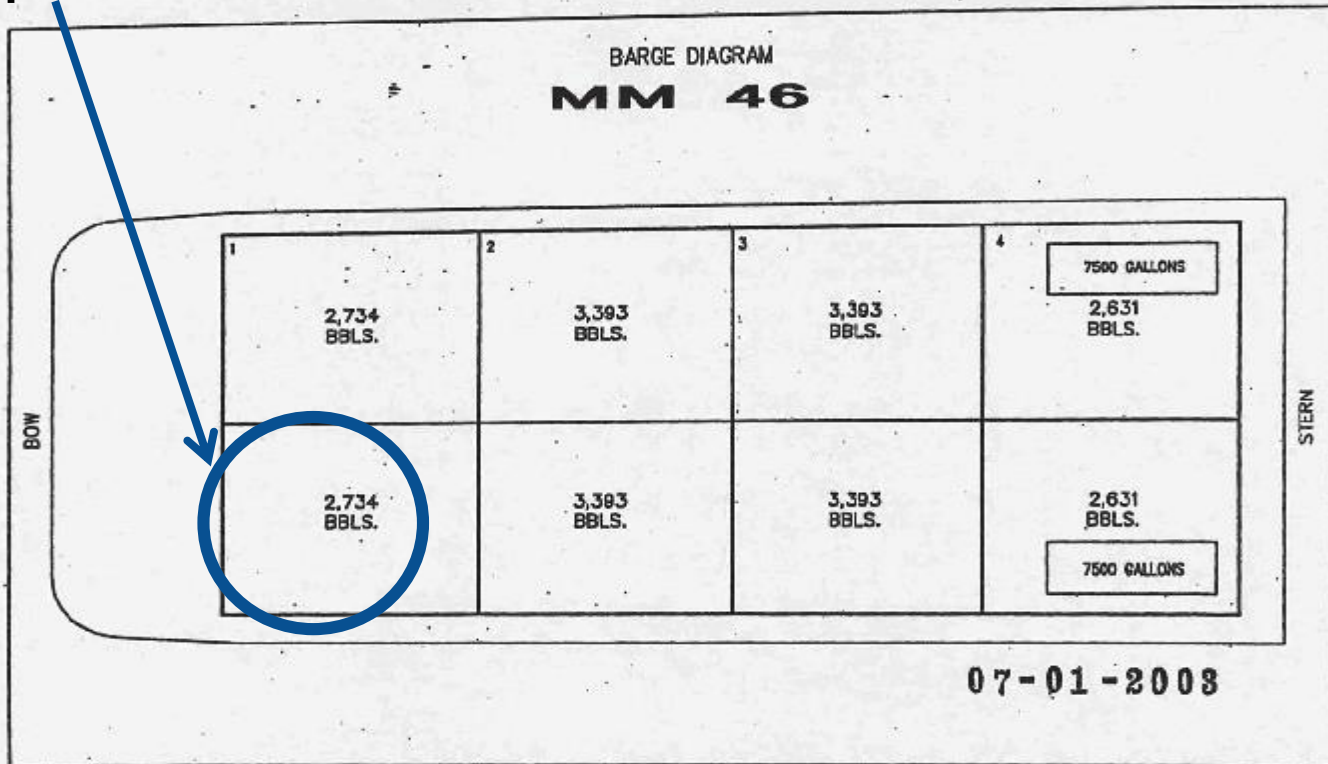
# Barge MM 46 Diagram

Compromised Tank

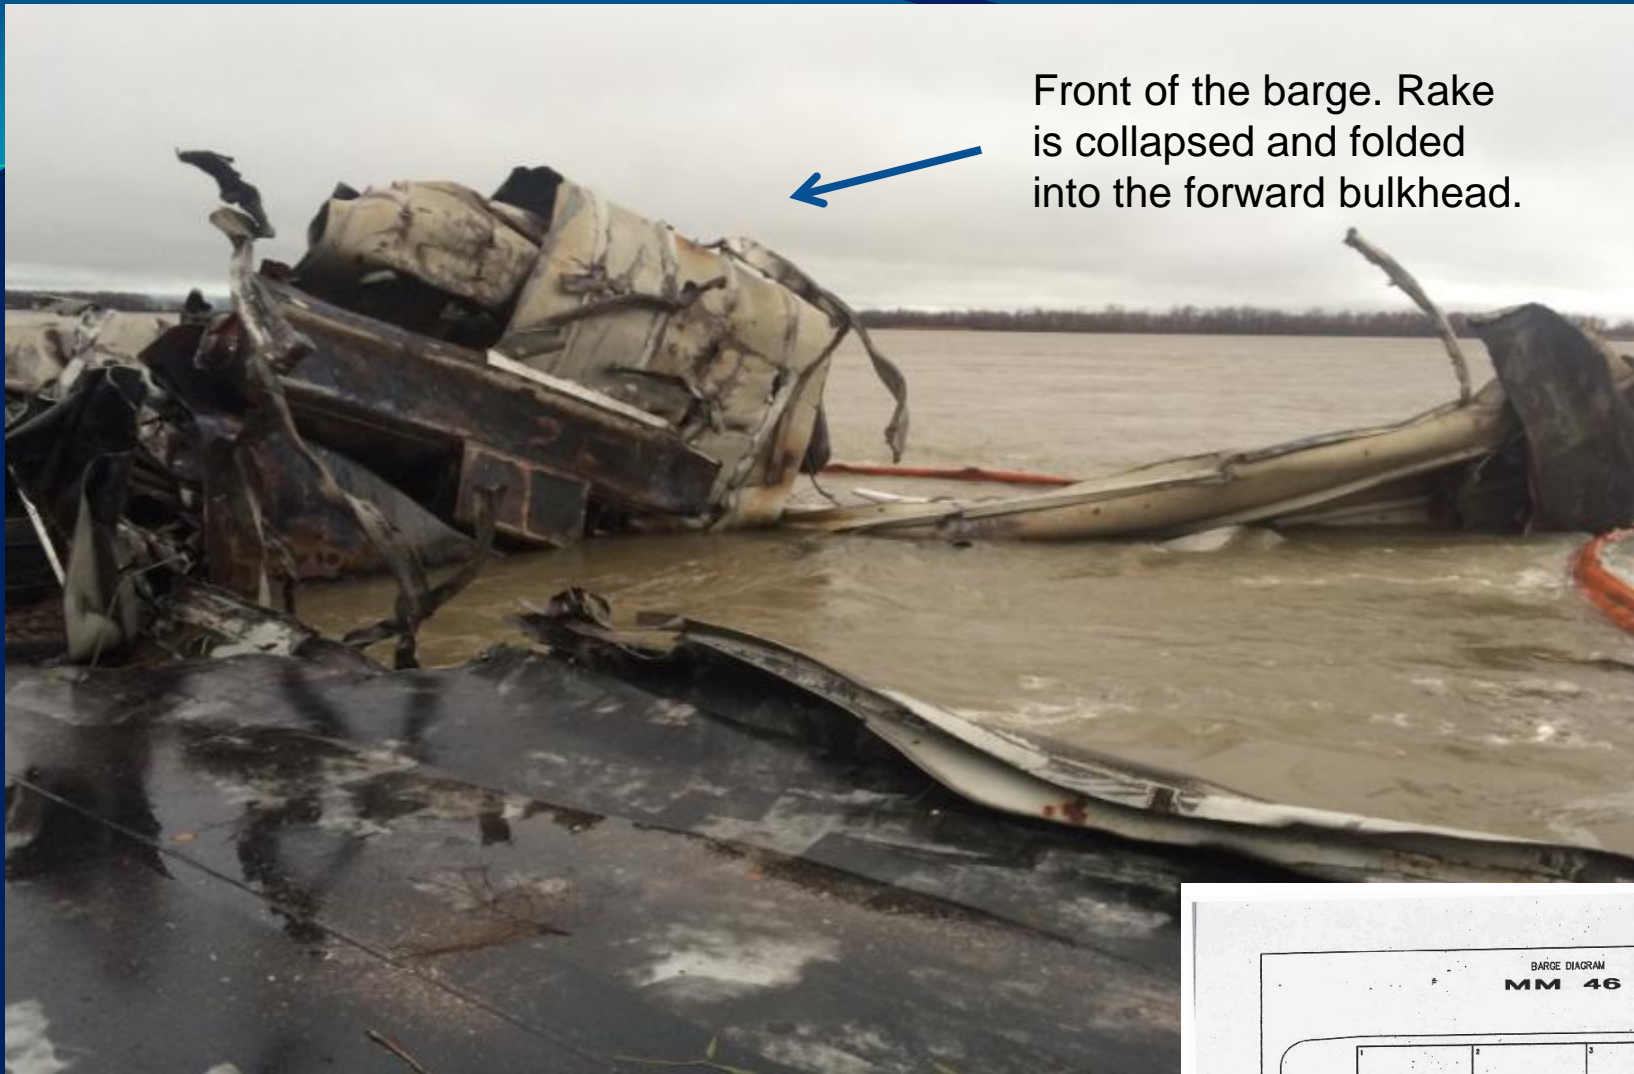
Front of the barge. Rake is collapsed and folded into the forward bulkhead.

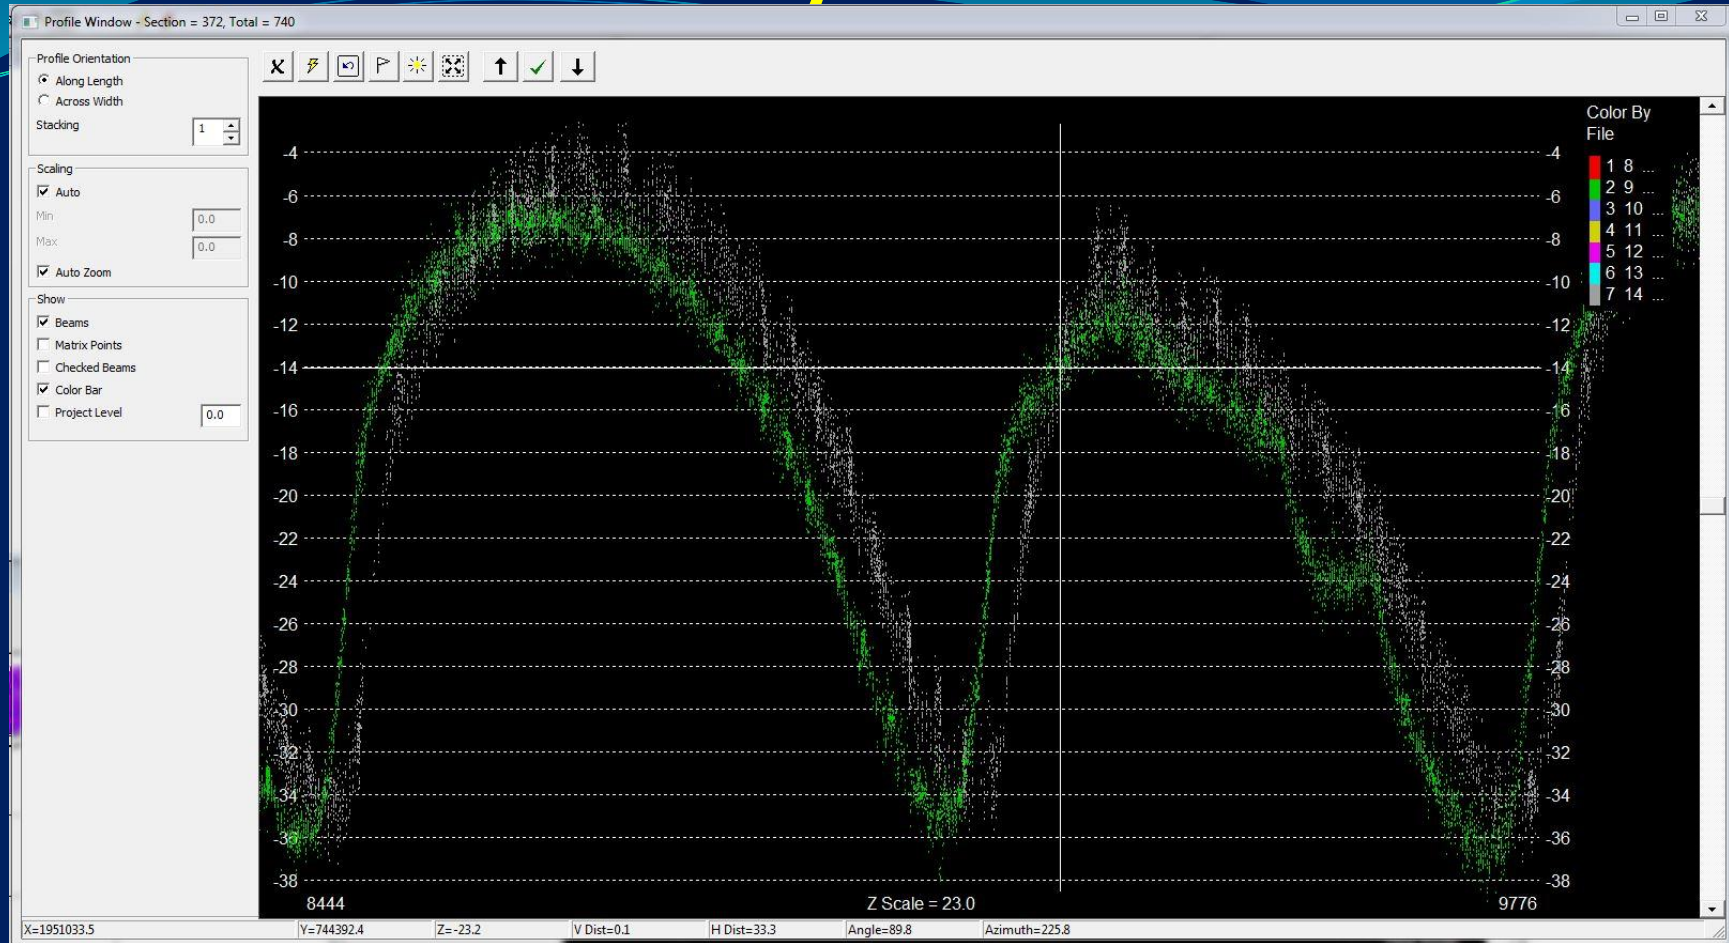
The gray line is a longitudinal profile from the multibeam starting near the bridge. The green line started near the bridge 2 hours later. The sand waves are moving from right to left, 30 feet tall and 600 feet long. The downstream face of the sand waves moved about 30 feet in 2 hours.

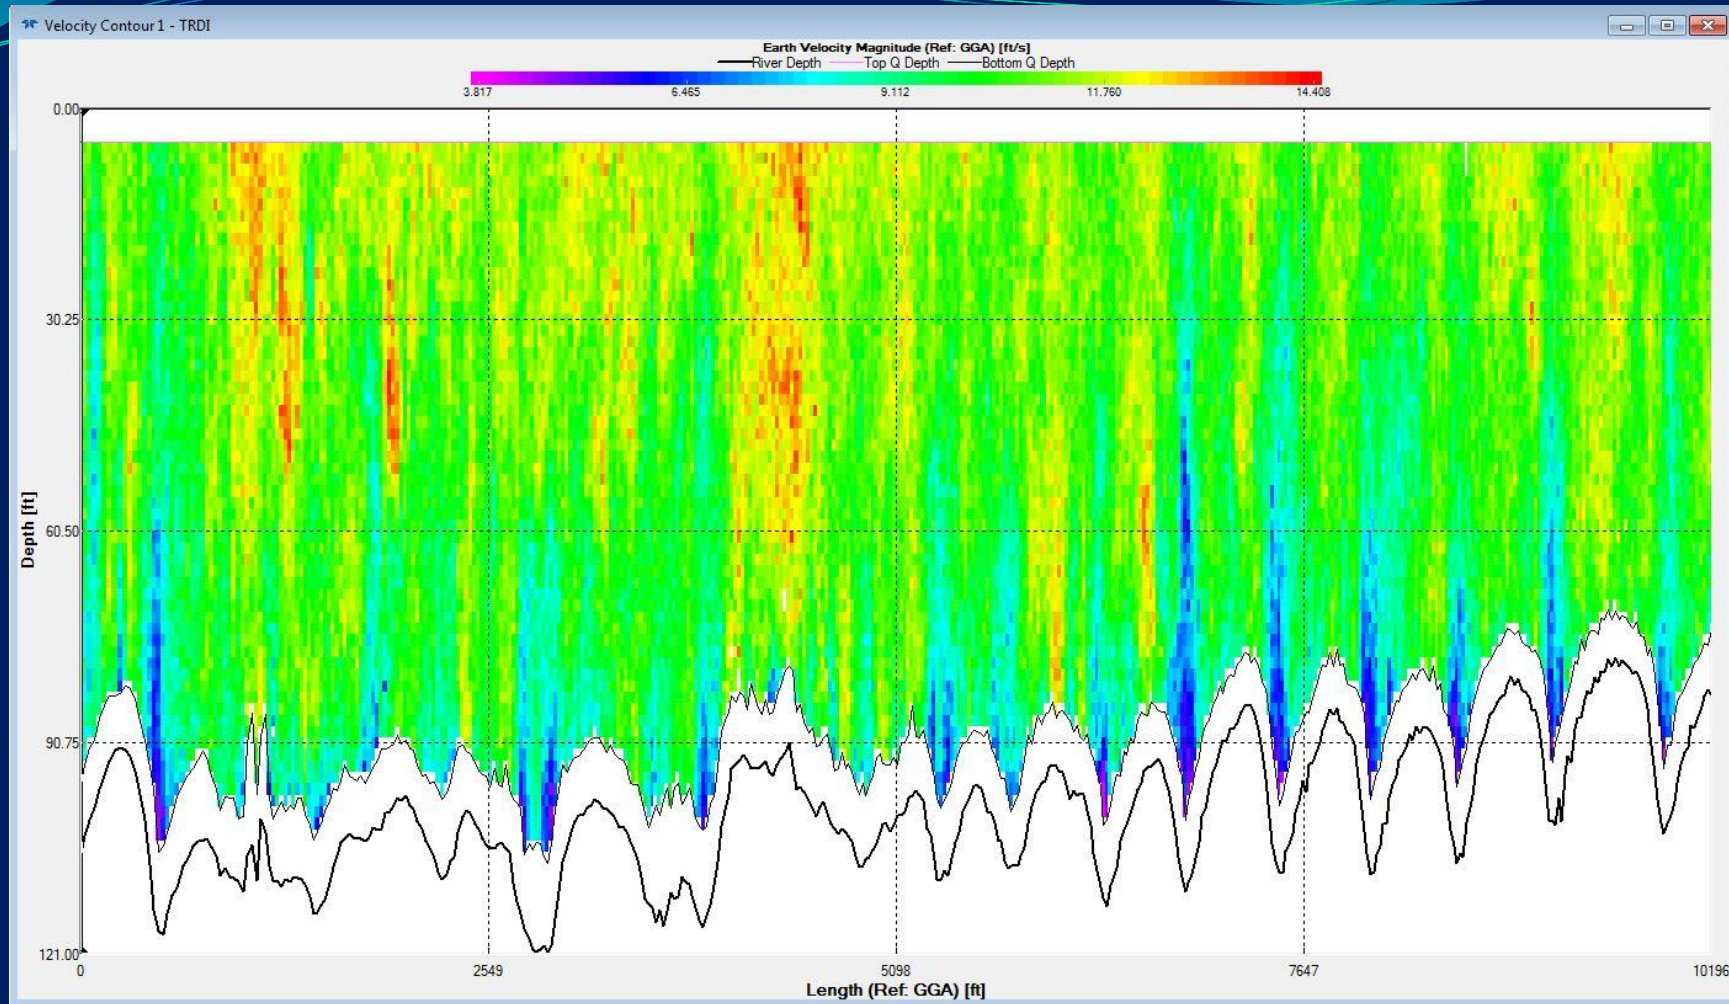
Velocity magnitude for 10000 feet of a longitudinal transect. The heavy black line at the bottom of the profile shows the sand waves on the channel bottom.

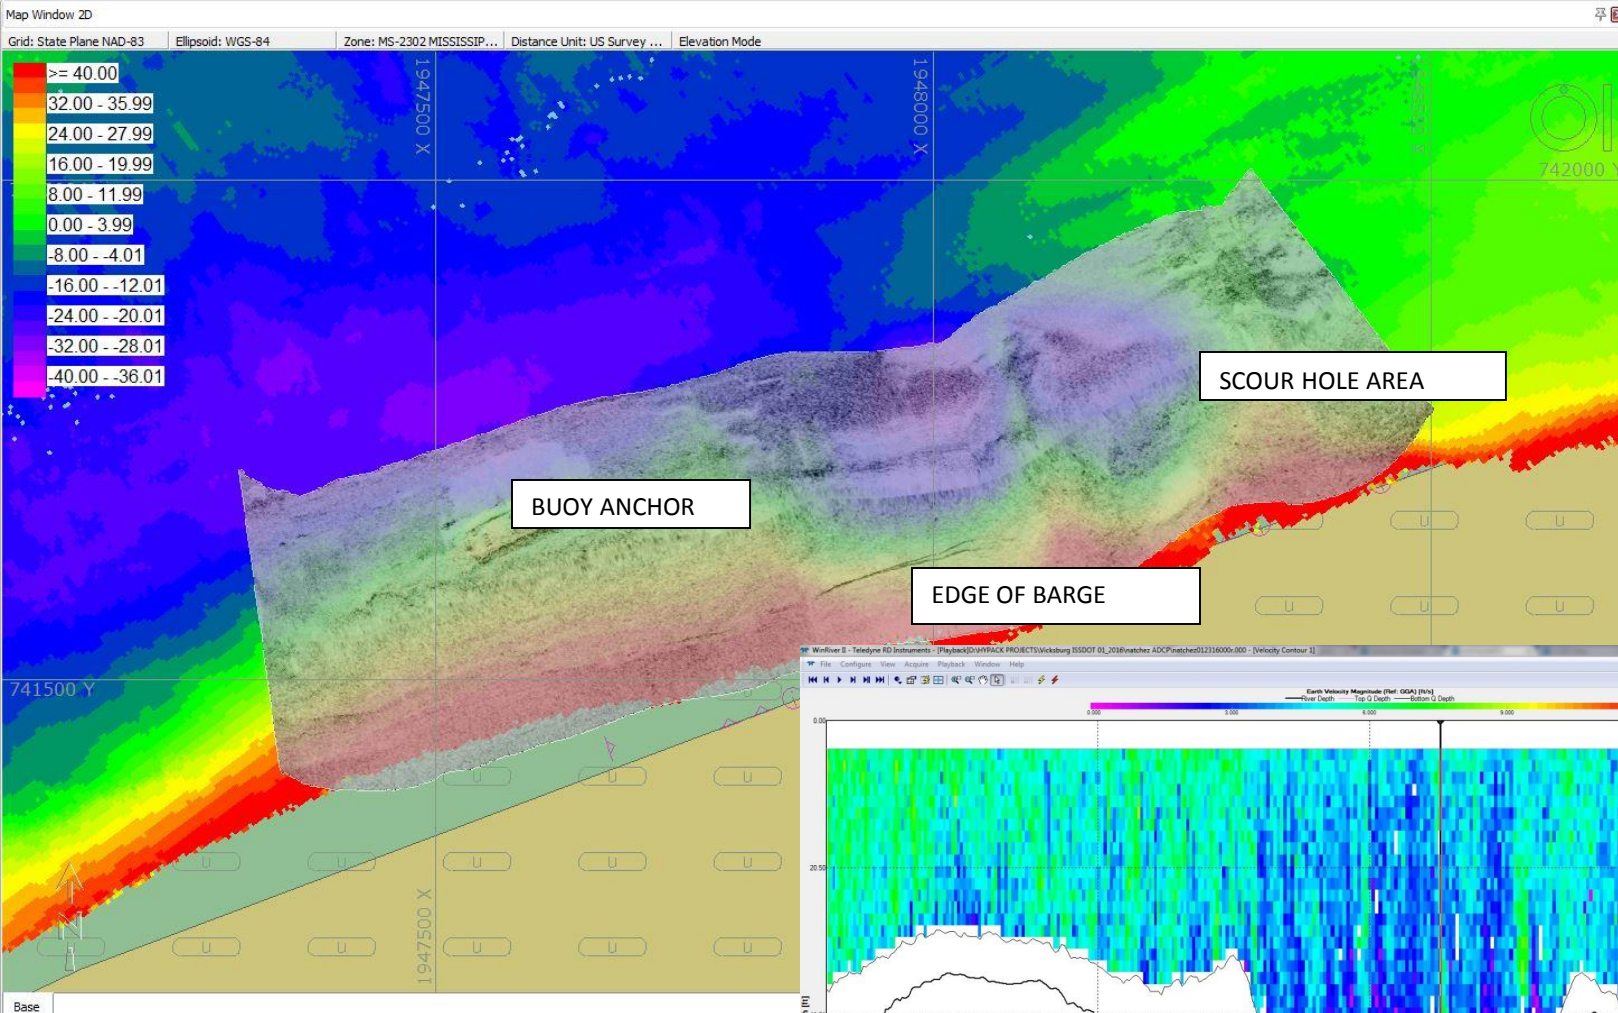
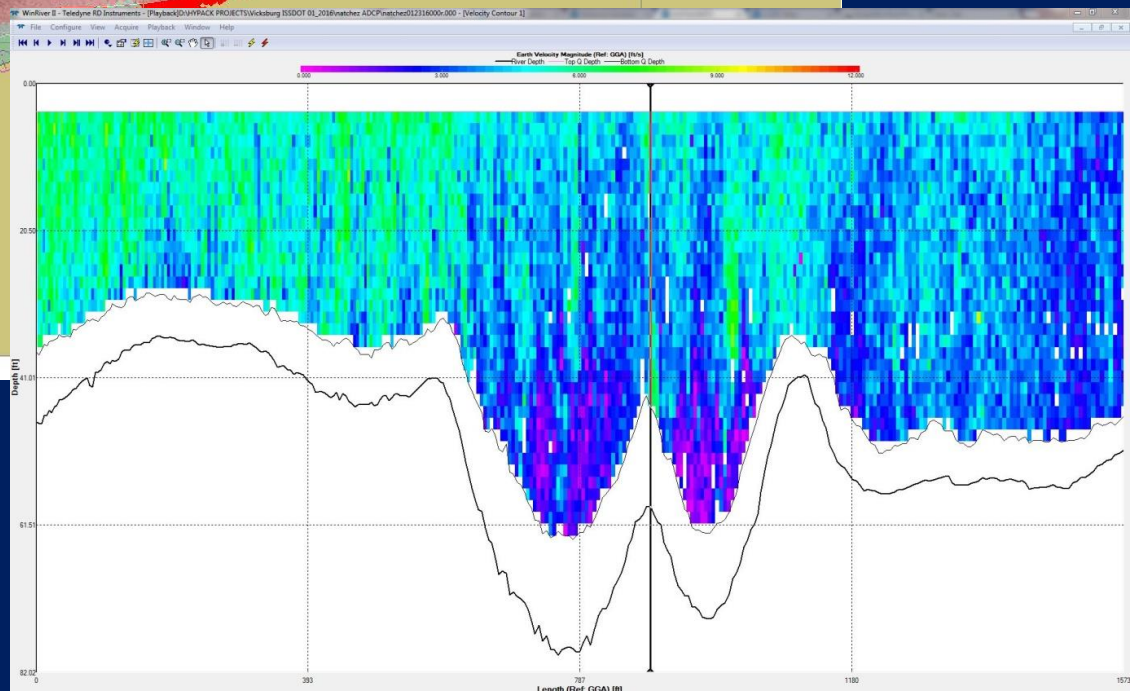
Area of Low Velocity near the barge in the 2 deep scour holes

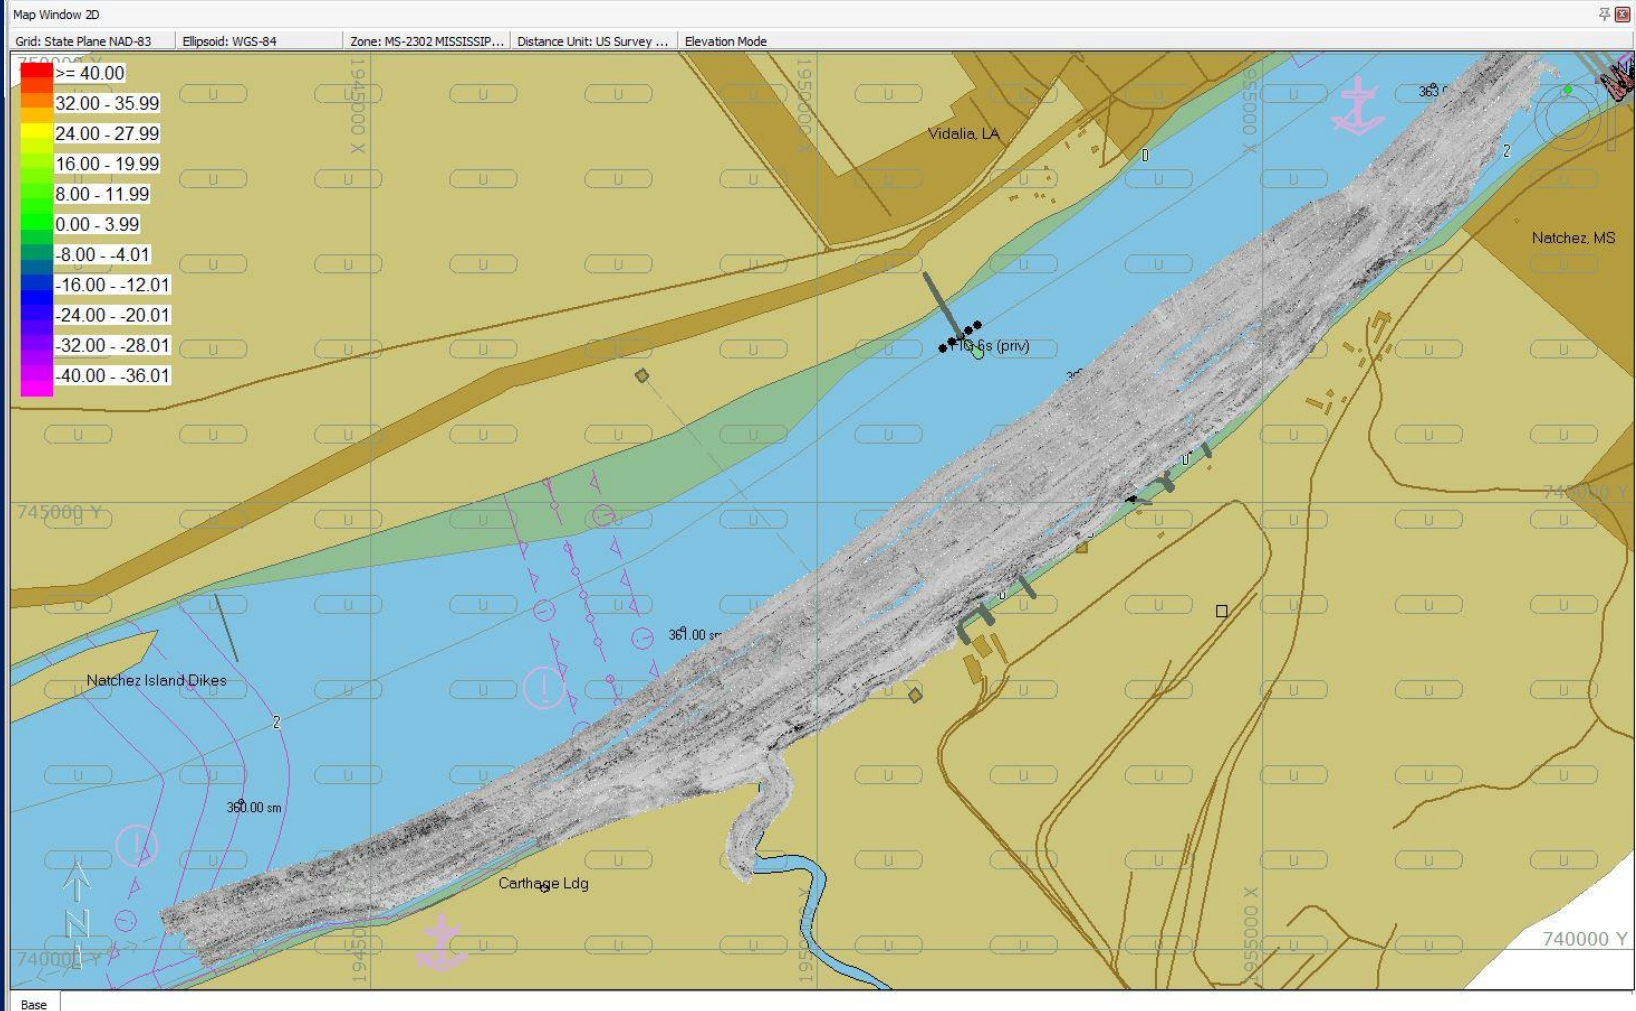
No anomalies noted.

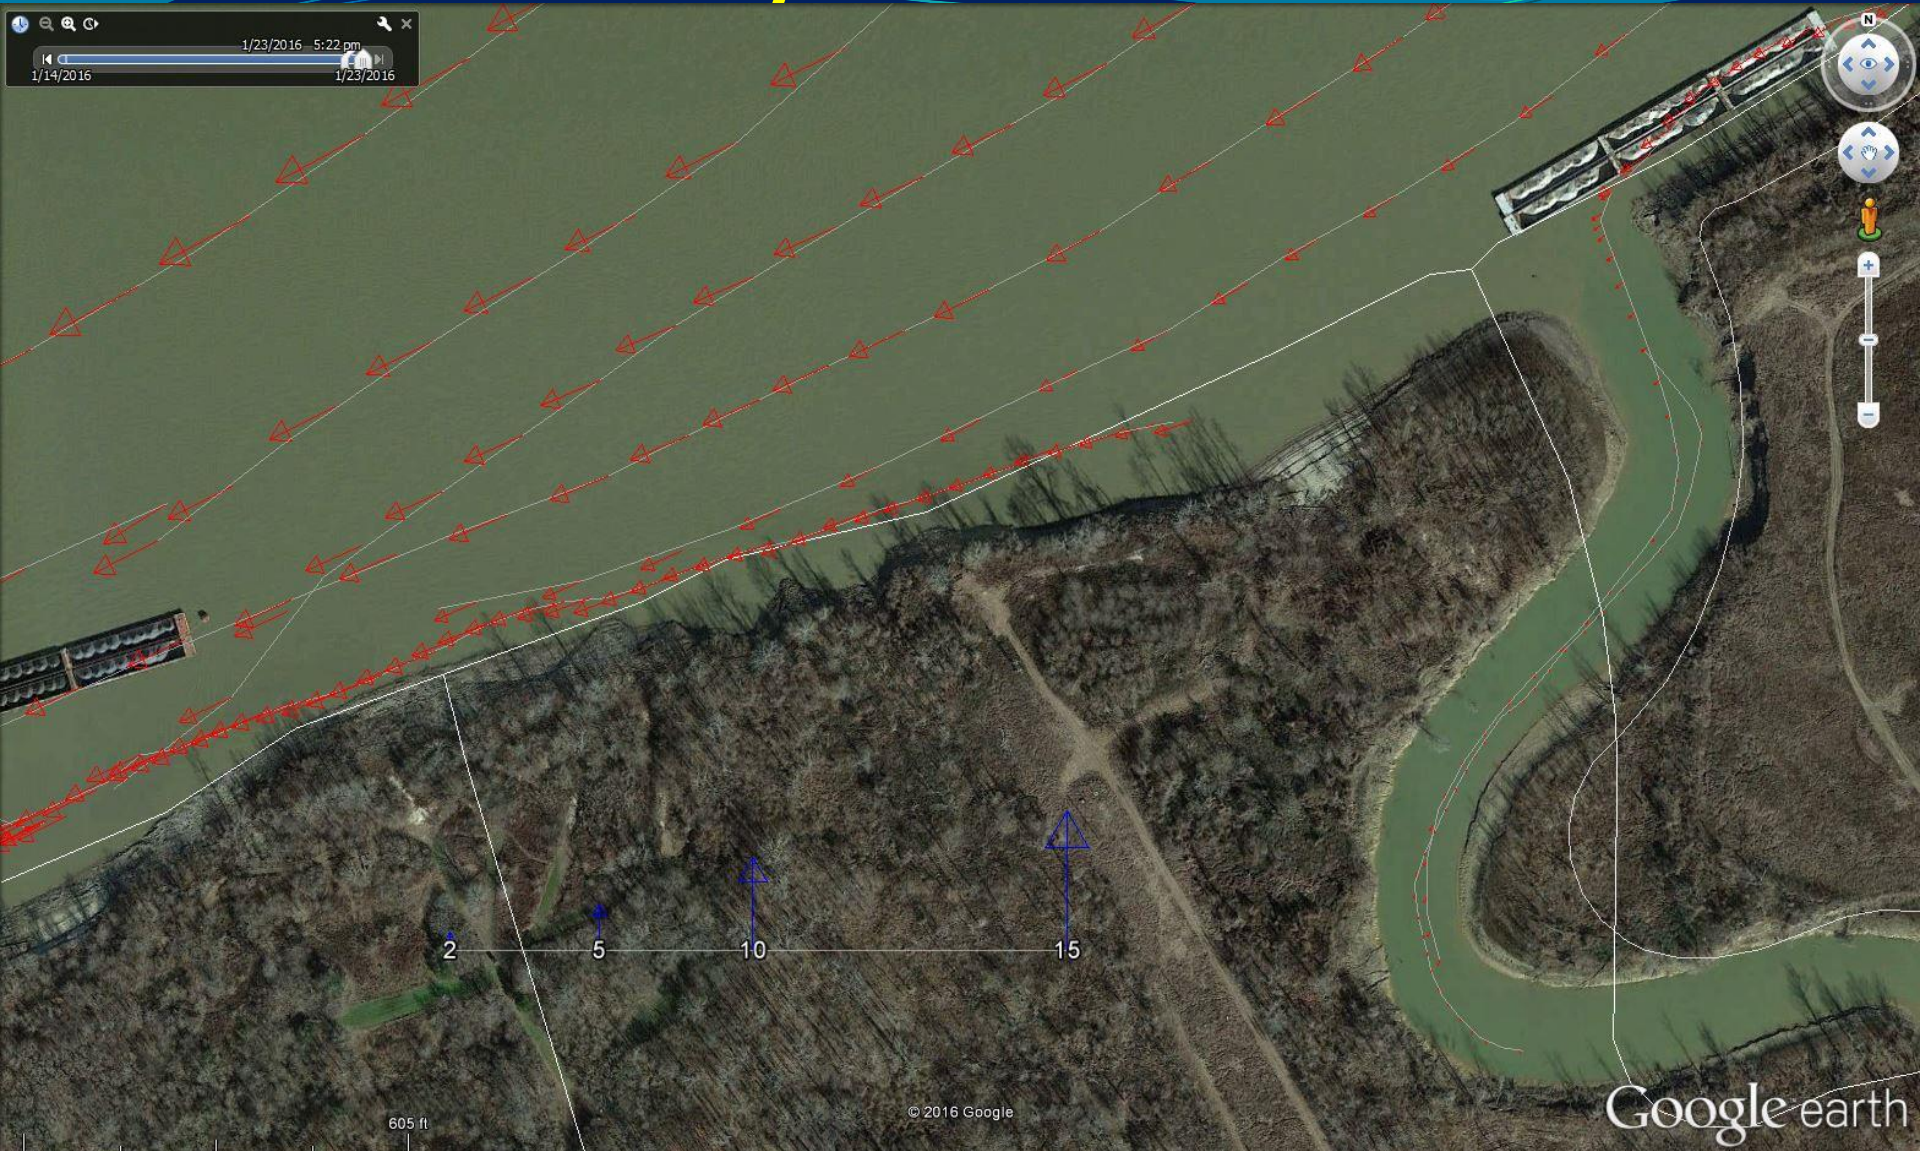
Longer arrows indicating faster velocity in center channel  
Shorter arrows indicating slower velocity along barge location

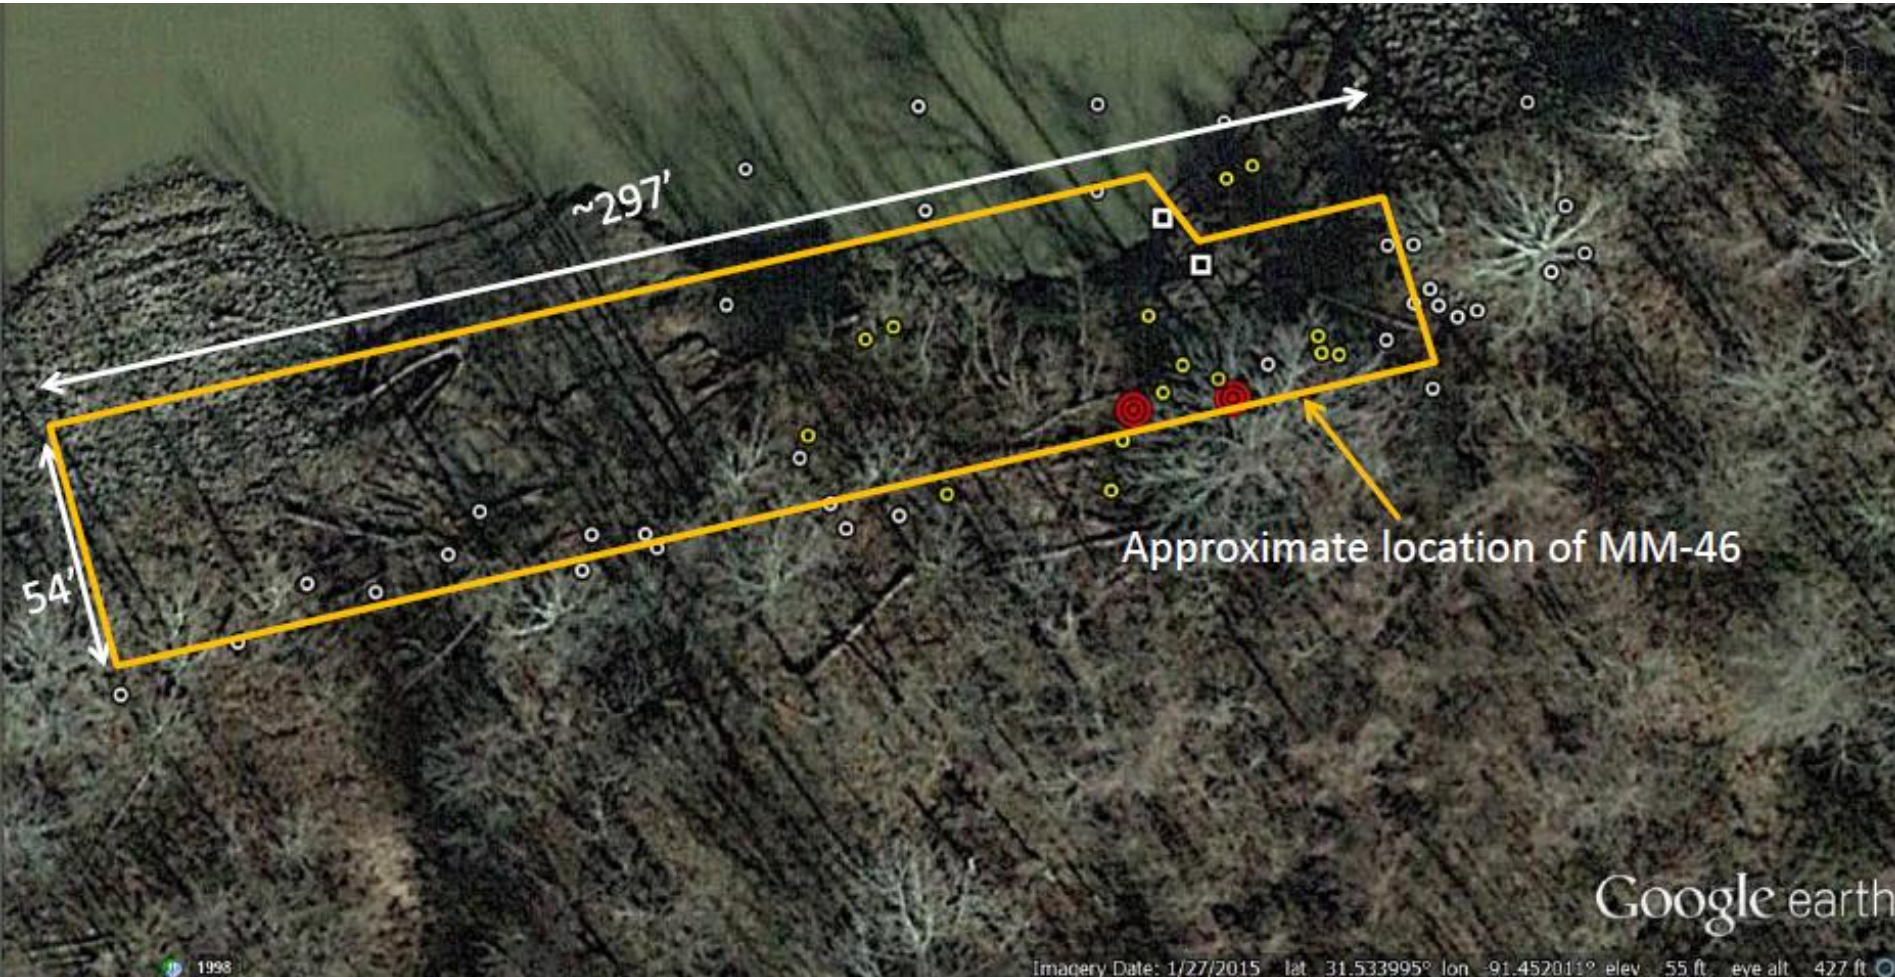
Jan 24 & Jan 25 VSORS Results

White filled dots were Non Detect, Yellow filled dots were trace, Red filled were the Q-Tip Method

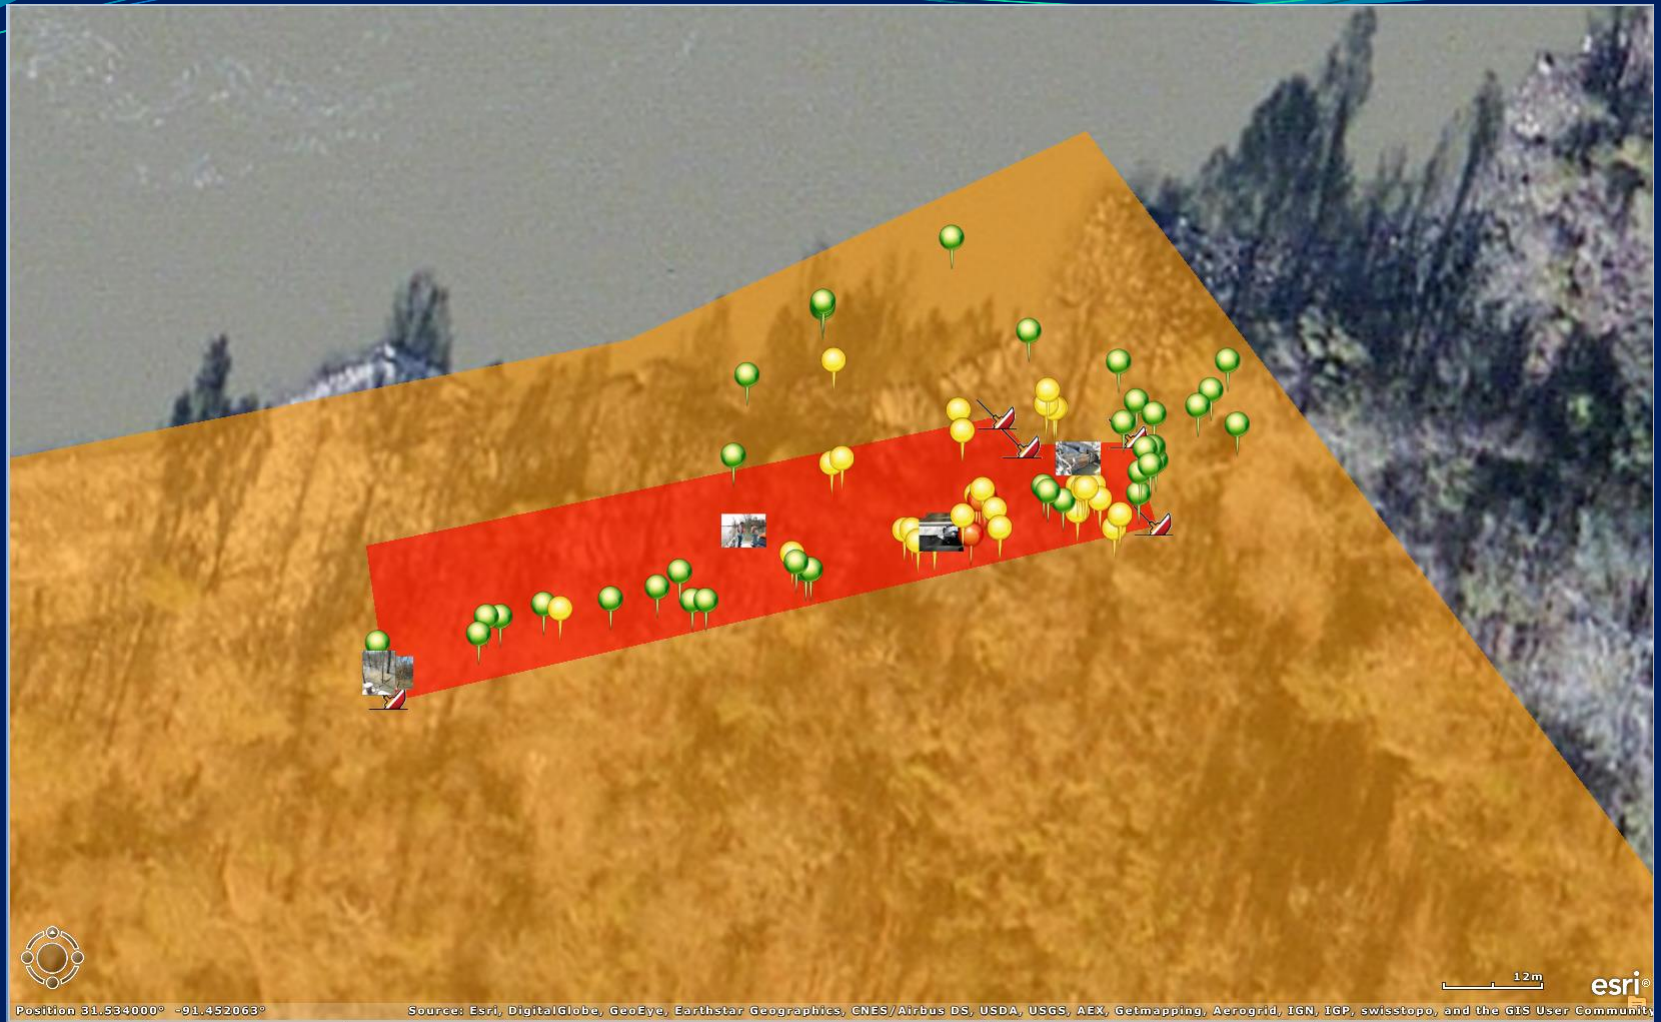
# VSORS- Bottom Sampling 25 Jan

Green – Non Detect, weighted sorbent snare  
Yellow – Non Detect, weighted sorbent snare  
Red – Detect using “Q-tip”
