# Guayanilla Bay

Chronic oil release

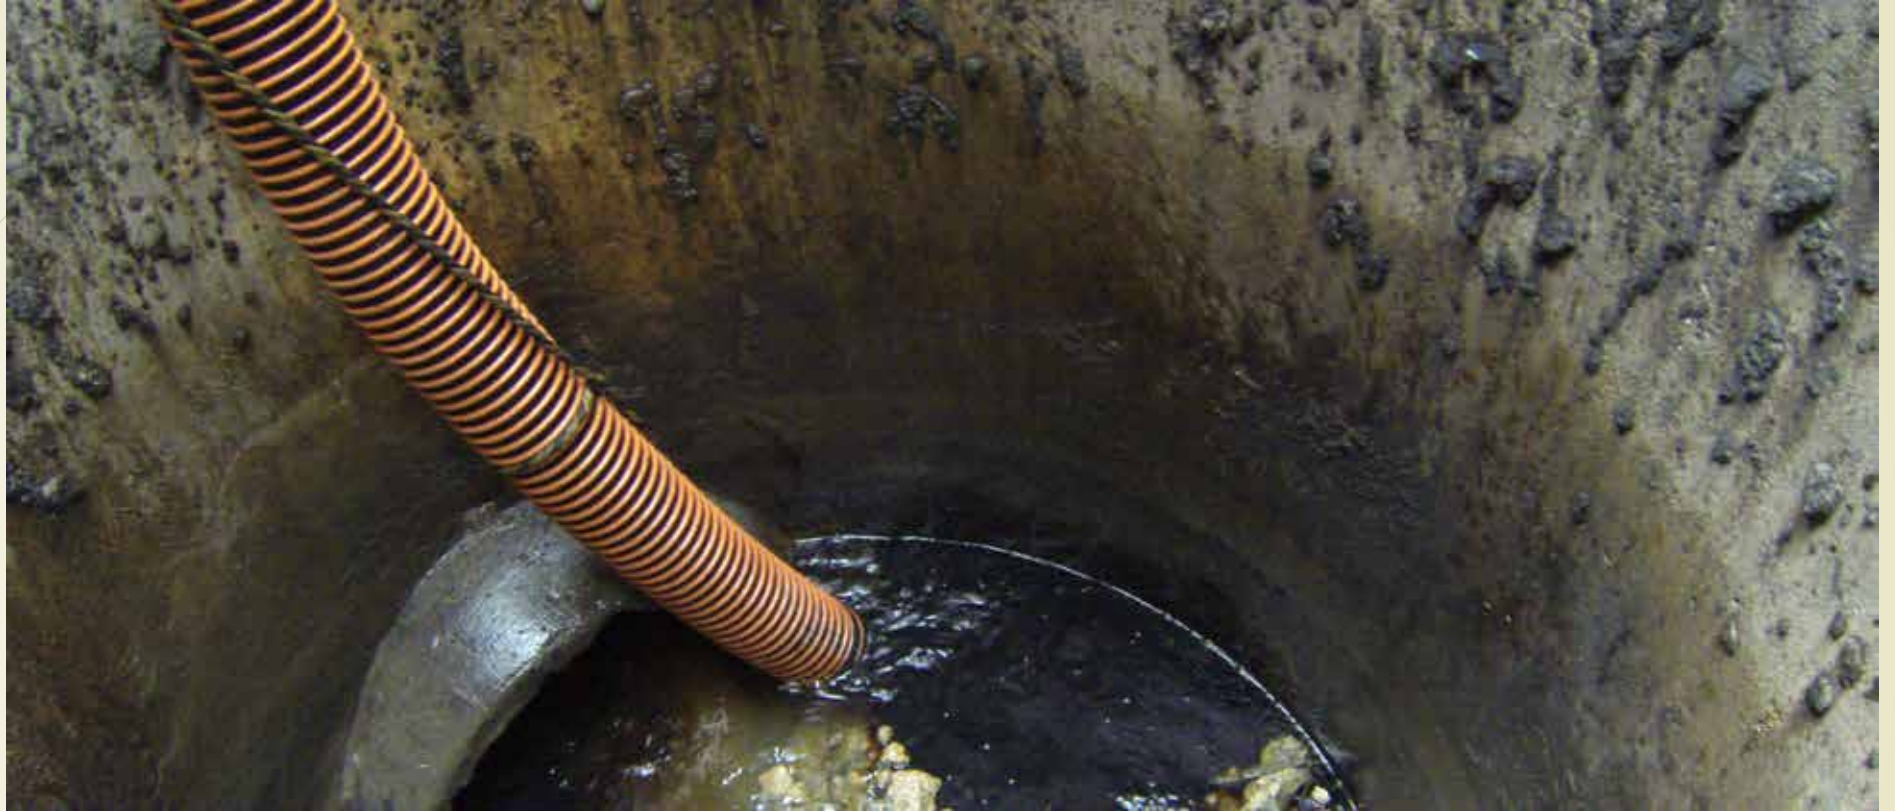
## Manhole #2

Located between Highway 127 and the PREPA property. Primary point of oil recovery.

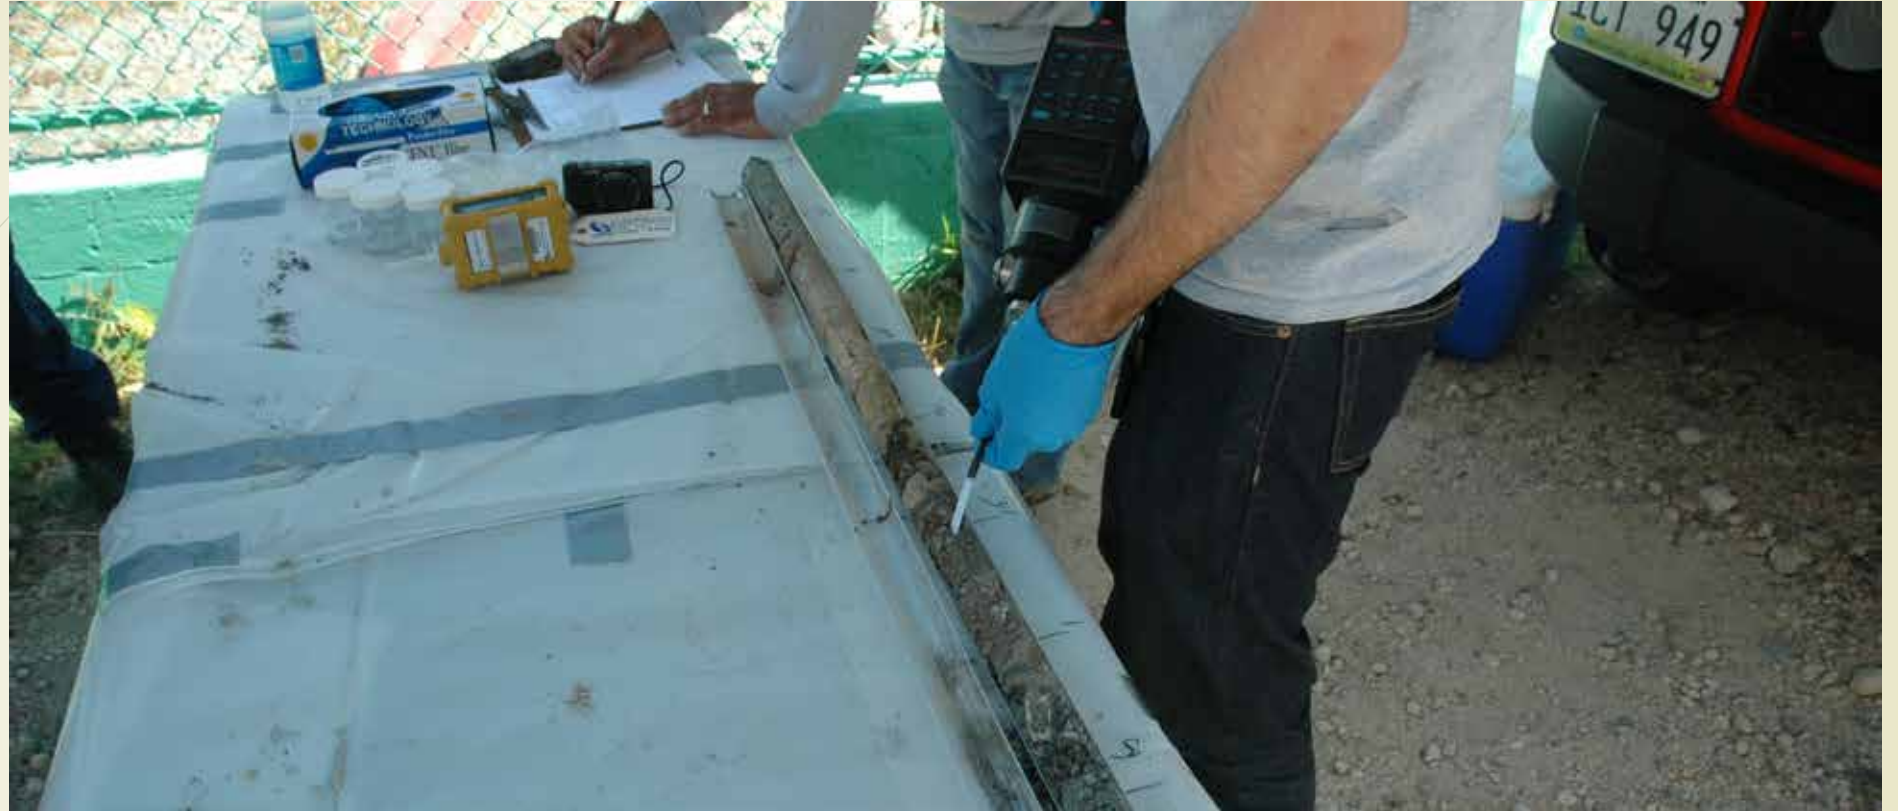
## Core samples were collected along the storm drain

Samples collected to a depth of twelve feet to get to the water table on the outside of the drain

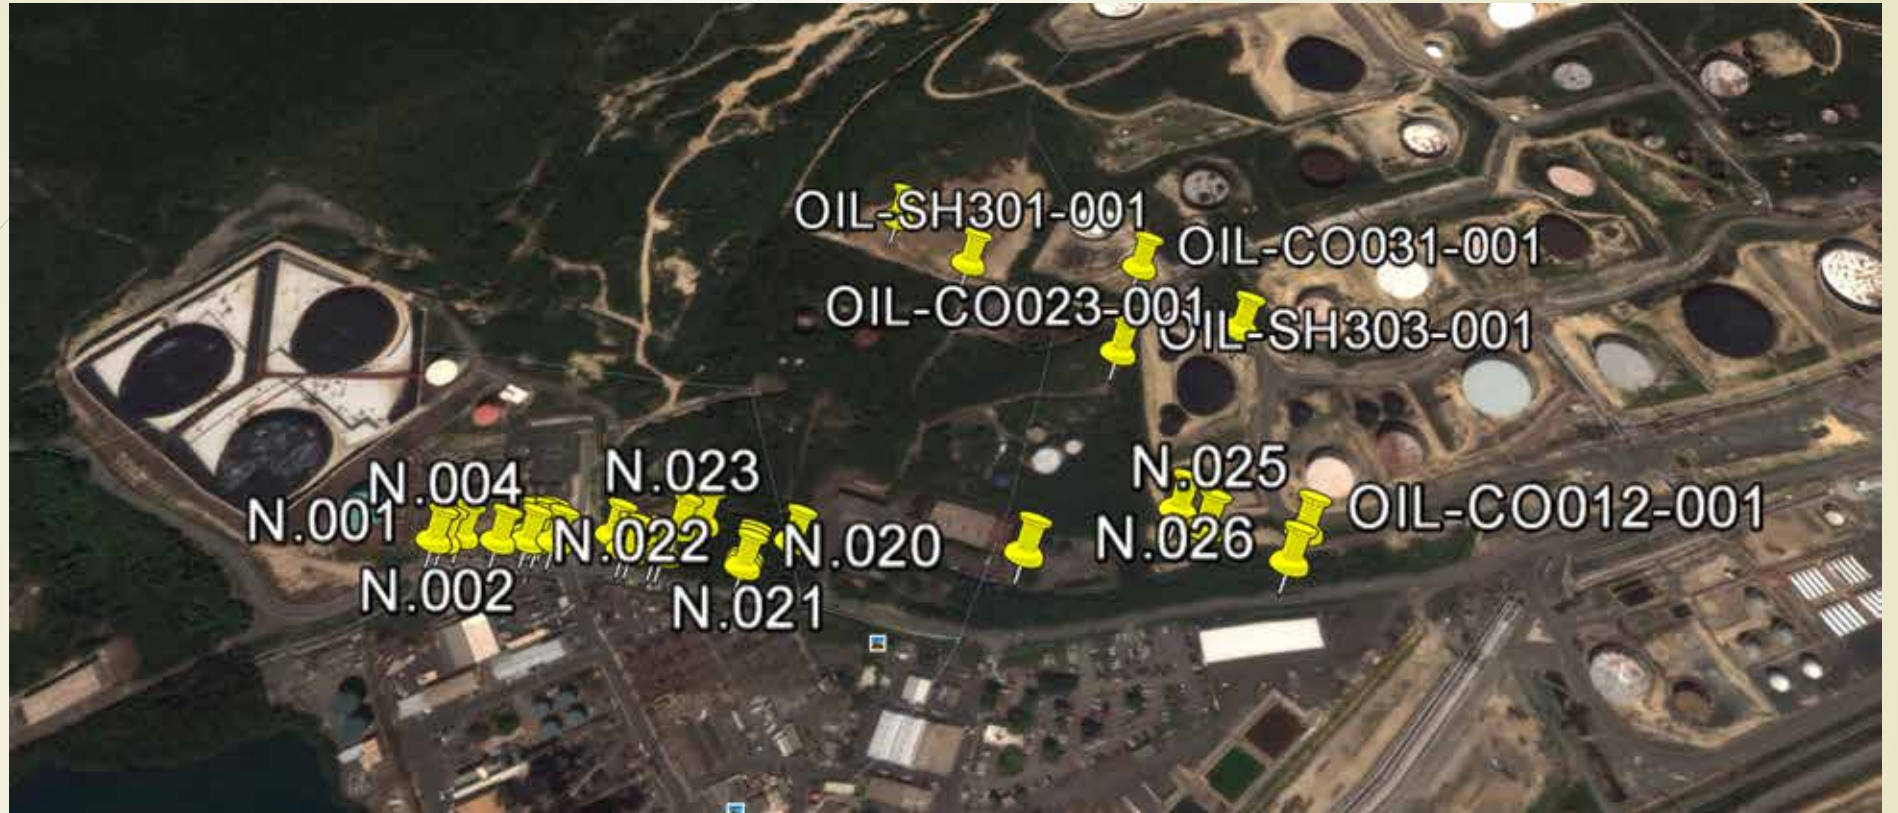
## Core samples were logged and screened for oil

An area west of PREPAS driveway revealed oil in the core at the groundwater interface

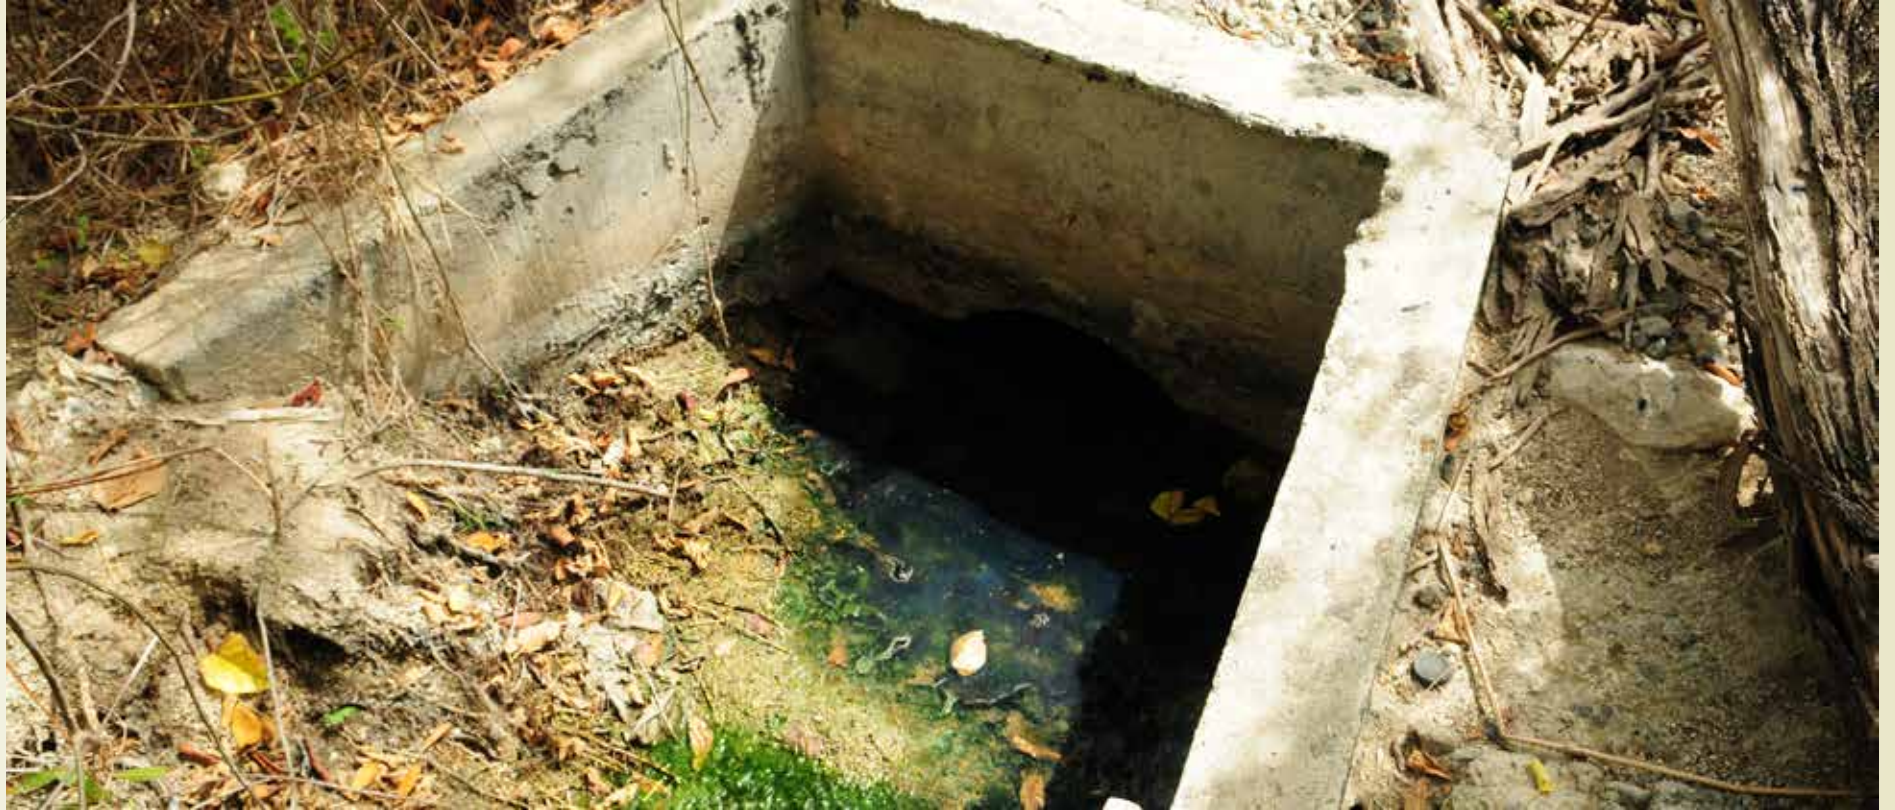
- No oil was seen entering through the pipe joints between Manhole #2 and the outfall.
  - Pipe plugs are currently deployed in both ends of piping extending between Manholes #1 and #2. A riser pipe has been installed in the 'pass-through' section of the plug in Manhole #2 to allow any infused groundwater/oil mix to be pumped/vacuumed from this section without removing the plug.

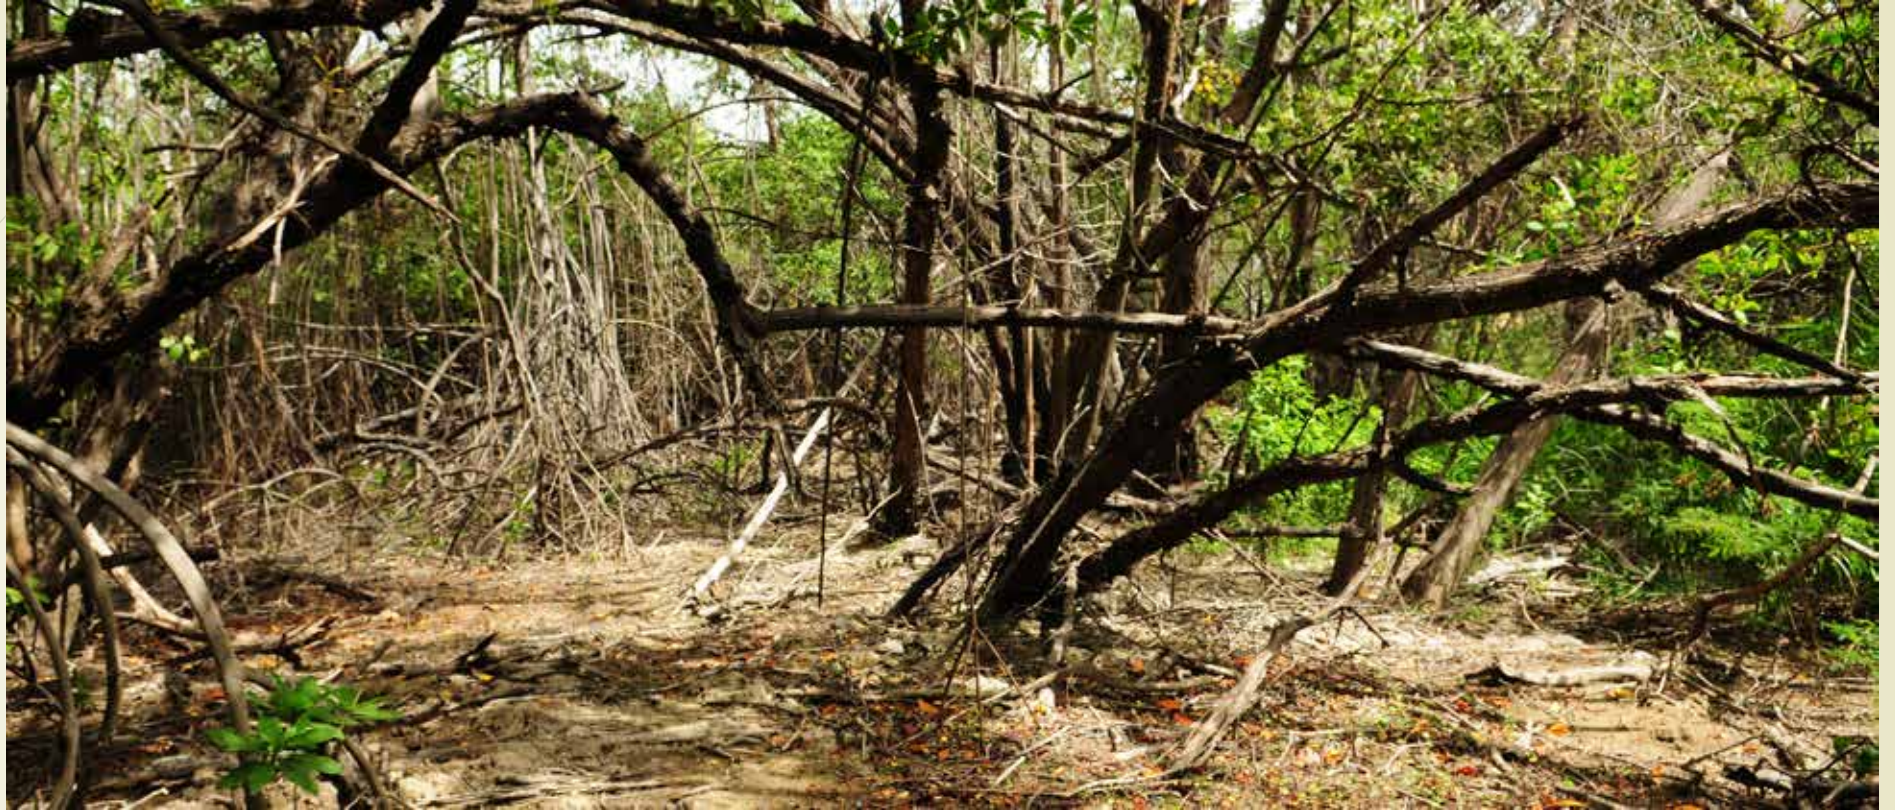
## Outfall into mangrove beach

From here oil moves overland into the waters of the bay
