Maryville CSX Train Derailment

August 2015
Regional Response Team
Meeting
Knoxville, TN

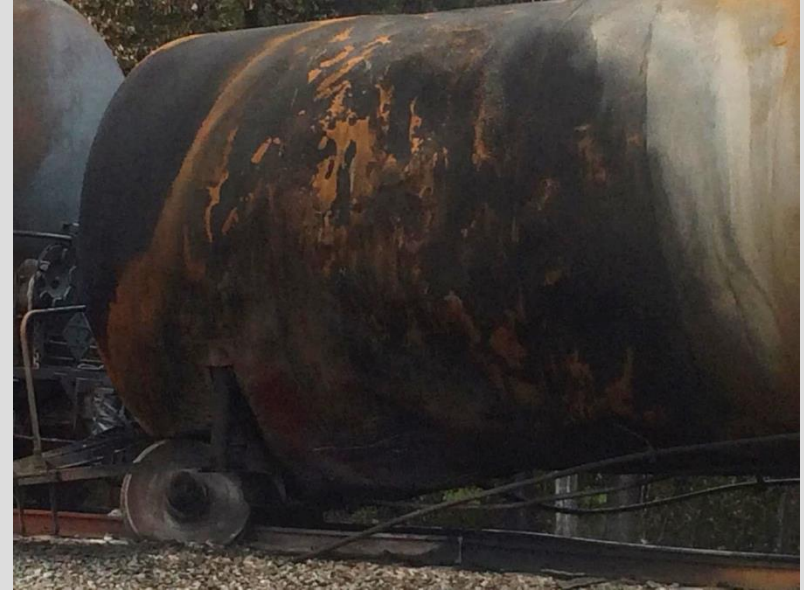
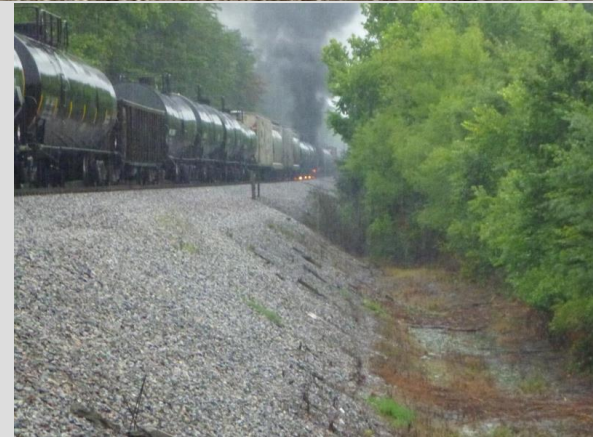
Derailment Information

- Rail car carrying ~26,000 gallons of Acrylonitrile was breached and partially derailed.
- Acrylonitrile, highly flammable, caught fire as the railcar was leaking, providing a constant source of fuel and making extinguishing the fire dangerous and difficult.

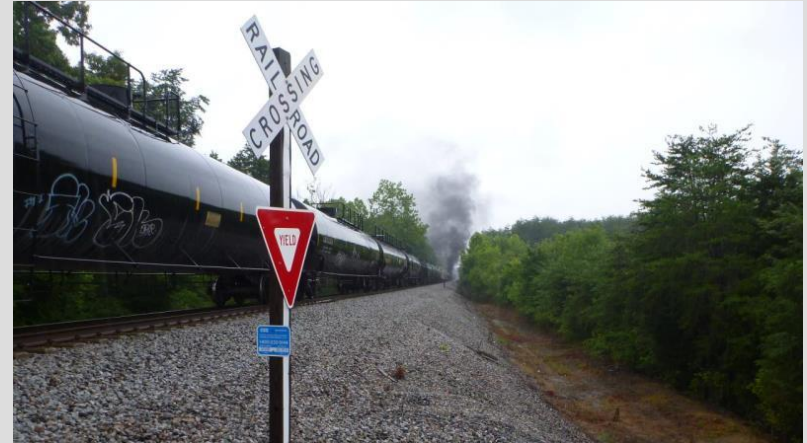
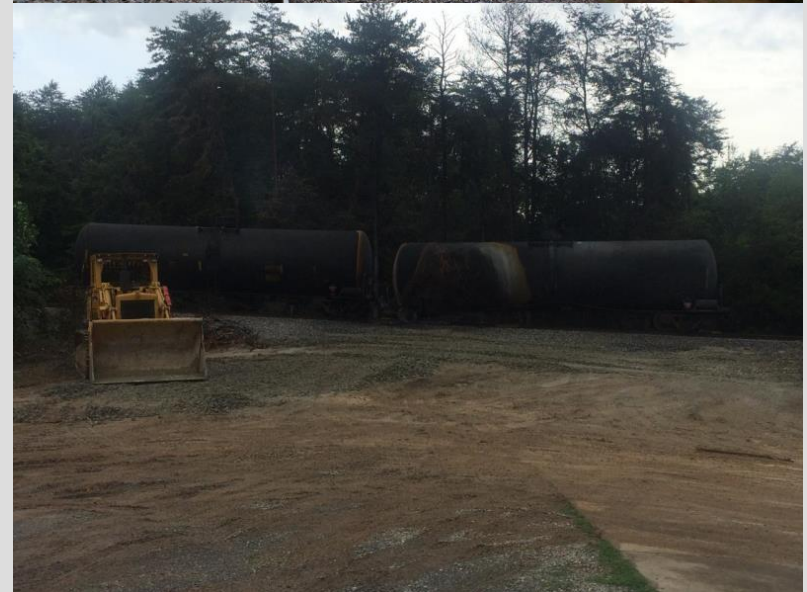
Firefighting Operations

- Firefighters utilized water spray to cool adjacent Acrylonitrile cars.
- Two buffer cars were between the Acrylonitrile cars and the LPG cars.

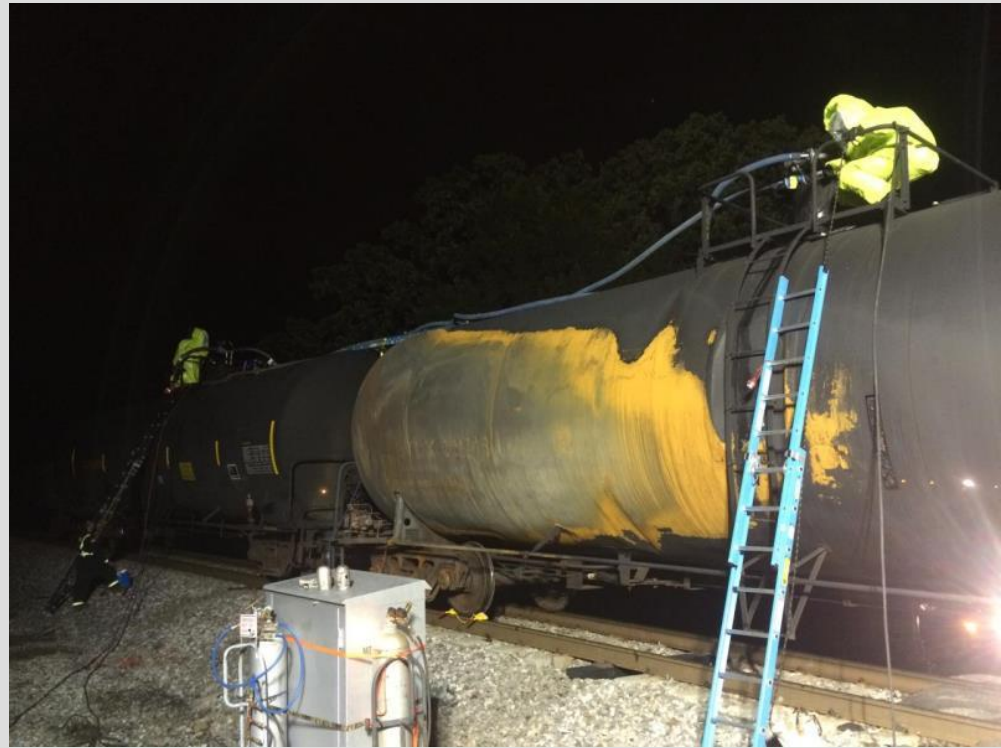
Acrylonitrile Transfer

- A second unbreached car, carrying Acrylonitrile was damaged by the fire but the contents were not lost.
- Acrylonitrile was transferred to a new car for shipment, via a closed-loop system.

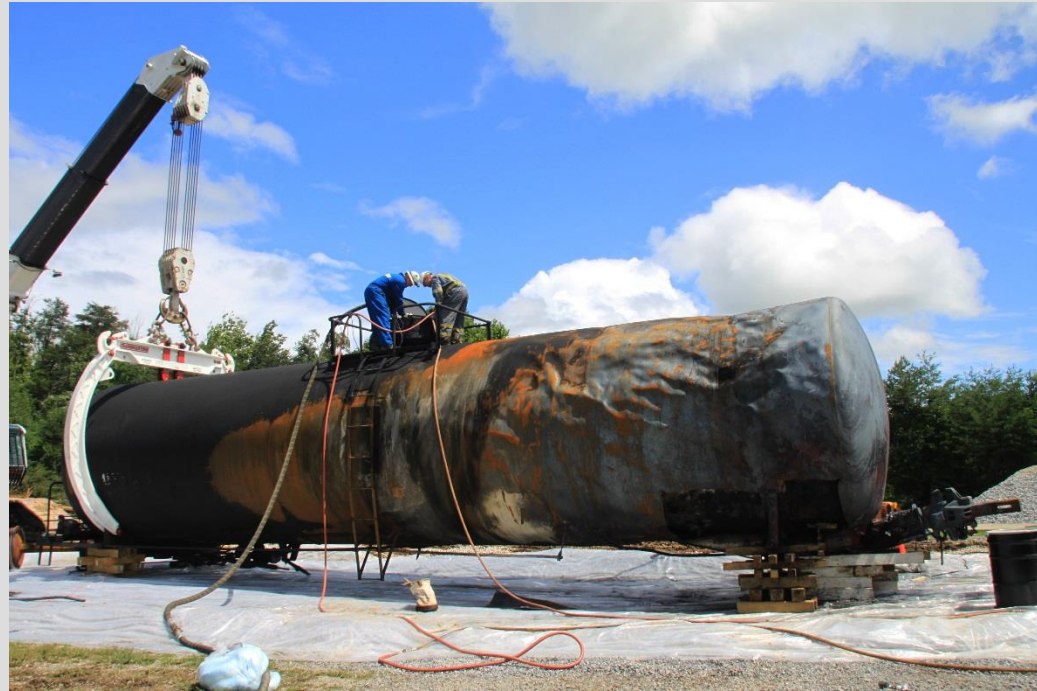
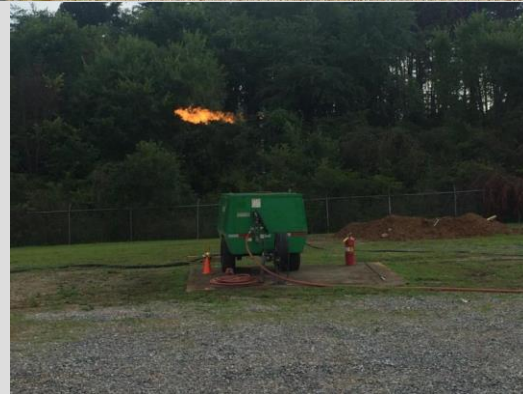
Acrylonitrile Flaring

- Some residual remained in the breached car.
- Prior to being shipped off-site, all contents had to be purged. To limit possible exposure, CSX flared the volatiles.

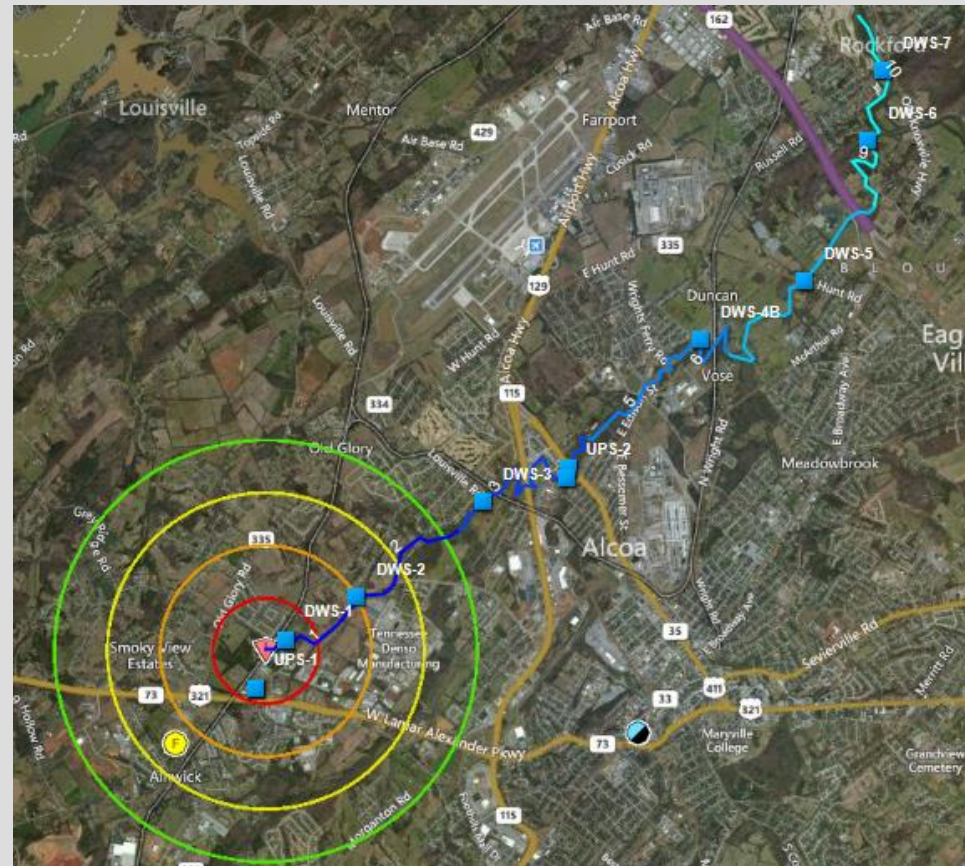
Surface Water Sampling

- Following initial firefighting efforts, it was unclear if nearby Culton Creek was impacted by the release.
- Surface water samples revealed elevated levels of Acrylonitrile in the creek.

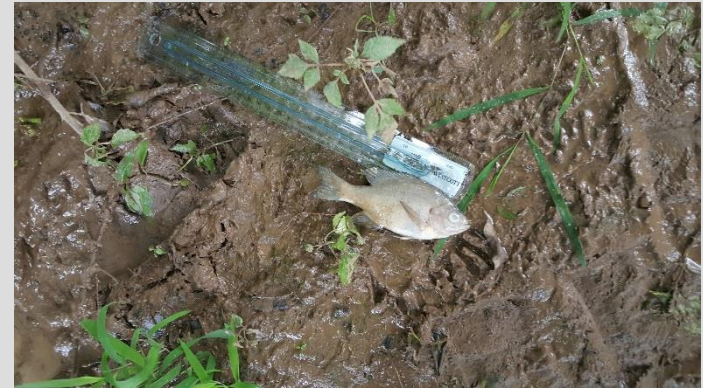
Fish Kill

- Results indicating contamination and discovery of a fish kill caused:
 - Additional water samples from further downstream
 - Installation of bubbling system at 3 points near the site
 - Issuance of a public advisory
 - Inventory of dead fish/animals

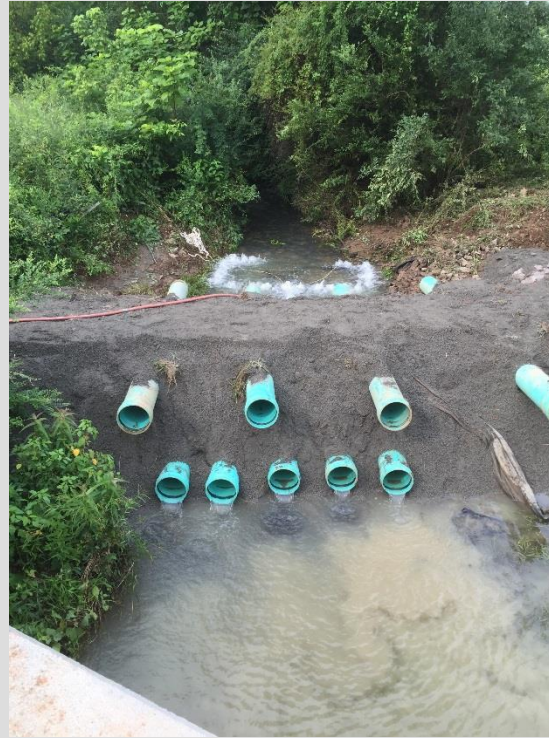
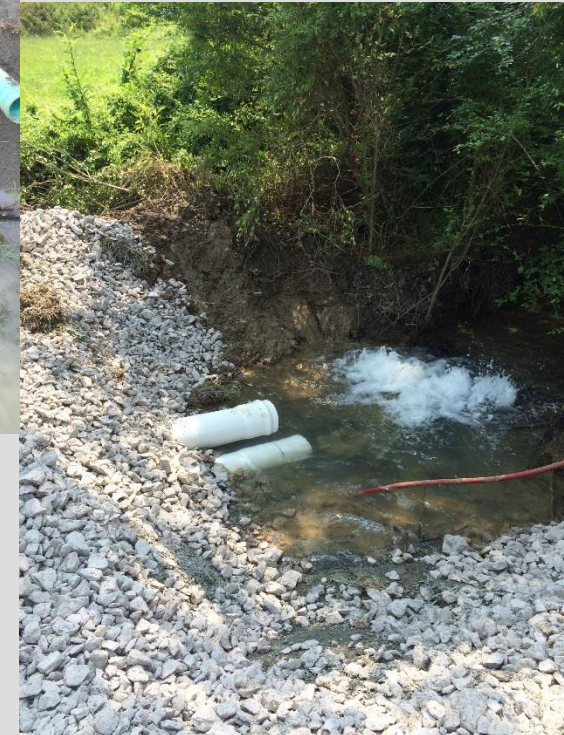
Surface Water Remediation

- Bubblers catalyze the natural breakdown of Acrylonitrile through additional volatilization and agitation.

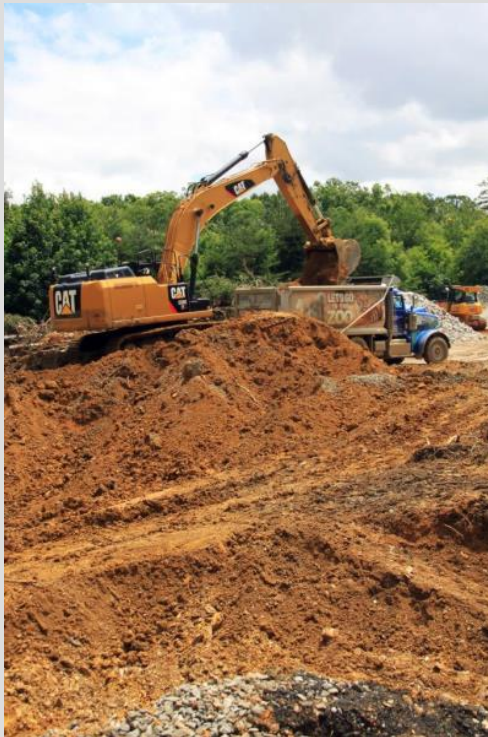
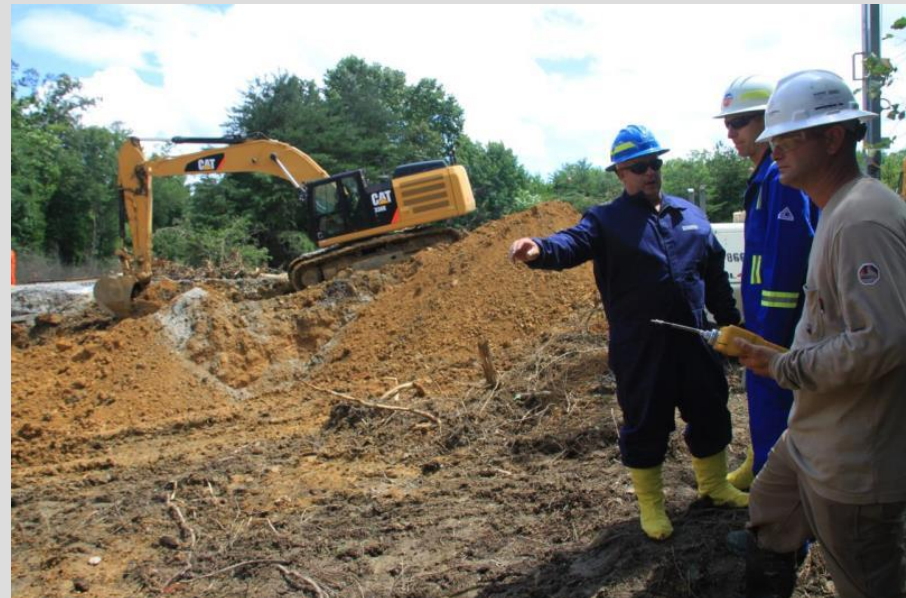
Soil Removal

- Soil under the railway was determined to be contaminated with Acrylonitrile and had to be removed prior to opening the rail line.

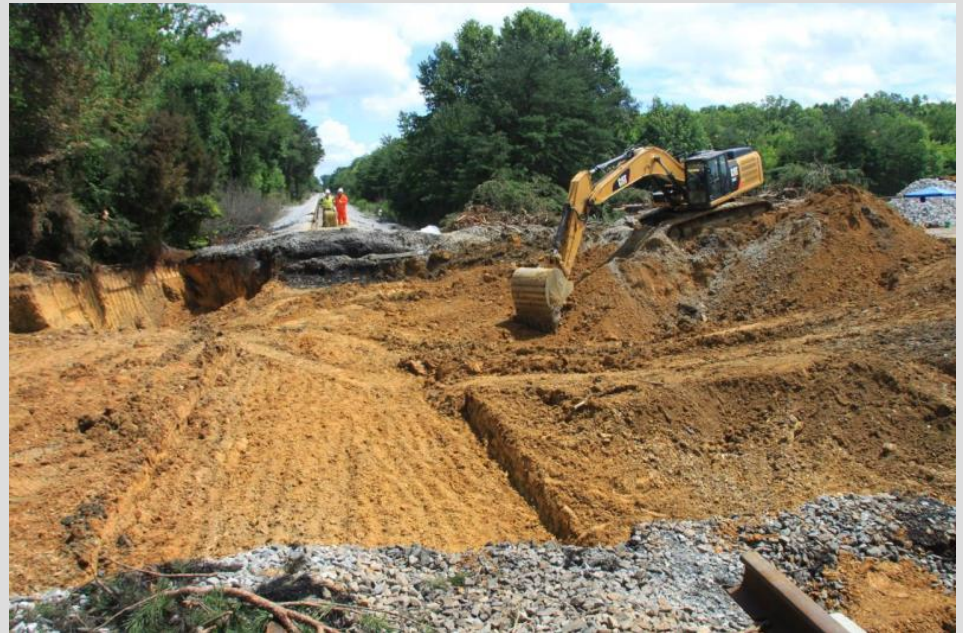
Ground Water Contamination

- On the final day of the response, groundwater sample results from an on-site well, indicated elevated concentrations of Acrylonitrile in the groundwater.
