8/9/2018

NYSWR

St. Rt. 17

Deposit

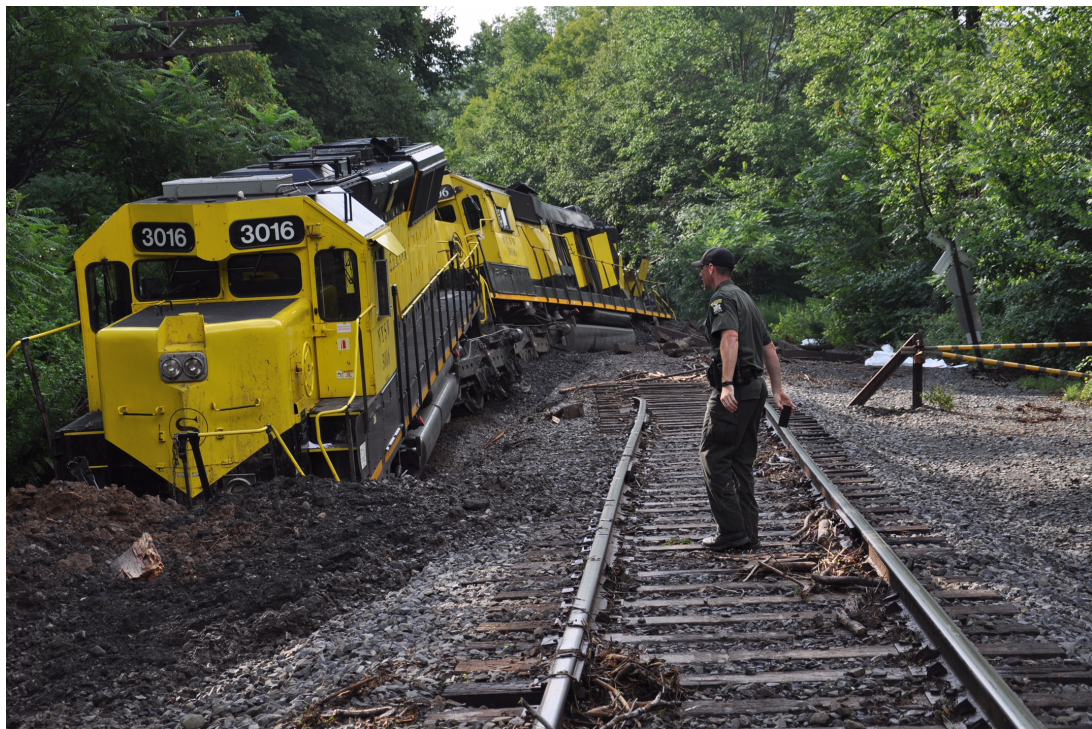
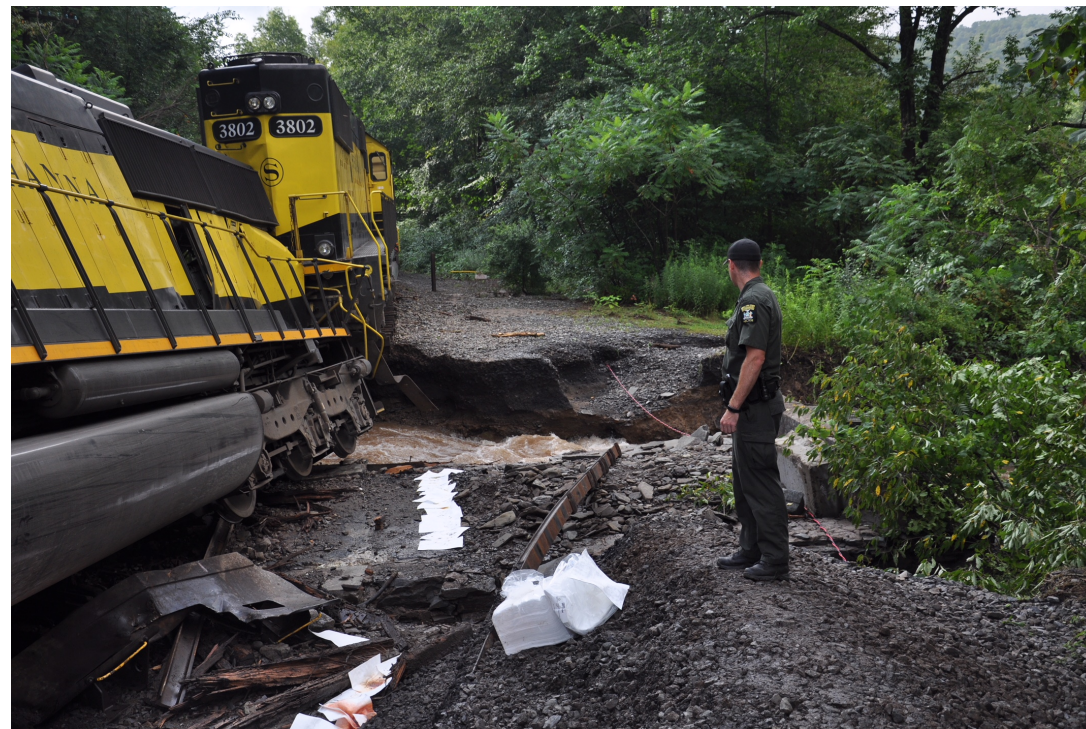
# Engines and Culvert

Heavy rains in the area the night before

RR culvert was washed out

Train derailed as it crossed the culvert

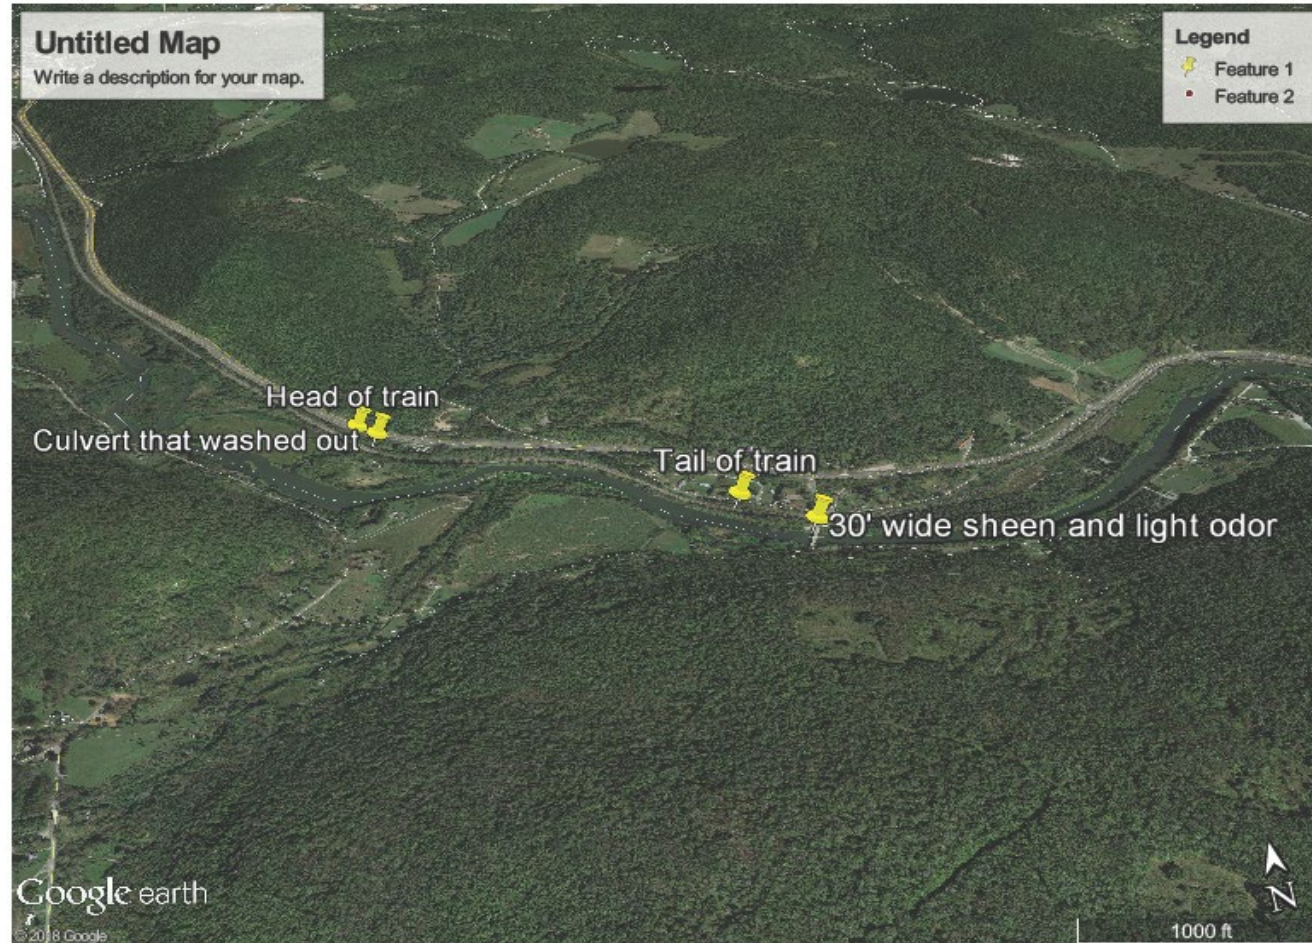
# Google Map – accessible areas and sheen (.75 m)
