Hurricane Michael ESF-10 Environmental Unit

HURRICANE MICHAEL RESPONSE Salvage Plan M/Y EL DORADO

M/V El Dorado Removal Post Removal Impact Assessment

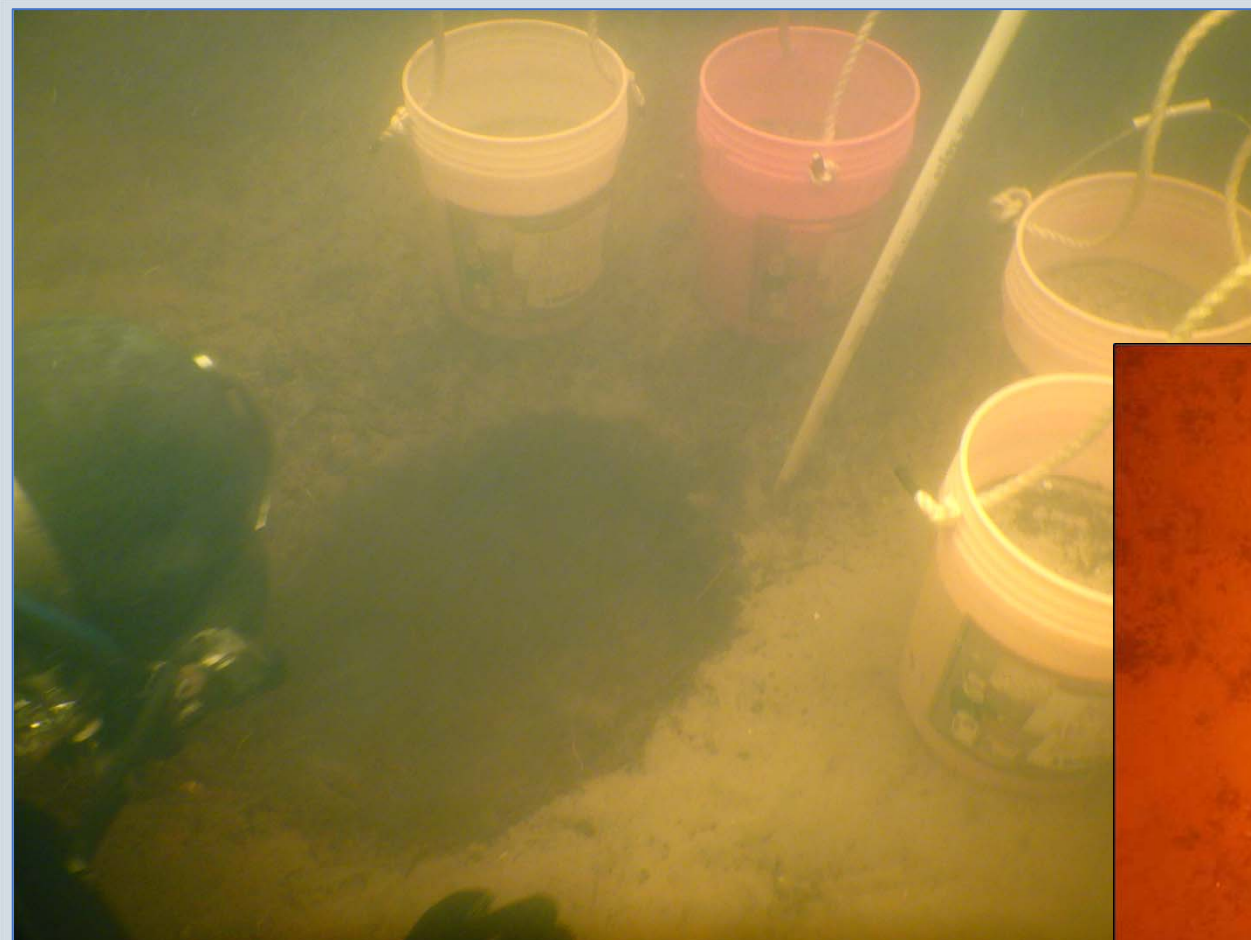
Divers filling spud hole from Heavy 1 Barge

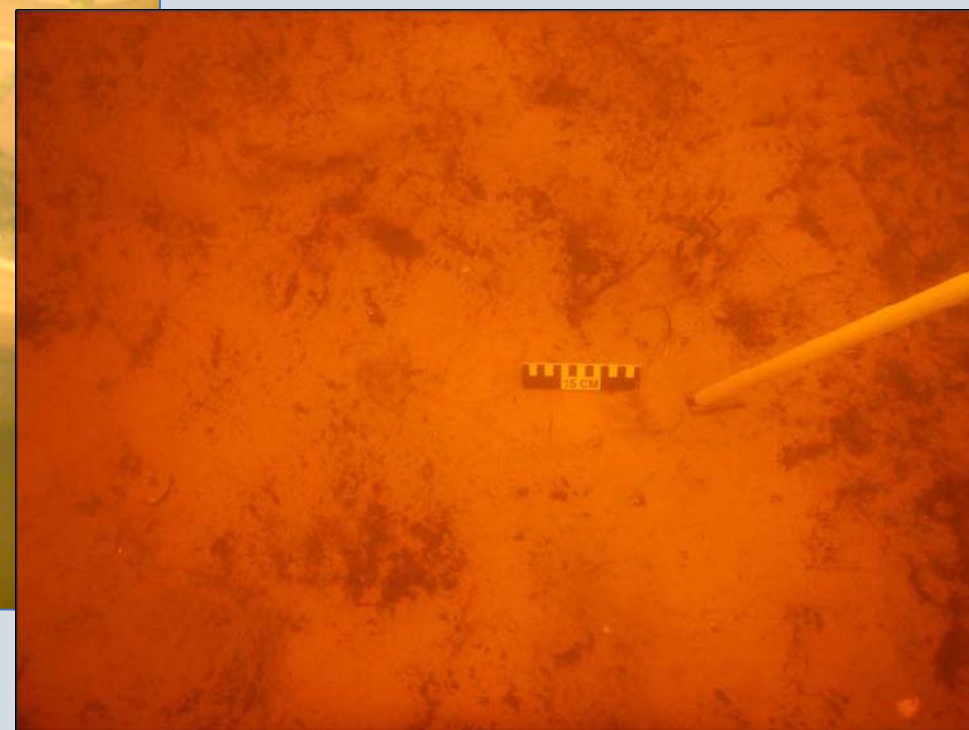
Same spud hole after filling to natural grade
