Case in Study:

Mitchell County Train Derailment

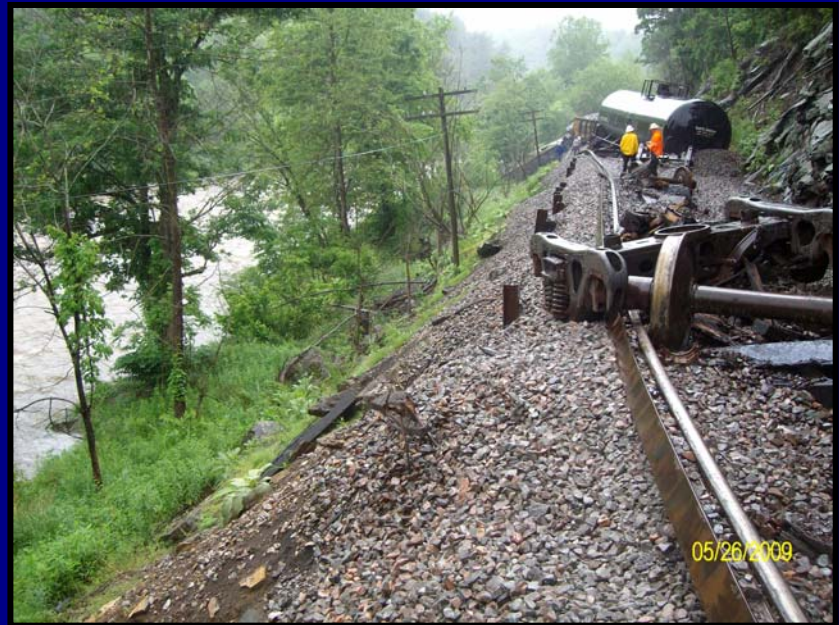
- 16 derailed cars
- 2 railcars contained ethanol
- 2 railcars contained molten sulfur
- 1 railcar contained corn feed
- 6 railcars contained “empty but not clean” petroleum residuals

The derailment happened alongside and up gradient from the North Toe River, which host the Appalachian Elktoe Mussel, an endangered species.

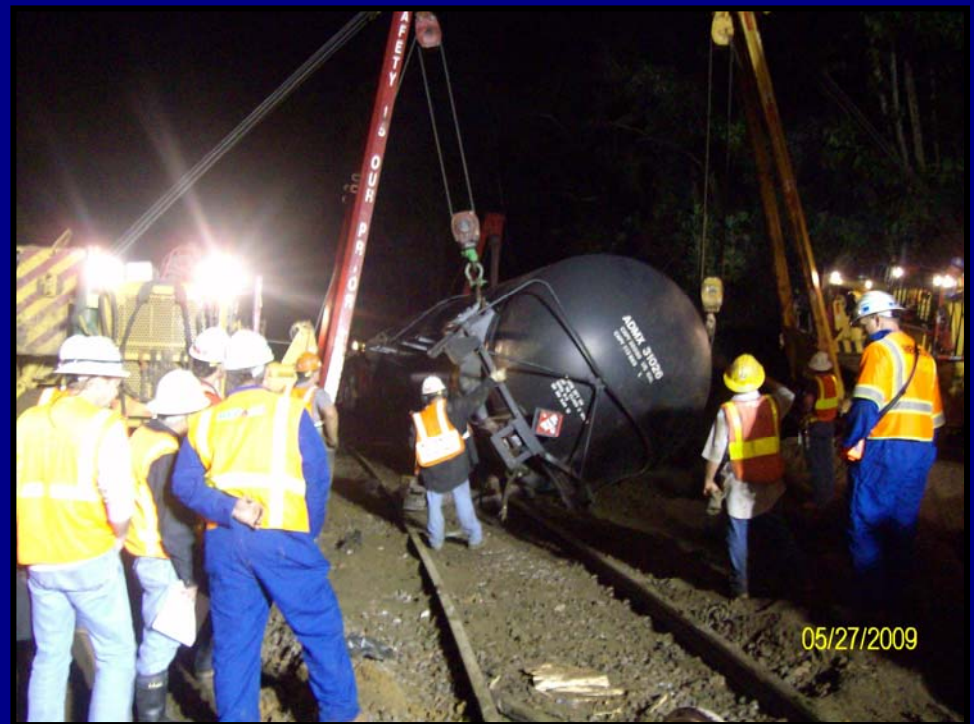
While attempting to reposition railcar the valve was sheared and resulted in a ethanol leak.

Sheared Valve - Leak

Wooden Plug
Installed

-Wooden Plug Replaced with more Permanent Expandable Plug

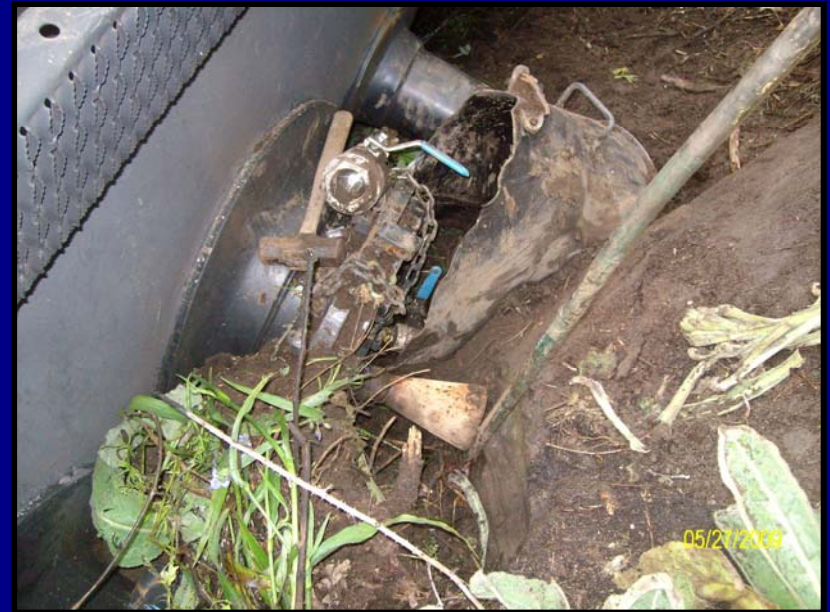
More Permanent
Expandable Plug Installed

Neither EPA or CSX
Incident Commander had
been informed of the
decision, and although
only minimal ethanol was
released, the potential for
a large release was
possible.
