Mercury Vapor Emission from Broken Compact Fluorescent Lamps and Cleanup procedures

Raj Singhvi

USEPA/ERT, Edison, NJ, 08820

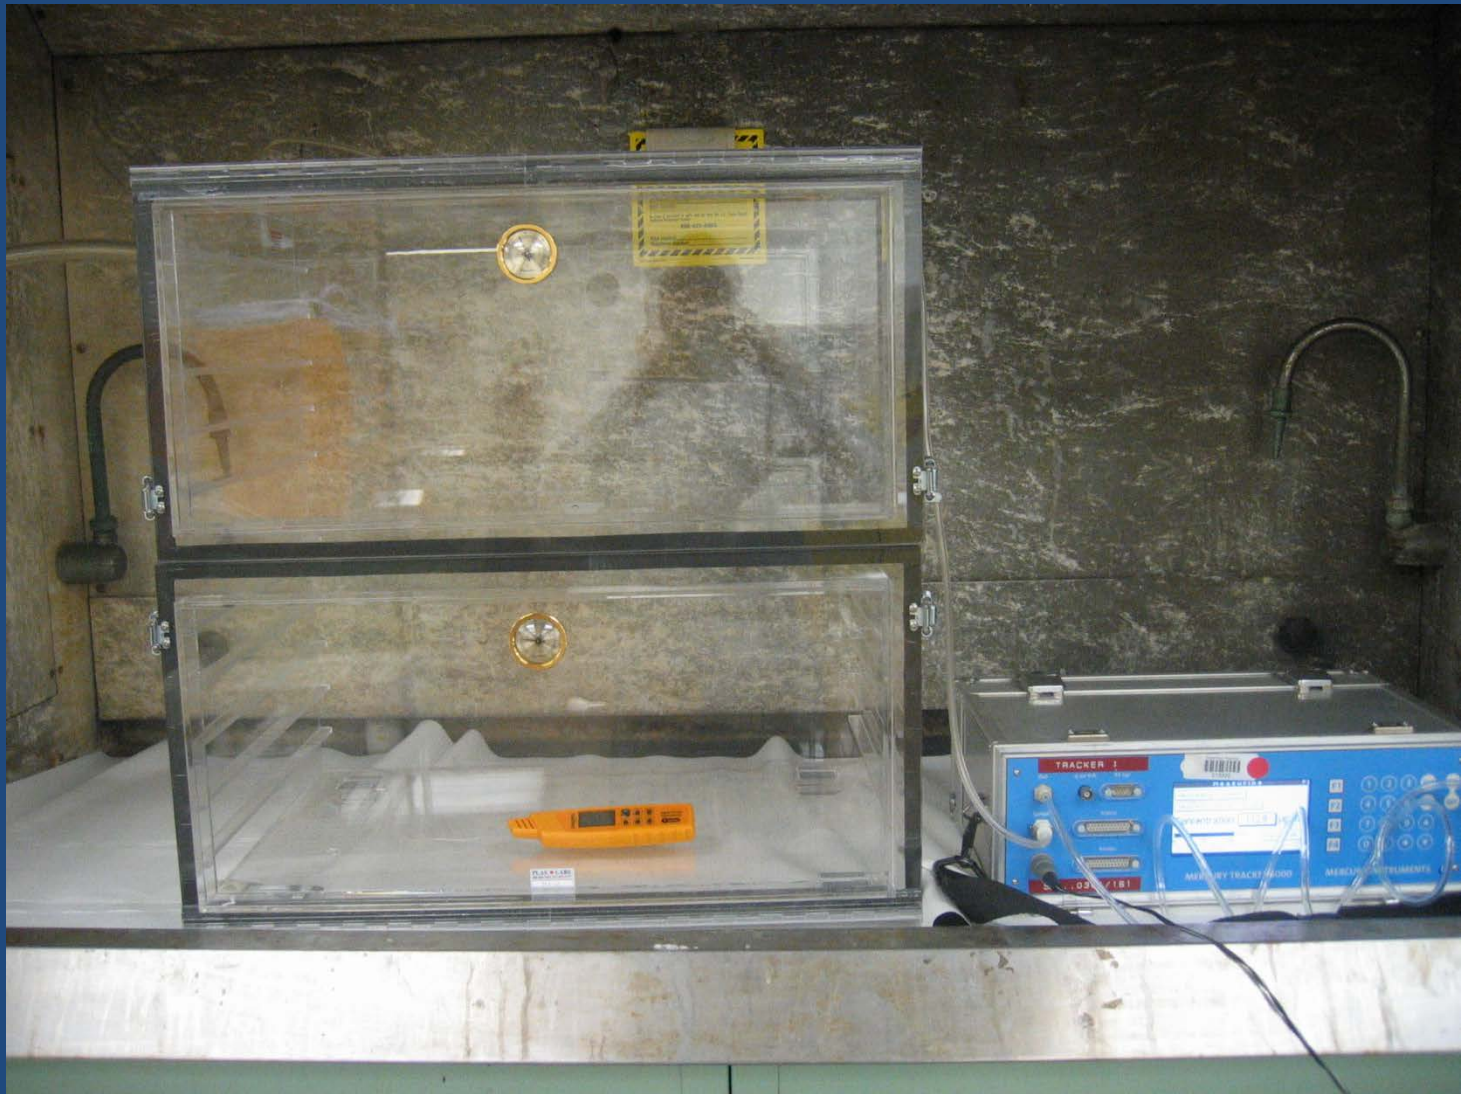
Figure 1. Acrylic chamber used for mercury vapor emission studies

Chamber: 24" x 18" x 24" (width x length x height) acrylic chamber two compartments (Fig 1), each 24" x 18" x 12", effective compartment volume 2.53 ft³ (0.0716 m³)

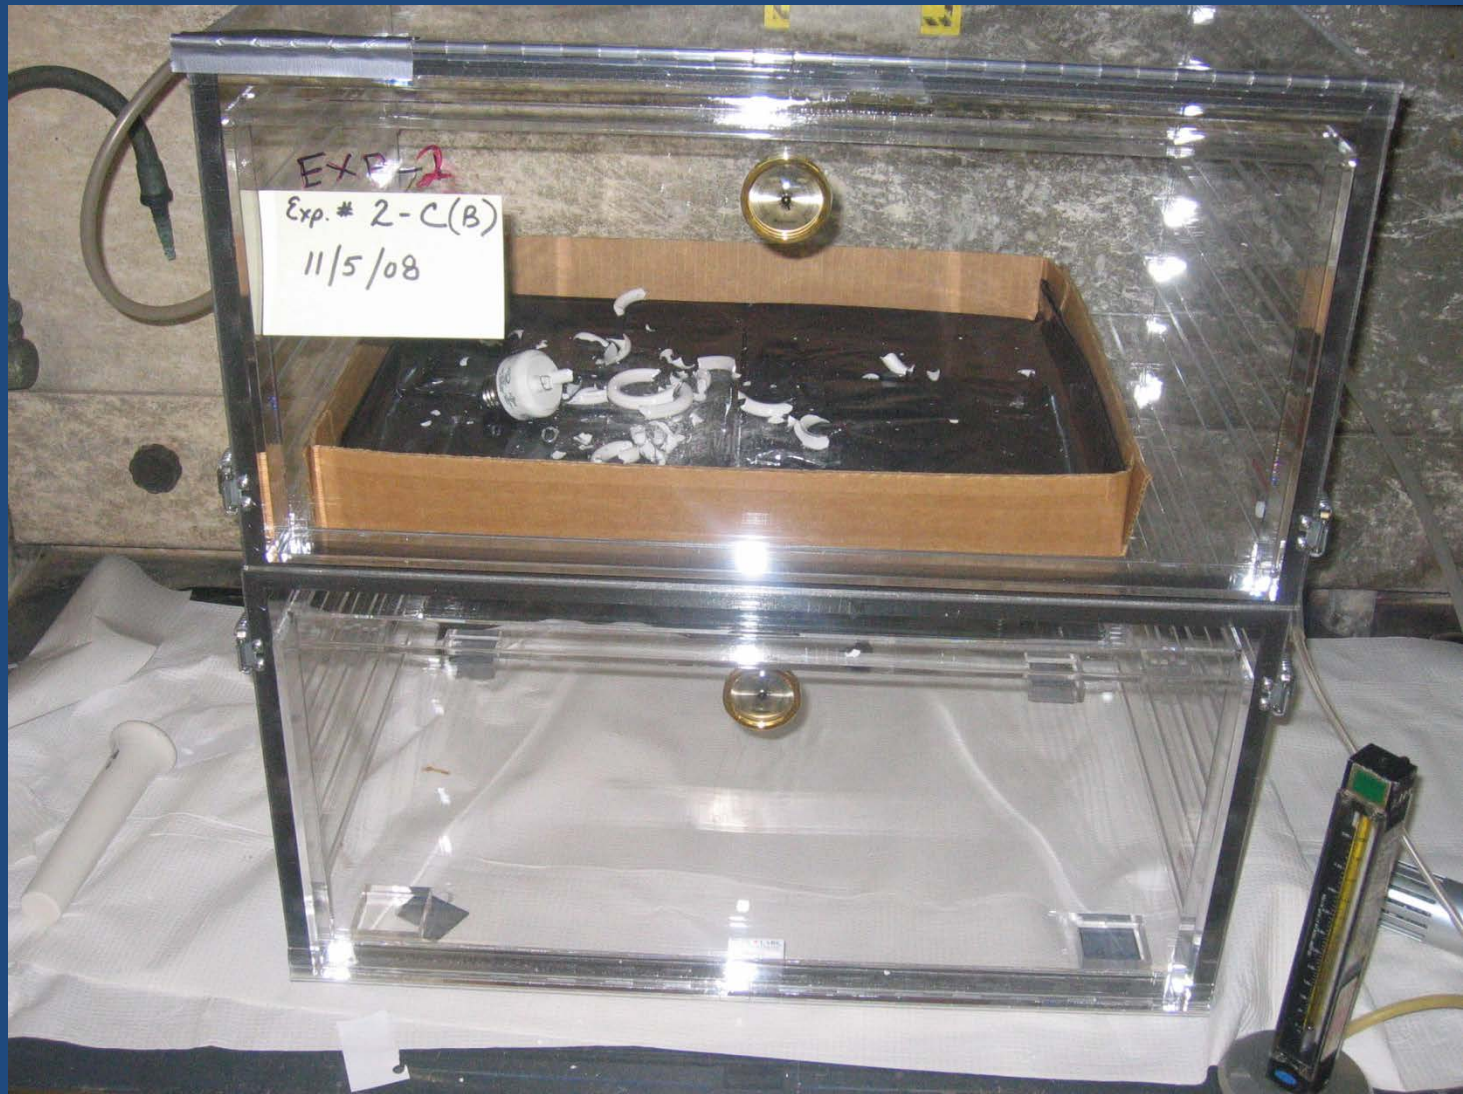
Figure 2. Broken CFL (on plastic) in the chamber

- Used one compartment of the acrylic chamber
- CFL in middle of piece of vinyl sheet in cardboard tray in chamber; CFL smashed into small pieces (Fig 2)
- Hg vapor monitored with Mercury Tracker 3000; air flow from the chamber 1.5 L/min (exchange rate of 1.25/hour)
- Hg vapor measurements logged every 15-sec for 24-hours
- Experiment repeated two additional times (triplicate)
- Four other types of CFLs measured in the same fashion

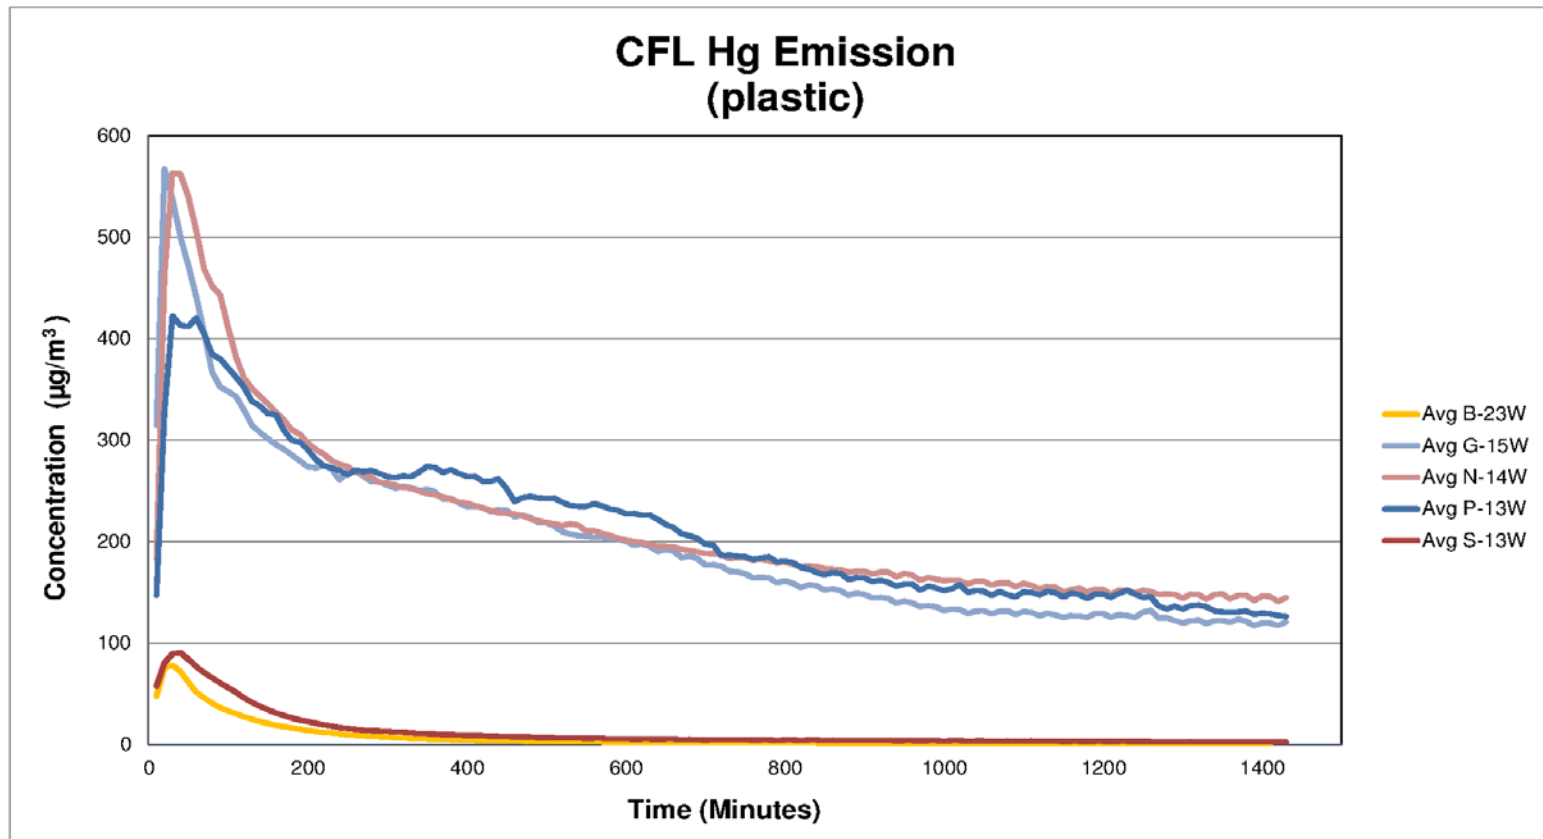
Figure 3. Mercury concentration vs. time for CFLs broken on plastic.

- Table 1: Percent Hg loss for five CFL bulb types on plastic
- Fig 3: Plots of emission data (average of triplicate runs for each bulb type)
- Average 24-hr Hg loss from broken CFLs 0.6% to 22%
- Hg loss not directly related to Hg content or how Hg is incorporated in the bulb (metallic or amalgam)
- Location of the Hg in the bulb, how bulb is broken, ambient temperature may affect emission after breakage

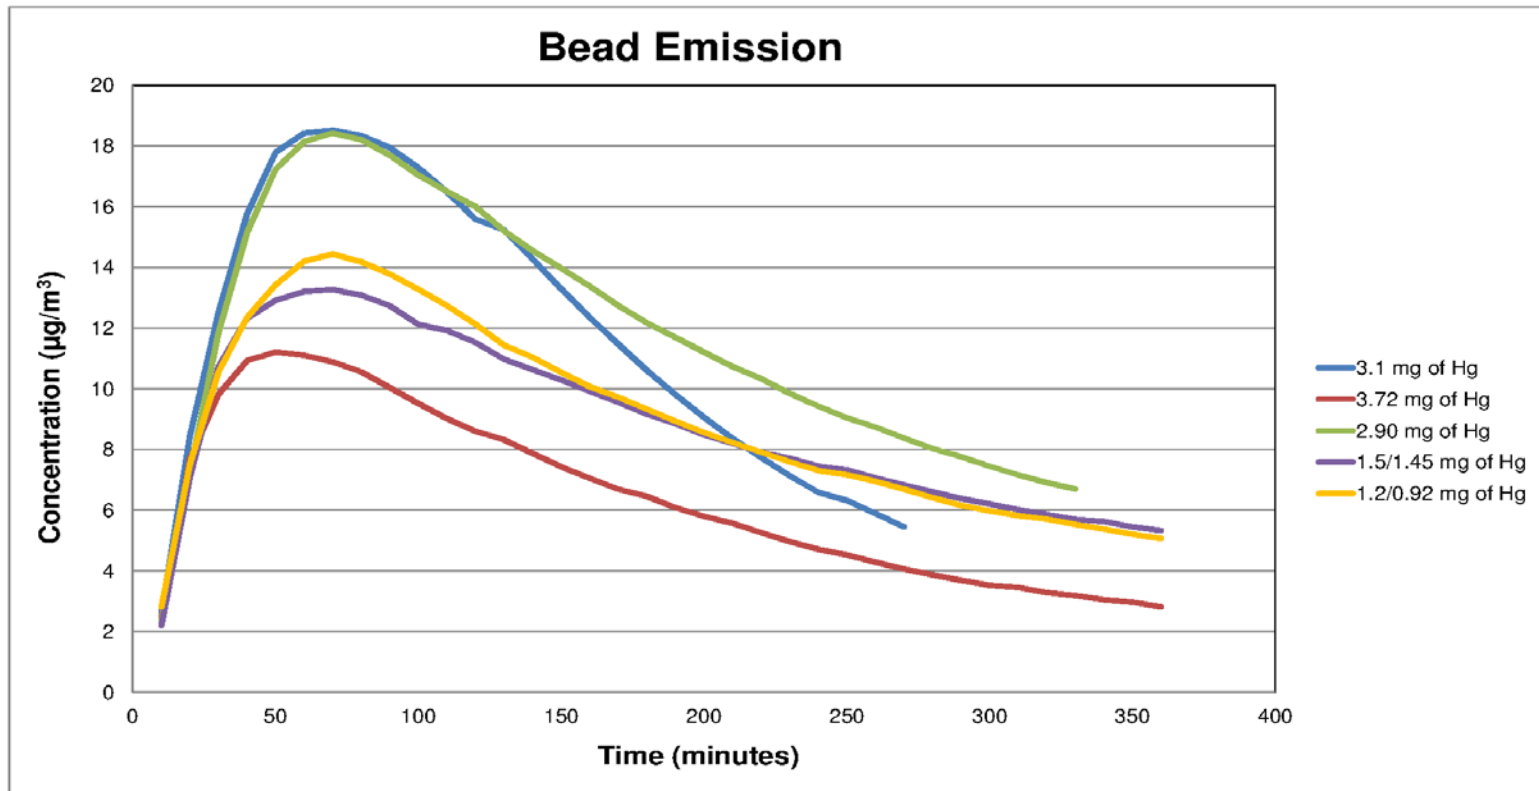
Figure 4. Mercury concentration vs. Time for different bead weights.

- Table 3 and Fig 4: Mercury loss from beads with different weights
- Projected 24-hour Hg loss (0.4% to 0.9%) much lower than that for CFLs with comparable Hg content
- Hg may emit at a higher rate from a broken CFL compared to a bead with the same weight of Hg
- Reason not clear; may be due to larger surface area or the presence of mercury vapor in the CFLs

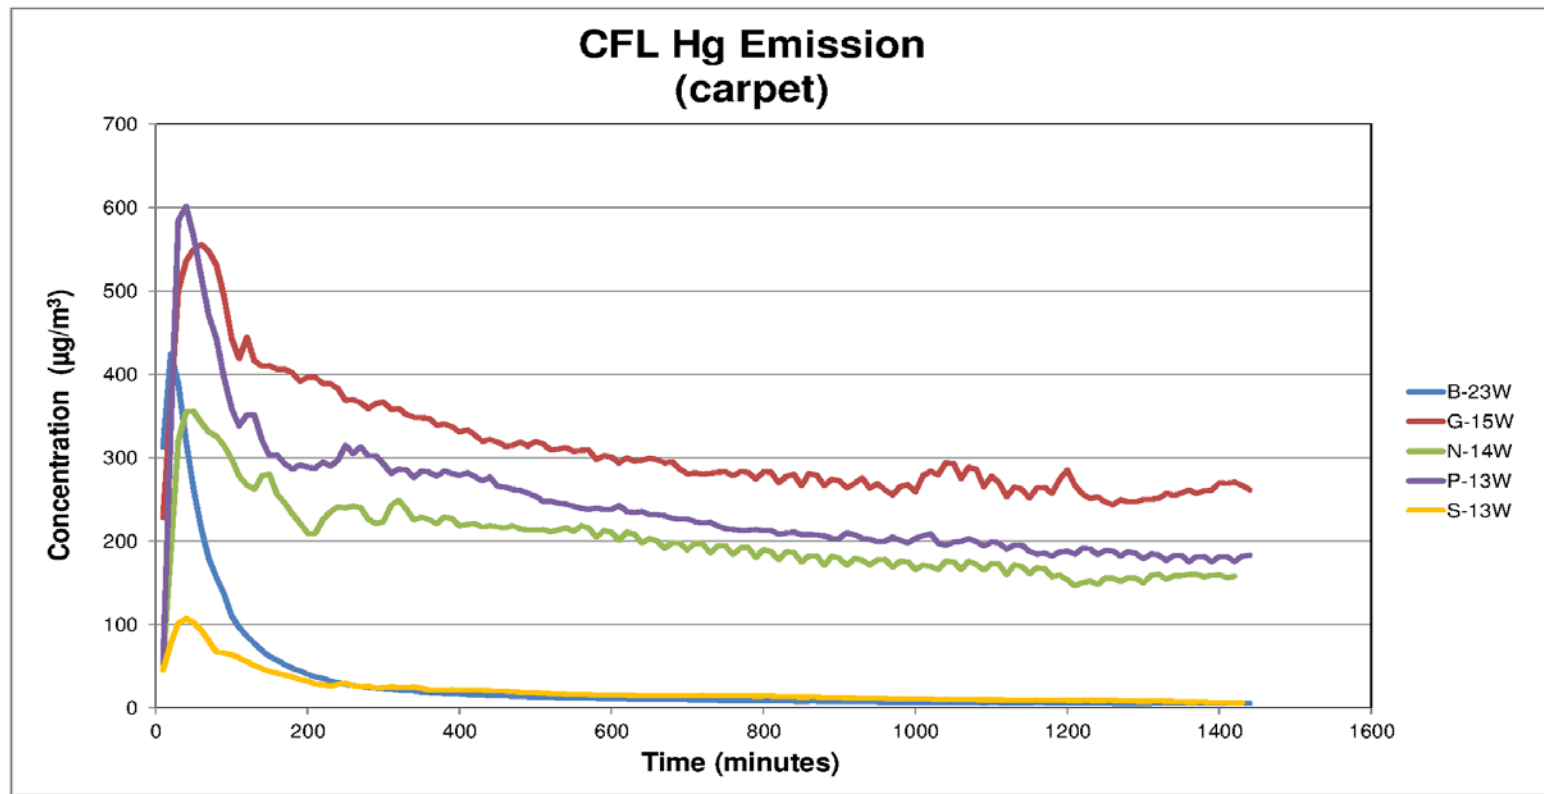
Figure 5. Mercury concentration vs. Time for CFLs broken on carpet.

- Table 4: Percent Hg loss for five CFL bulb types on carpet
- Fig 5: Plots of the emission data
- Avg. 24-hour Hg loss from broken CFLs 2.6% to 28%; not directly related to the Hg content or how Hg is incorporated in the bulb (metallic or amalgam)
- Avg. emission and mercury loss higher for breakage of CFLs on carpet compared to plastic except for the N-14W CFL bulb type
