Minillas Complex Asbestos Site

CARIBBEAN REGIONAL RESPONSE TEAM
MEETING
AUGUST 6 - 8, 2013
GUAYNABO, PUERTO RICO

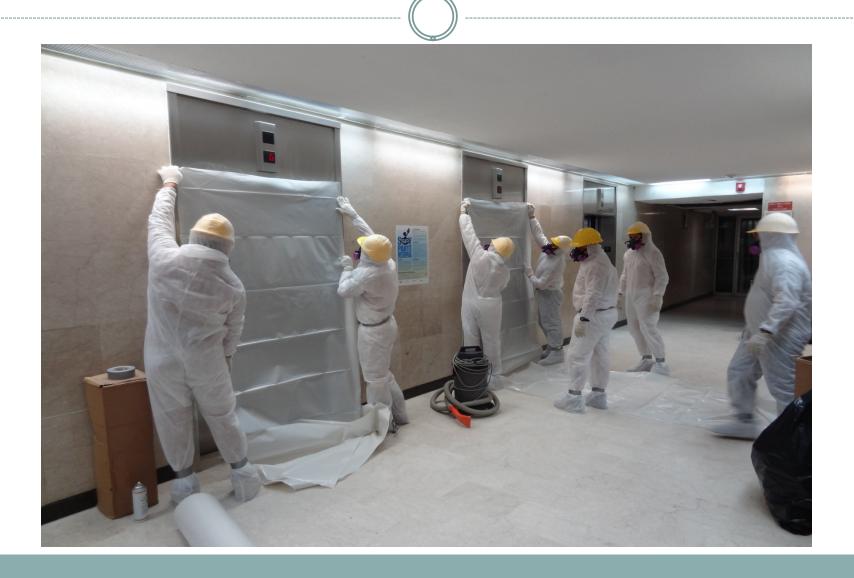
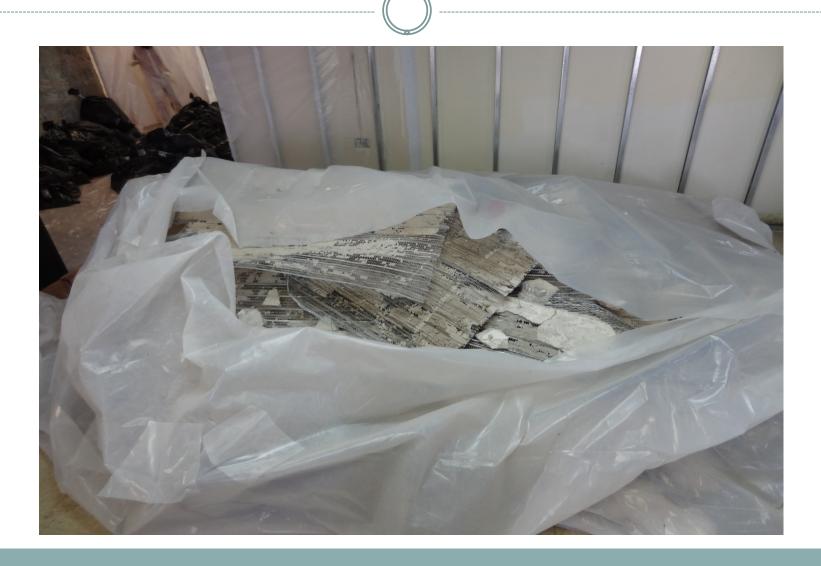
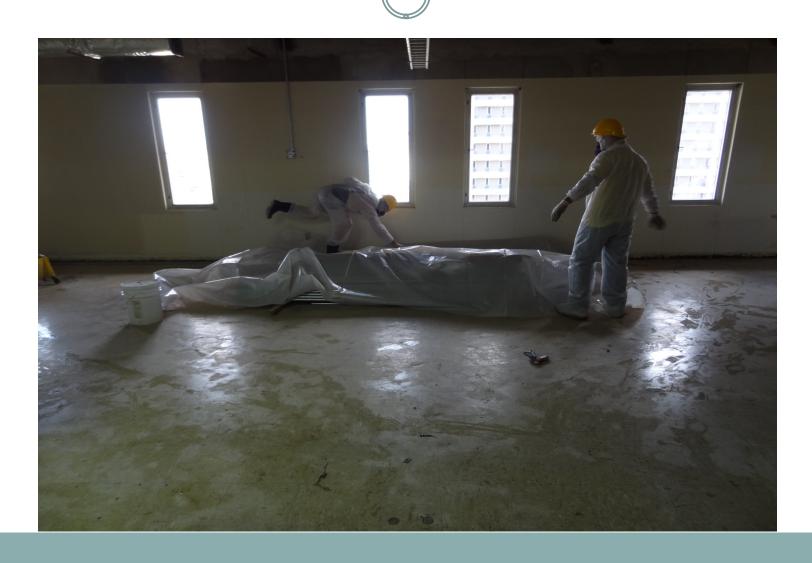
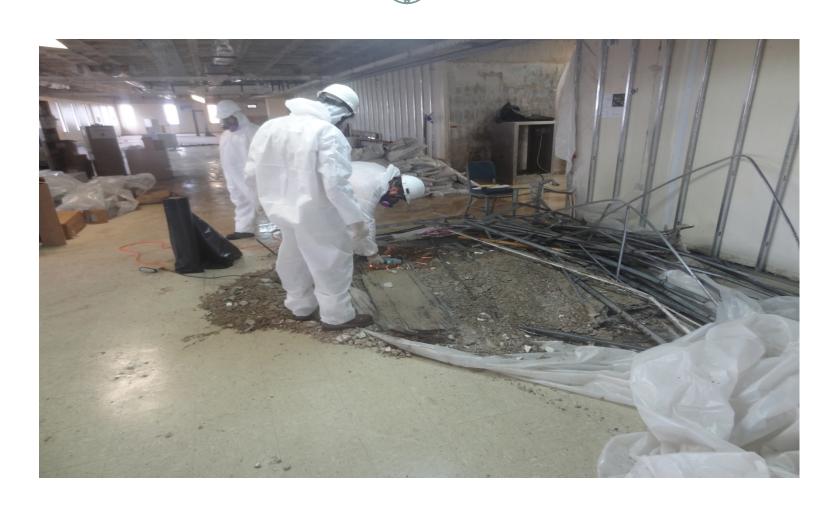
Cleanup Sequence

- **Four elevator cabins**
 - **Elevator** machine room
- Second
 - × Floors 17 to 9
- Third
 - × Floors P to 8
- Fourth
 - **X** Stairways
 - **Ground floor**
 - **x** Two elevators
 - × Decon area
