# Caribbean Petroleum Explosion and Fire Response Bayamon, Puerto Rico

# Incident

# Facility Background

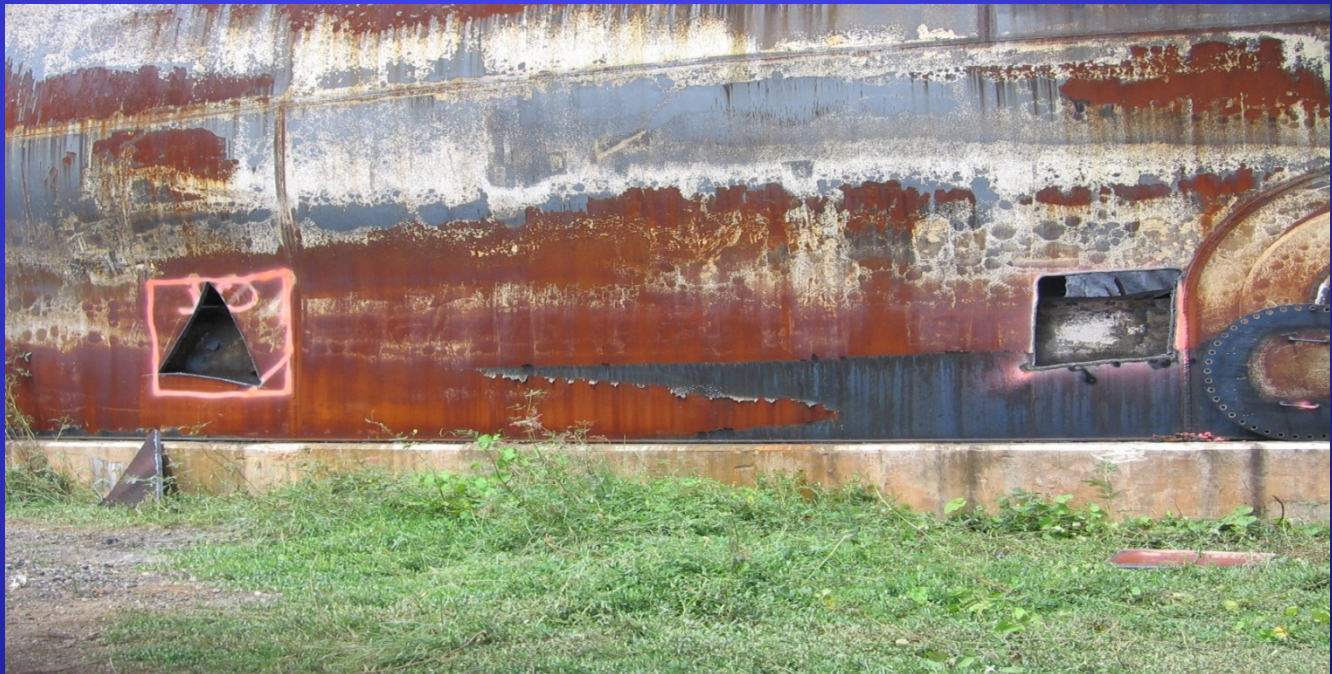
# Tank Demolition

- View of test cuts in tank used to collect samples and determine level of sludge and oil remaining in tank bottom

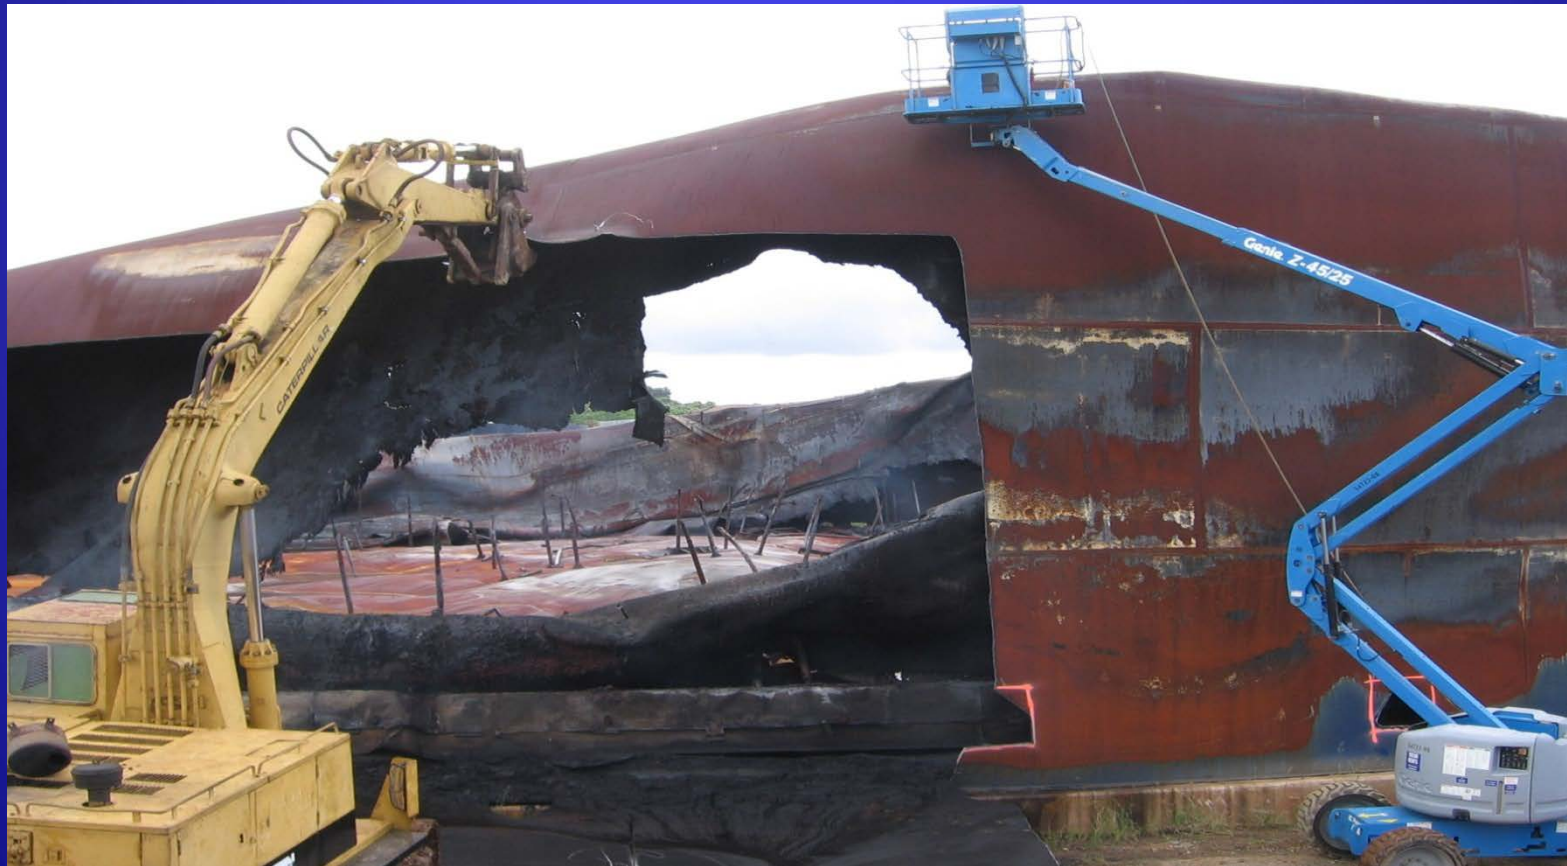
# Tank Demolition

- View of cutting operations with shears

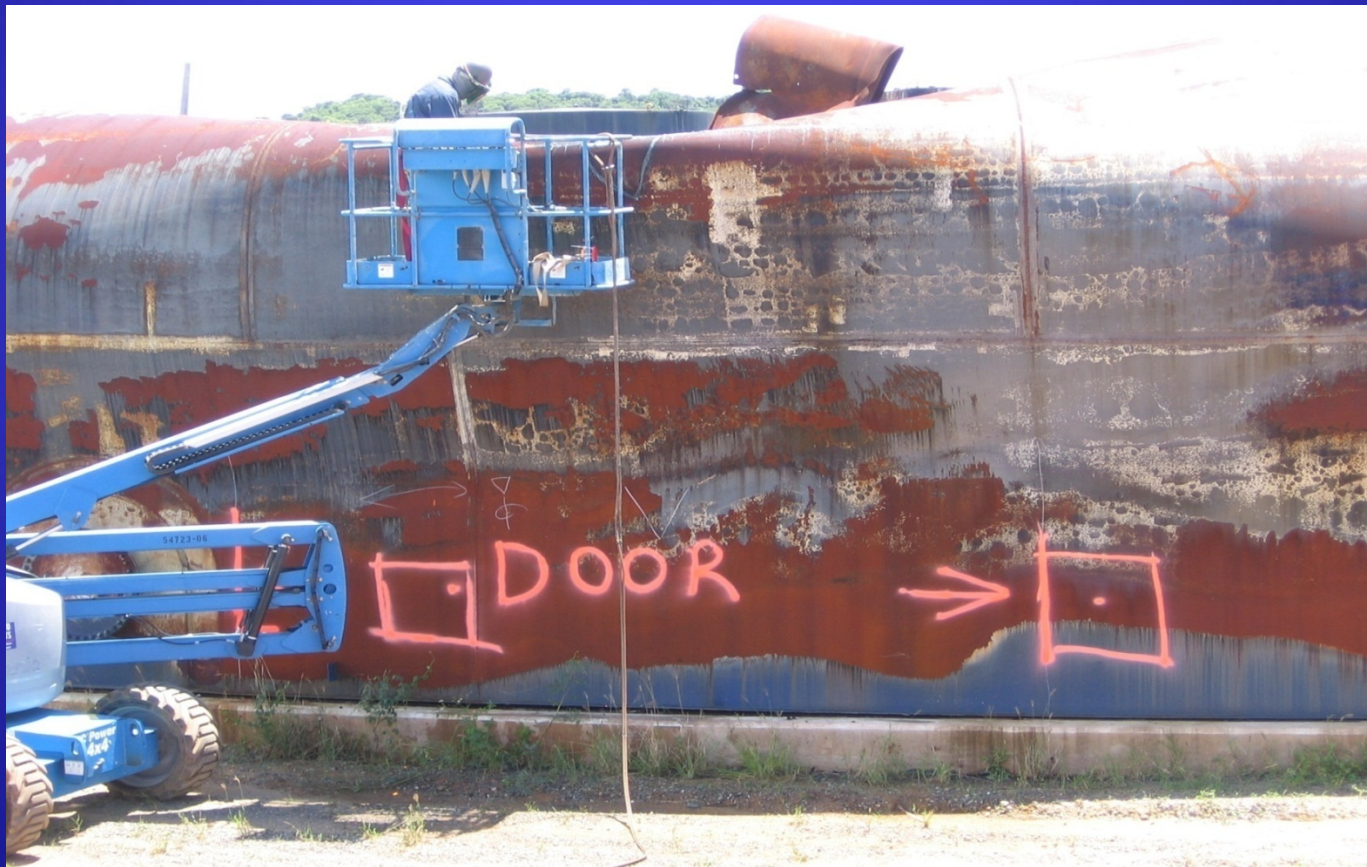
# Tank Demolition

- View of torch cutting operations

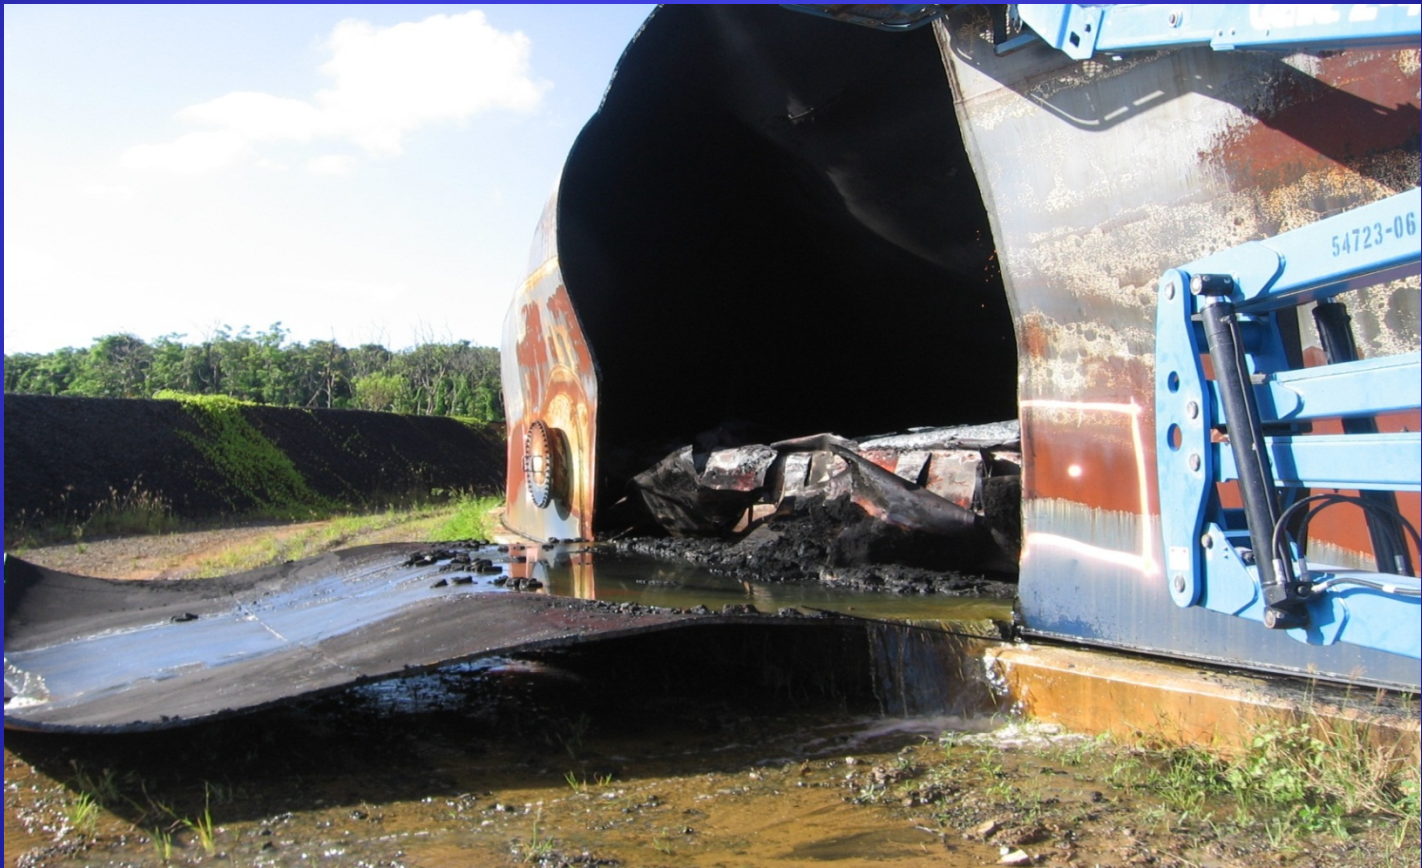
# Tank Demolition

- View of panel lay down

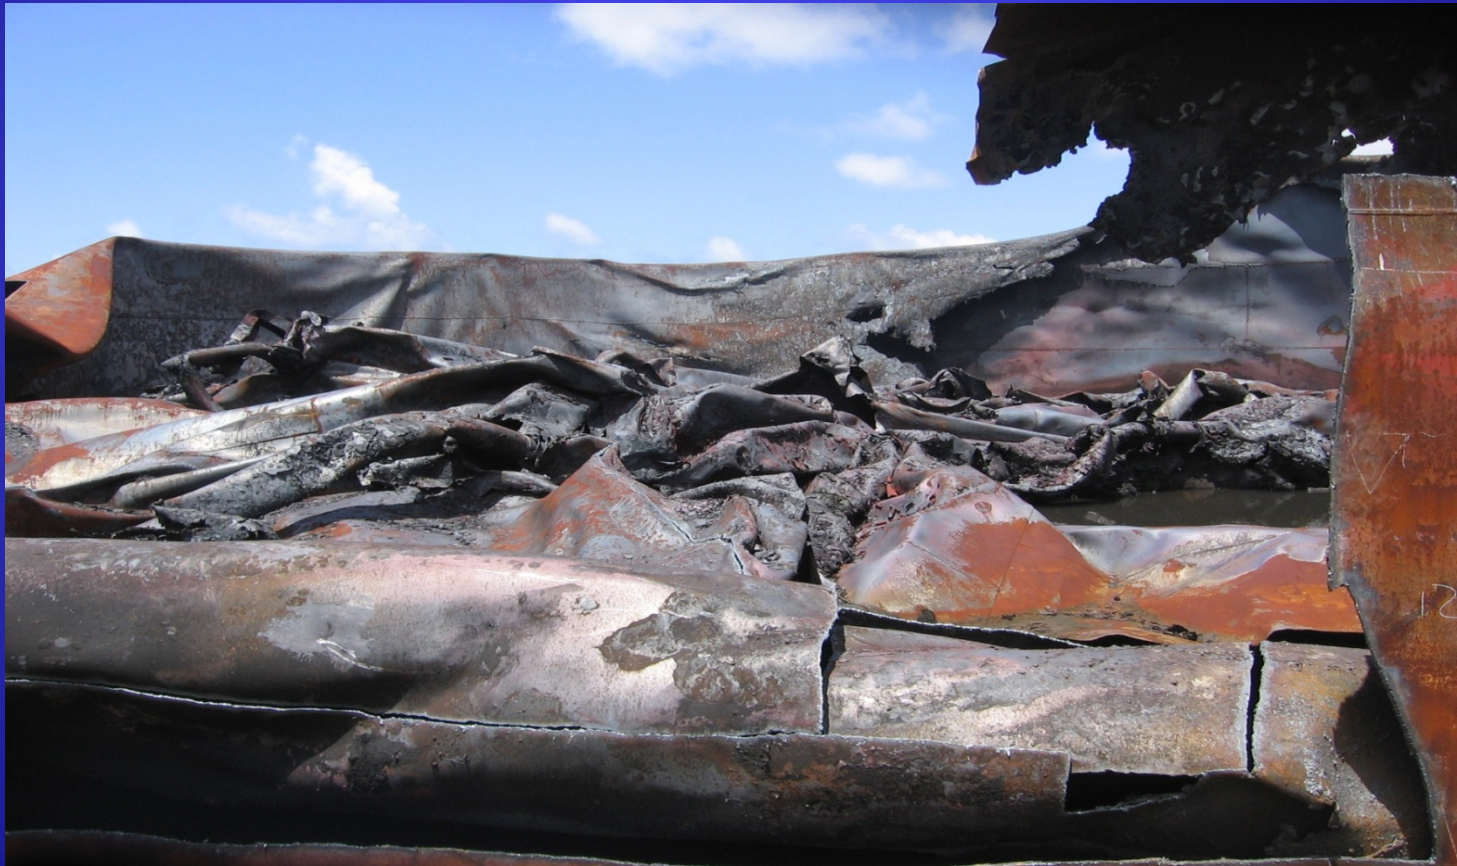
# Tank Demolition

- View of tank interior

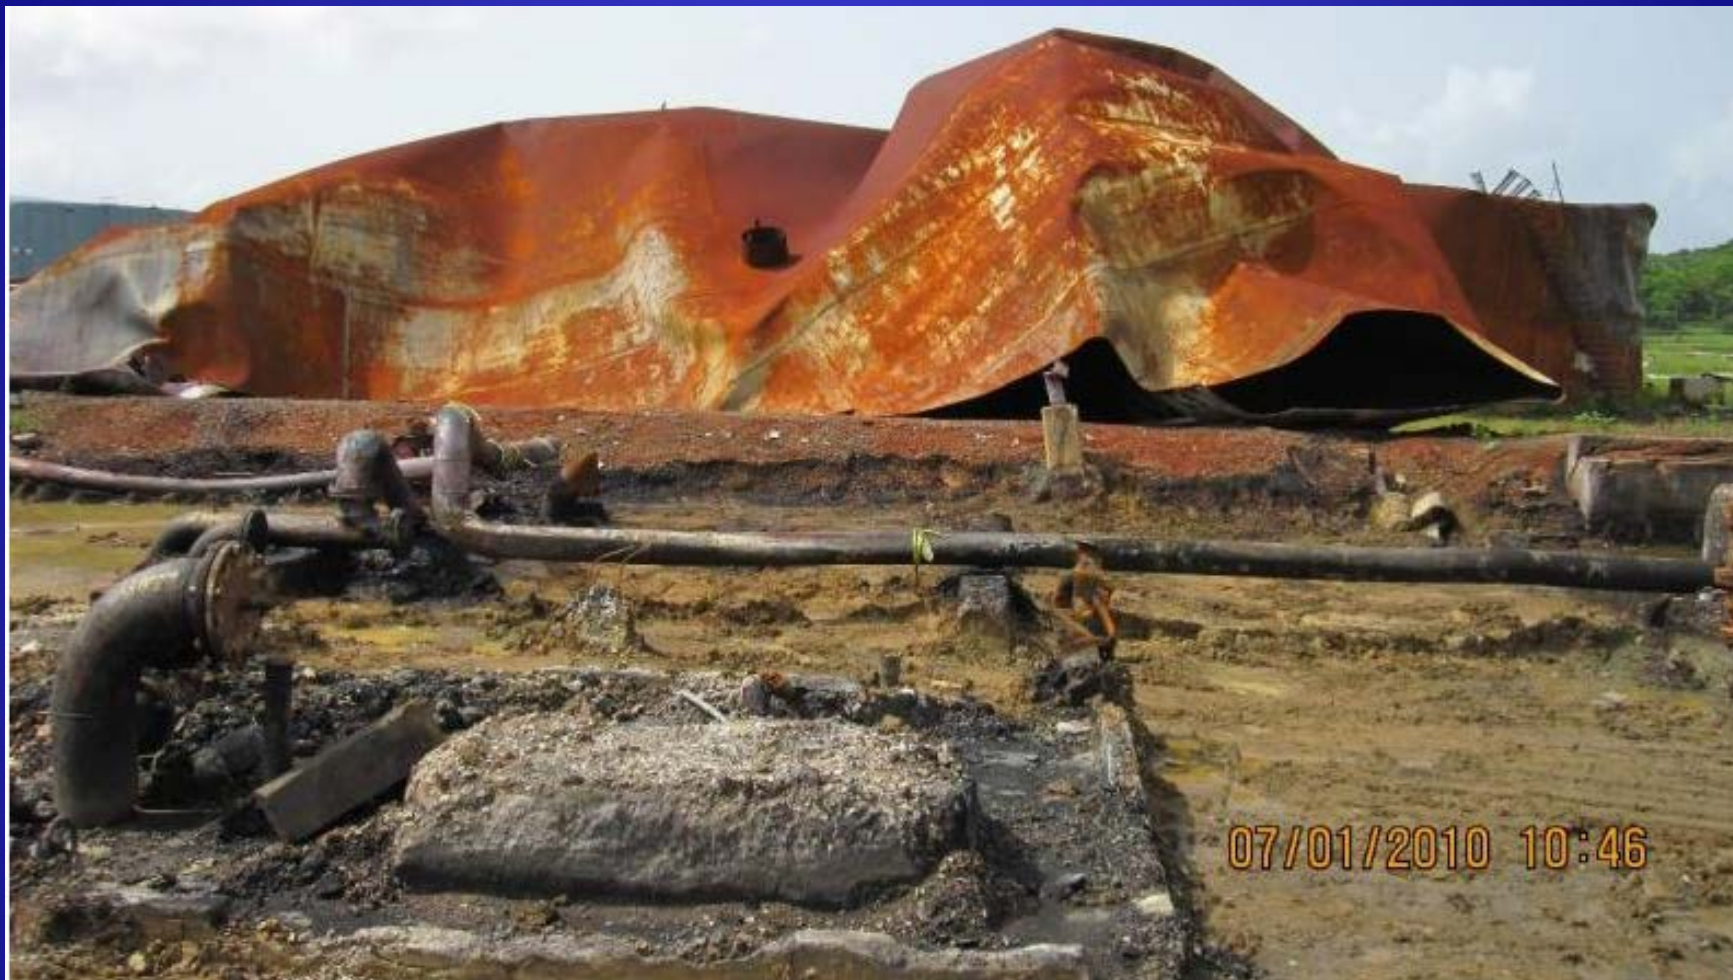
Avenue D after soil/line removal. Tank 503 lid in background

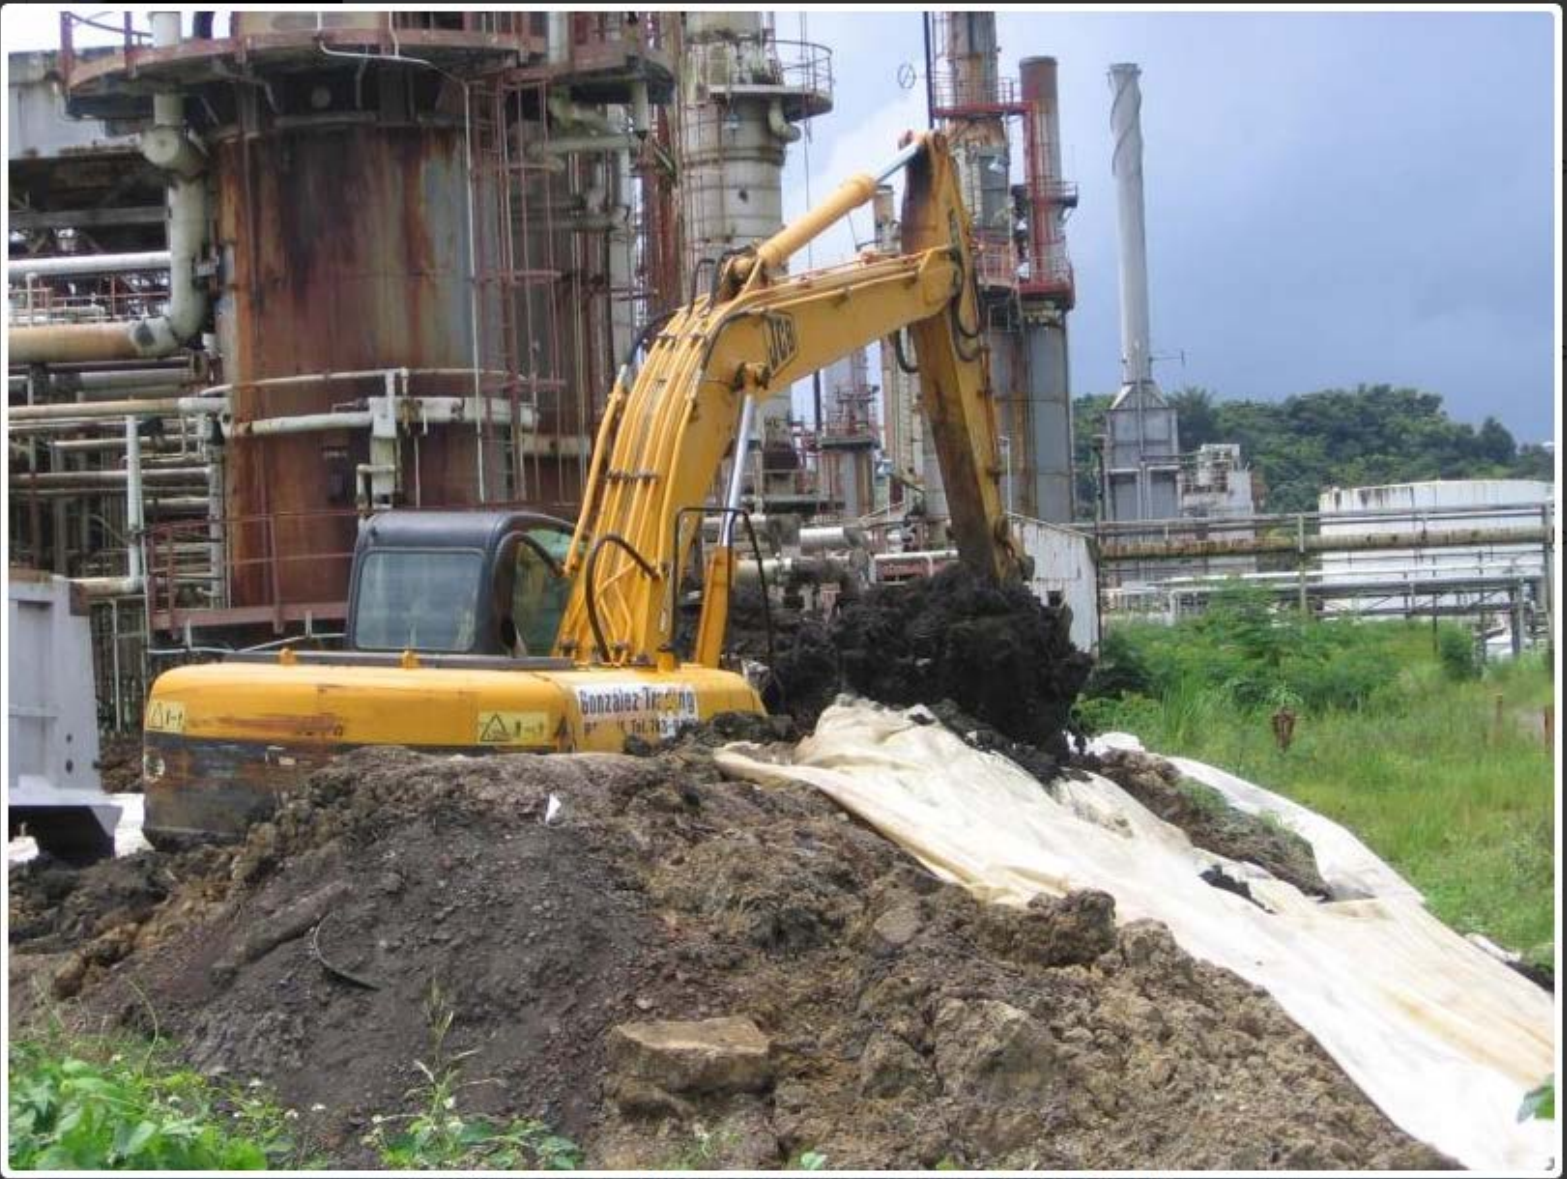
Loading oil contaminated soil

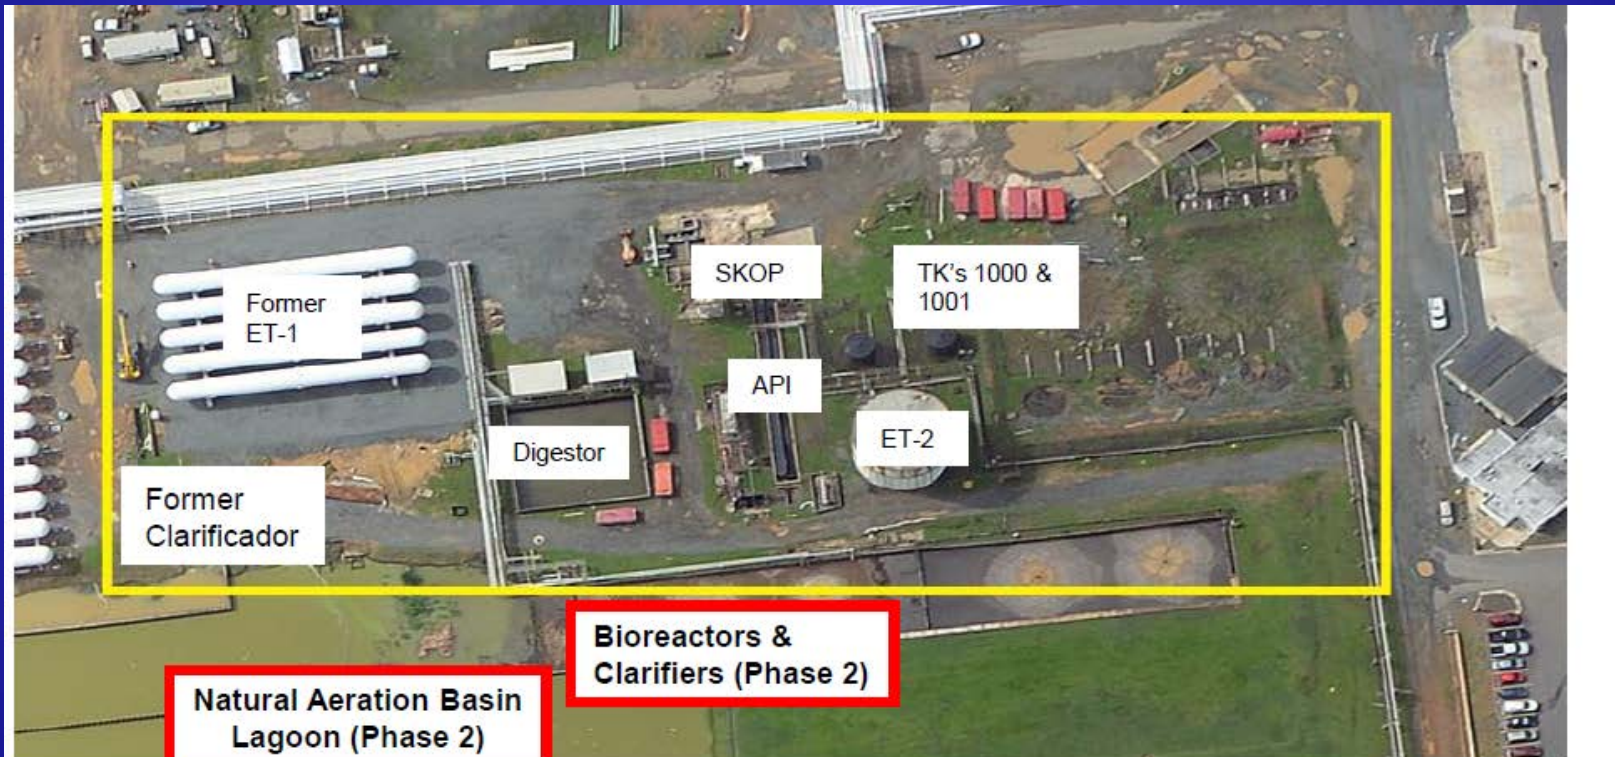
# Waste Water Treatment Plan – Bayamon Terminal 2014 Phase 1 Decommissioning and Demolition Current Aerial picture September 2014

After Demolition

Phase 1 Units

Phase 2 Units

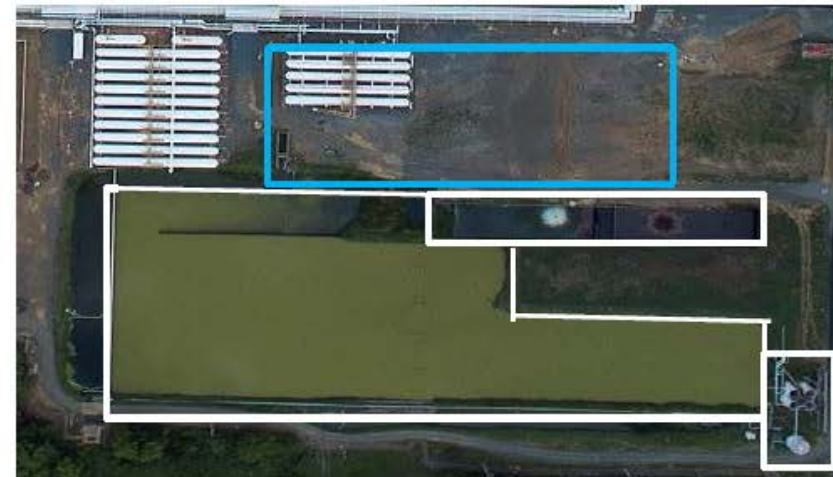
Natural Aeration Basin  
Lagoon (Phase 2)

Bioreactors &  
Clarifiers (Phase 2)

ET-3 & filters  
(Phase 2)

General SOW to be presented to the EPA as part of the Order requirements:

- Dewatering, Sludge removal and unit clean up for: Bio Reactors #1 & #2, Clarifiers #1 & #2, Sand Filters and Equalization Tank (ET-3)
- Disposal - Haz and Non-Haz according to waste classification.
- Backfill - of the units re-using the soil storage in the north section of the Terminal
- Expected to be completed by EOY 2017
