RRT 3

Case Study:

M/V DALI

HAZARDOUS MATERIALS SALVAGE PLAN AND
OVERVIEW

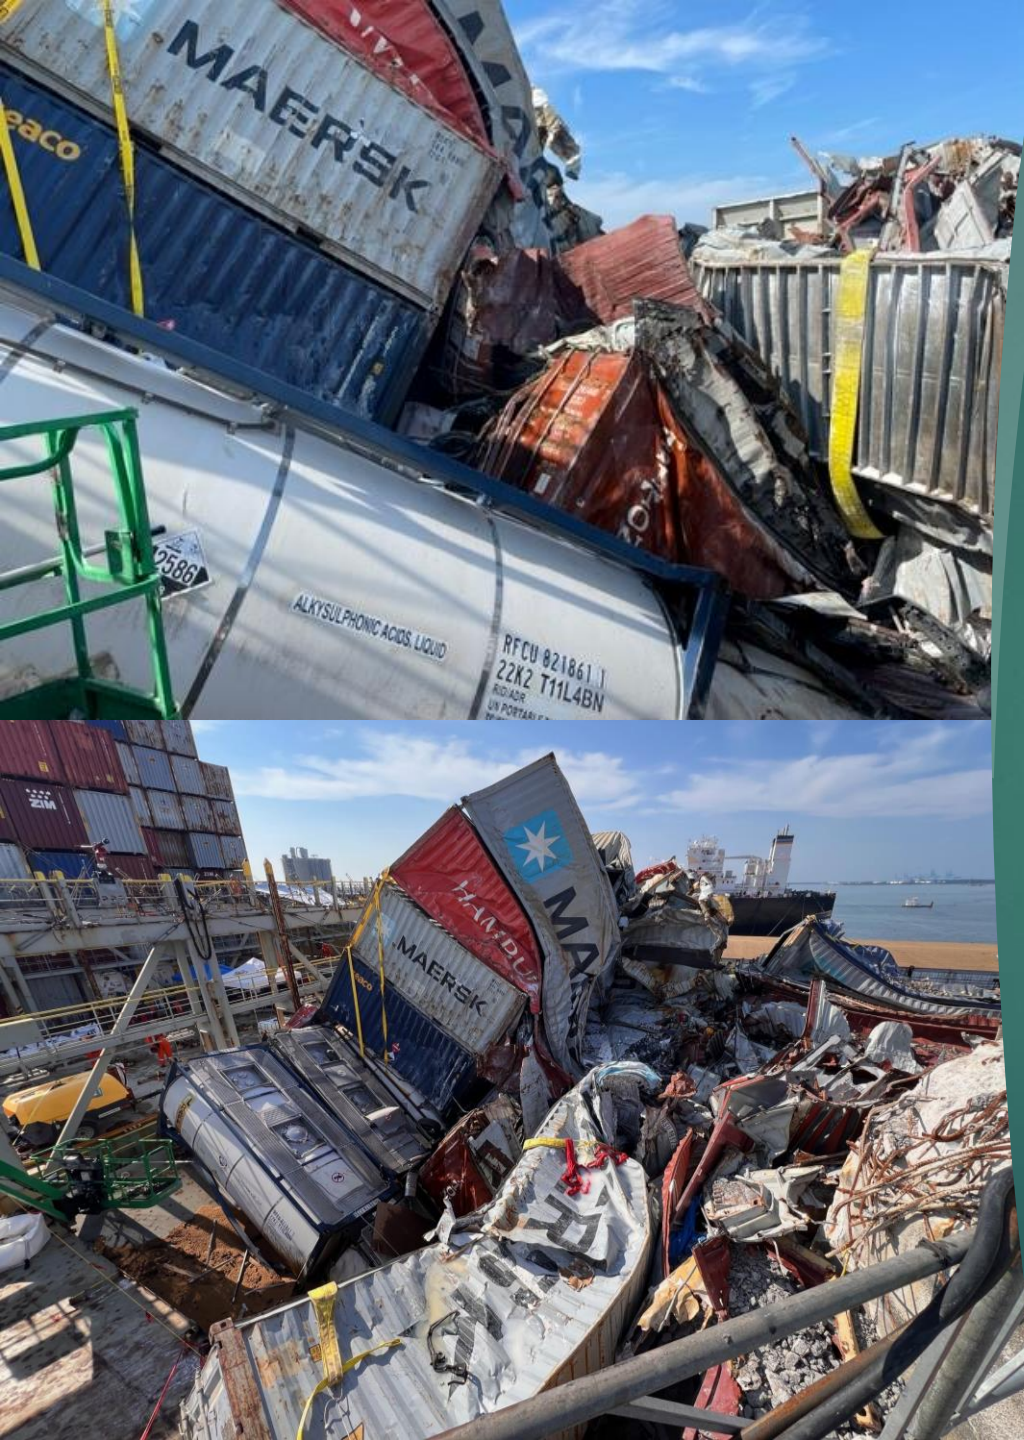
#1 Cargo Hold Sludge

Generated by hazardous chemicals that were released during the incident along with rainwater that accumulated in the cargo hold over time. Known contents of the sludge include:

- ▶ Decomposing Soybeans
- ▶ Hydro sulfonic Acid
- ▶ Rainwater
- ▶ An unknown quantity of pesticides

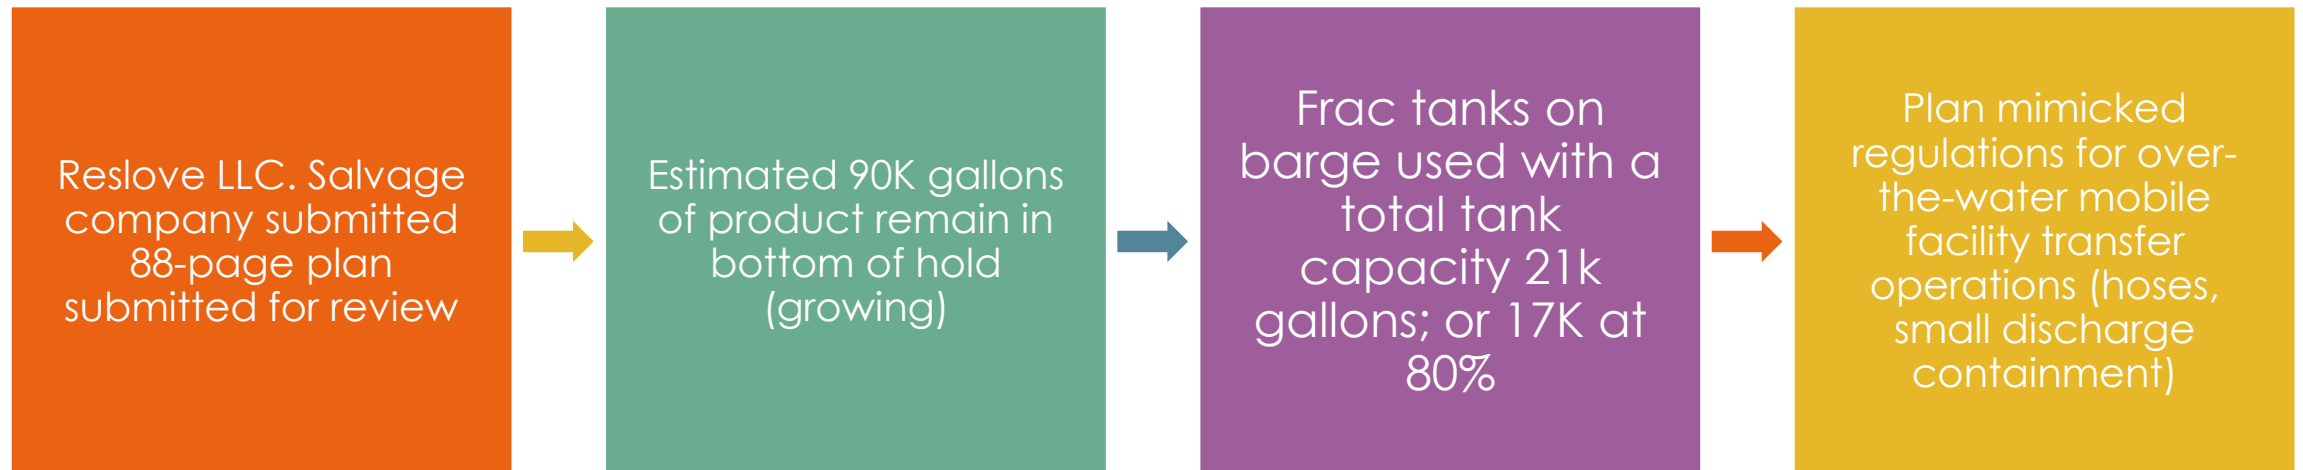
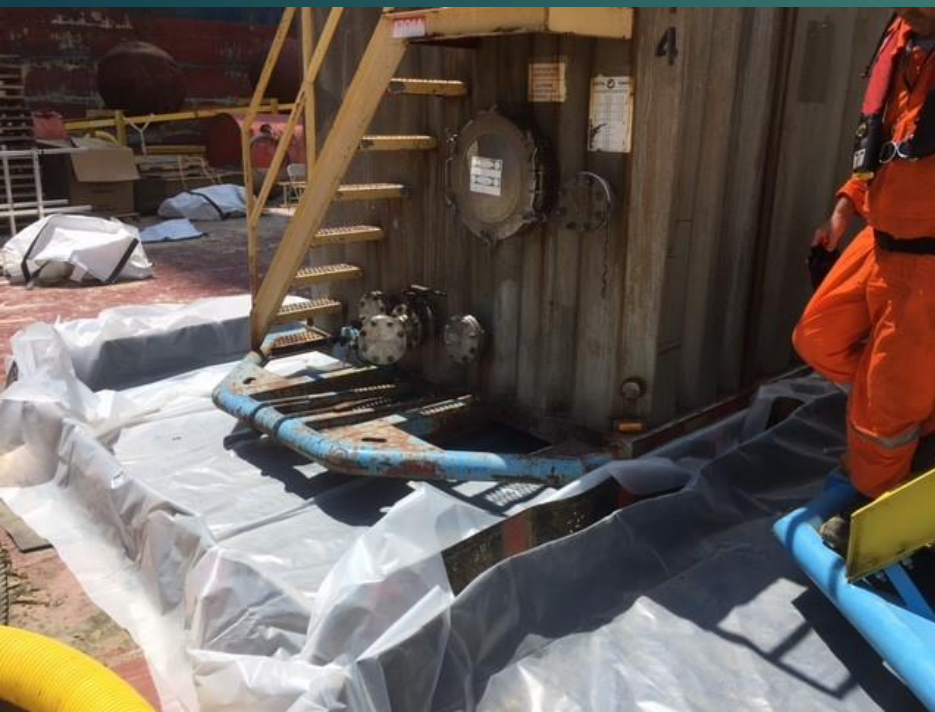
Hazardous Liquids Transfer Plan

Identified Challenges

- ▶ Since product sinks in water, boom not effective
- ▶ 50' hose lengths left possibility of connection points mid-air
- ▶ Product not tested for sorbent pad clean up

Challenge Mitigation Techniques

- ▶ 100' hose length purchased- 6-inch, bolted flange
- ▶ Operate at 150 psi vice 200 MAWP
- ▶ 12' corrugated pipe purchased to act as secondary hose containment
- ▶ Sorbent material tests conducted on sludge
- ▶ (20) 50-lb bags of saw dust ordered for on-deck spills

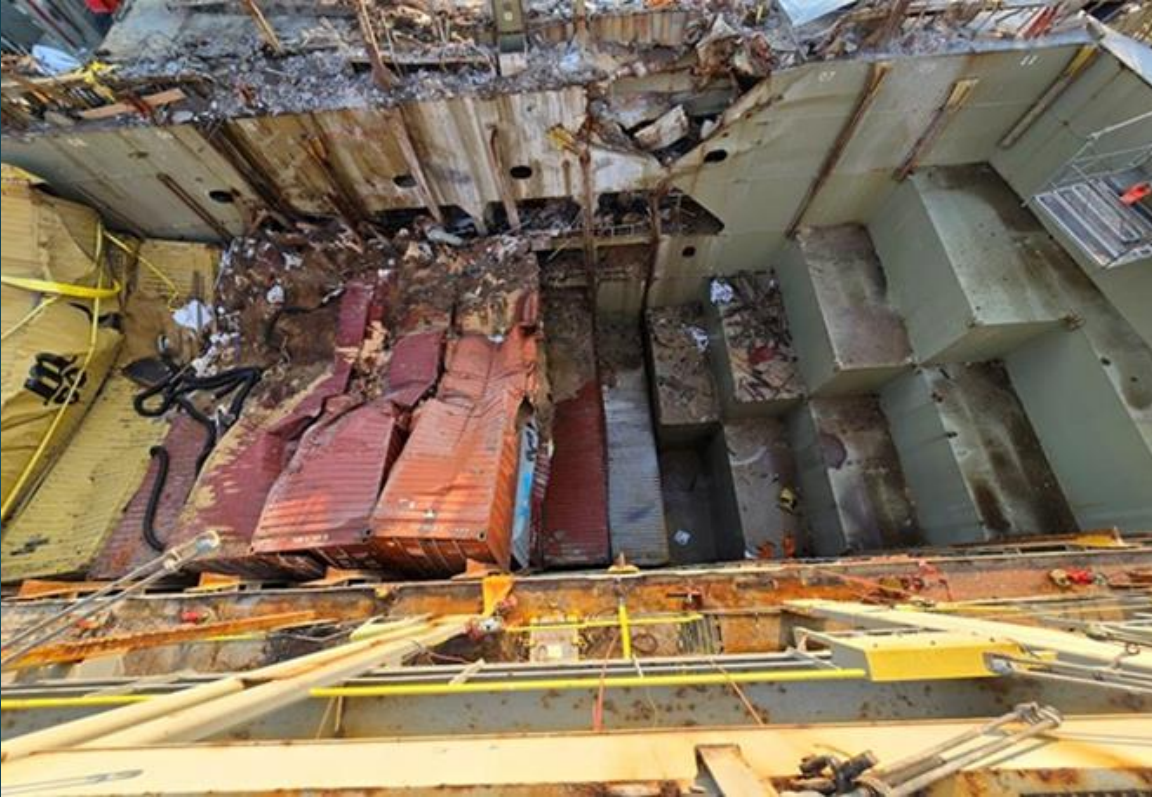
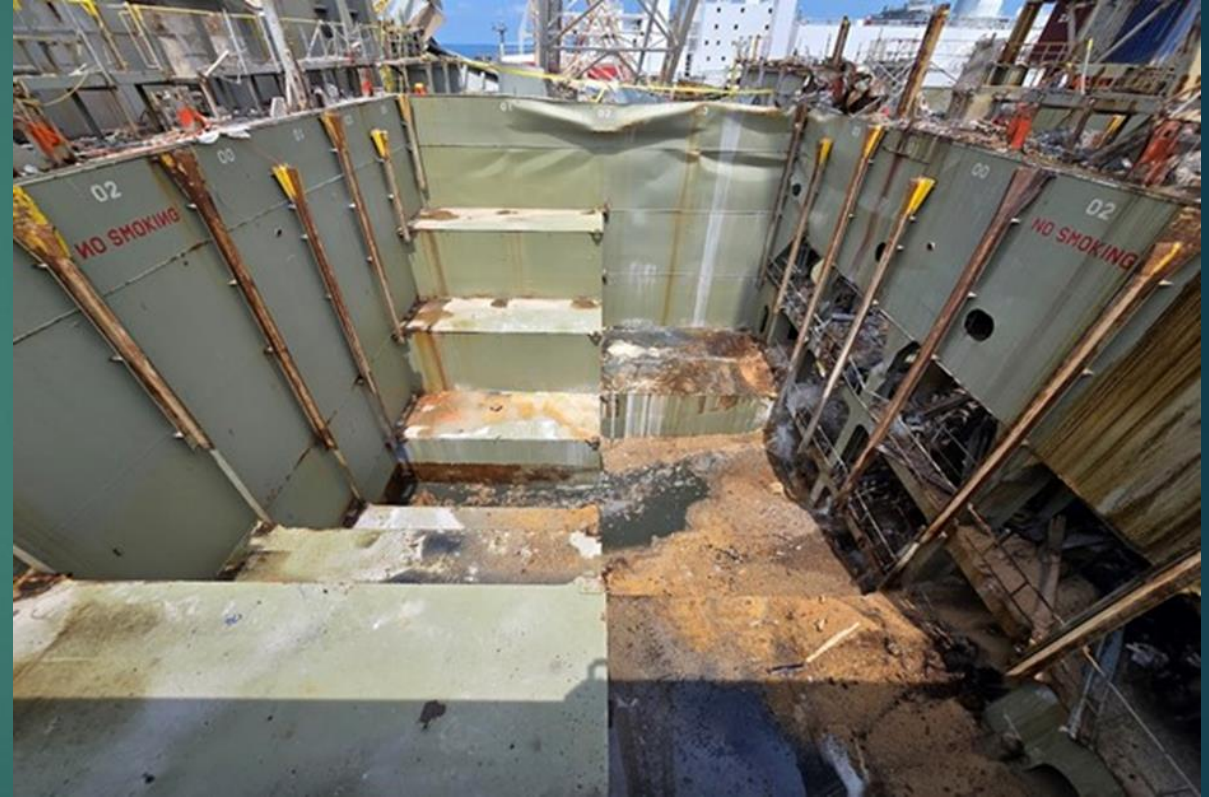
Pumping Operations Begin

- ▶ Vessel ballast utilized to tilt bow 2 meters higher than the stern

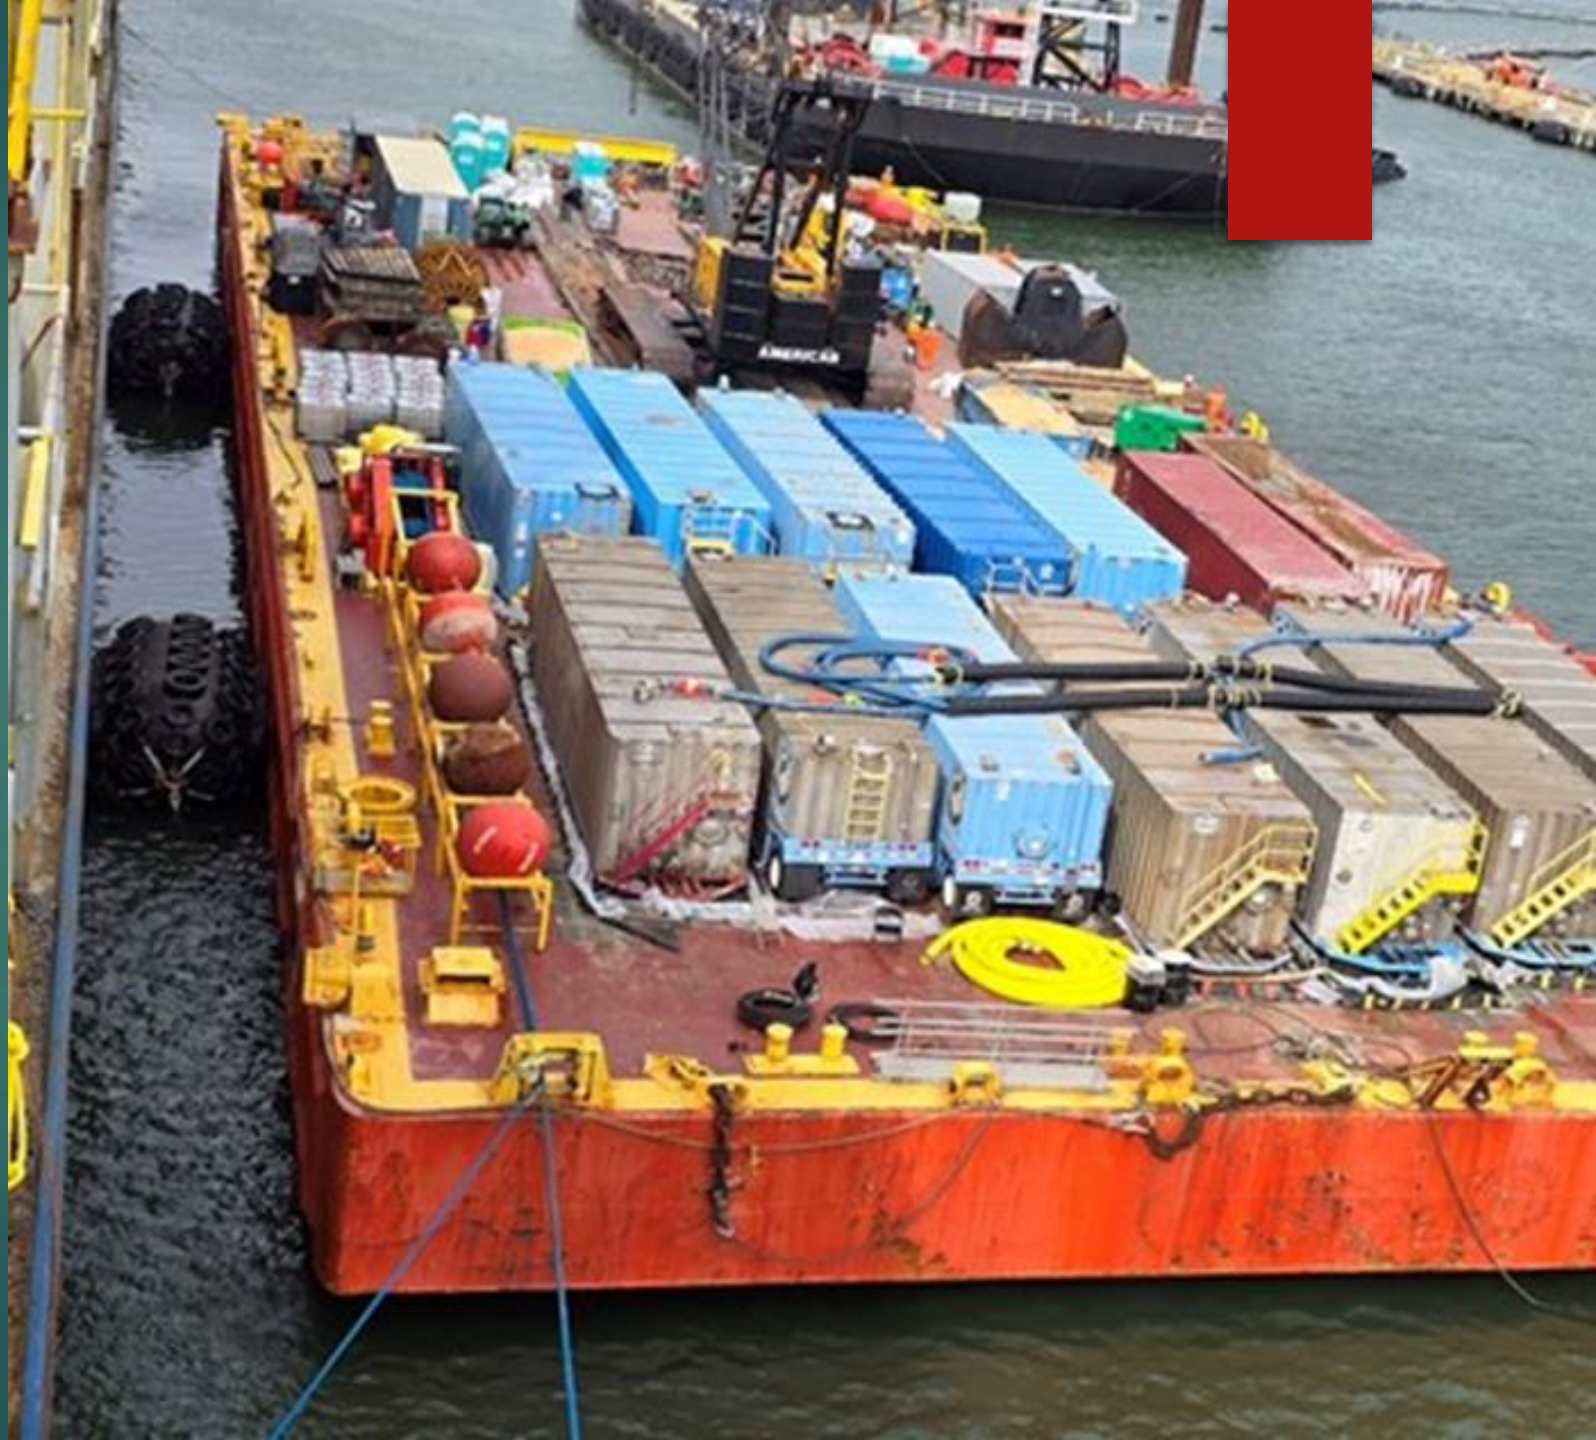
Sludge Departure

- ▶ Frac tanks Preparing For Departure To Seaward Marine to be offloaded
- ▶ 6 Frac tanks of sludge totaling ~117,000 gallons

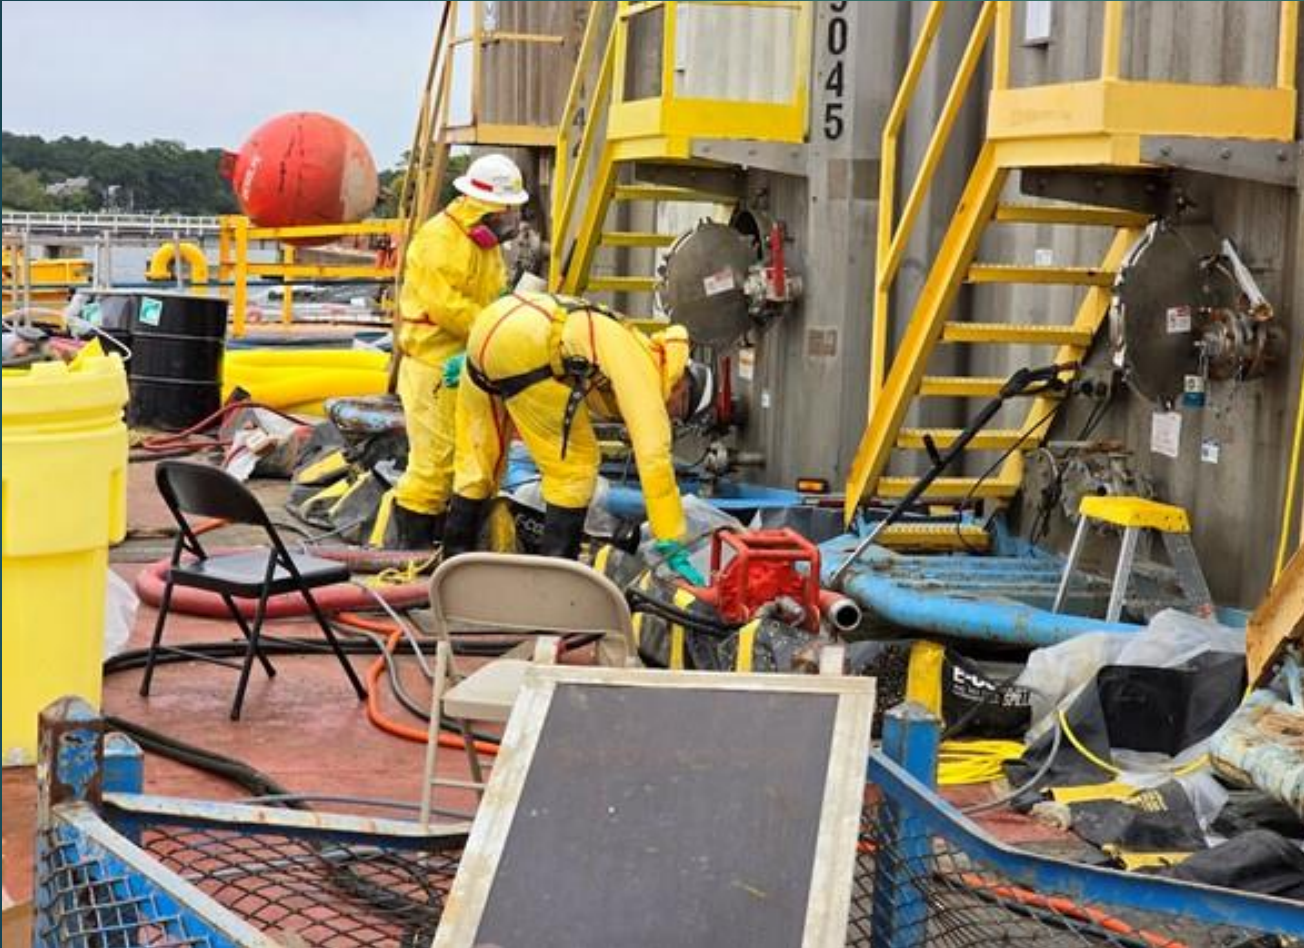
The Final Step in Sludge

Confined Space Entry
To Decon Frac Tanks
