Maryville CSX Train Derailment

August 2015
Regional Response Team
Meeting
Knoxville, TN

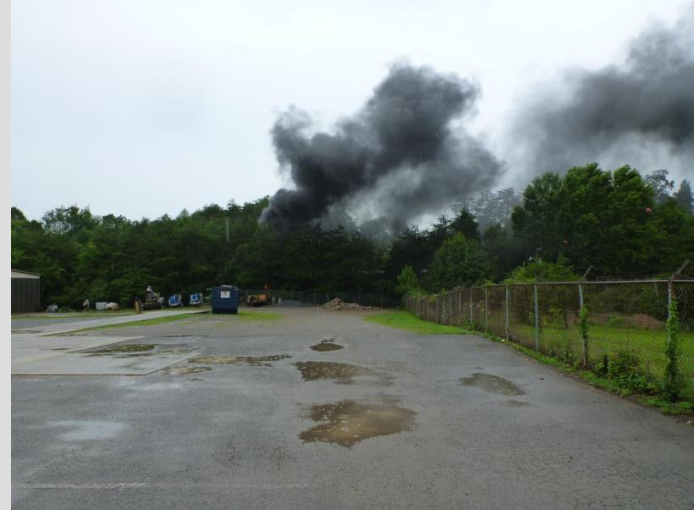
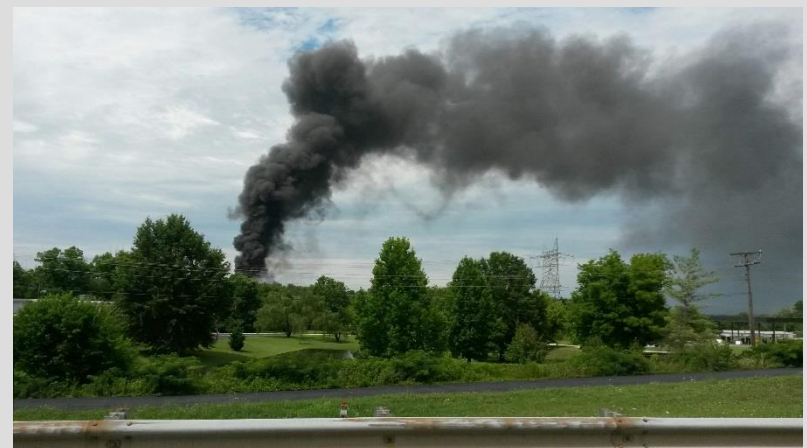
Derailment Information

- Rail car carrying ~26,000 gallons of Acrylonitrile was breached and partially derailed.
- Acrylonitrile, highly flammable, caught fire as the railcar was leaking, providing a constant source of fuel and making extinguishing the fire dangerous and difficult.

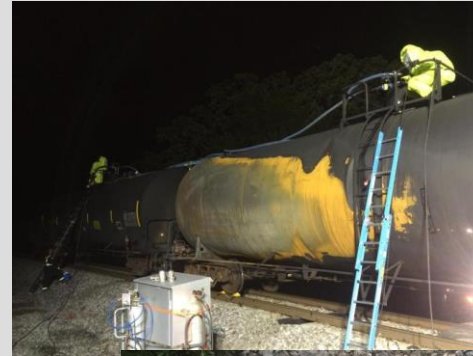
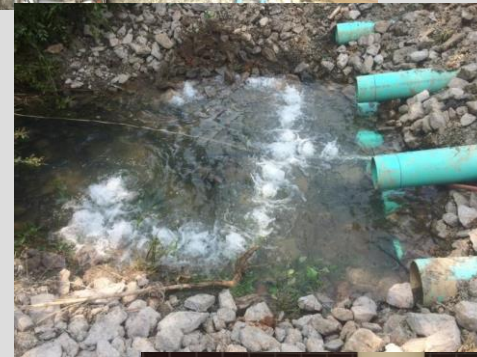
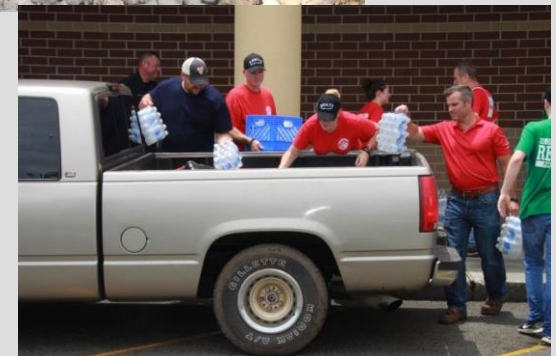
Acrylonitrile Transfer

- A second unbreached car, carrying Acrylonitrile was damaged by the fire but the contents were not lost.
- Acrylonitrile was transferred to a new car for shipment, via a closed-loop system.

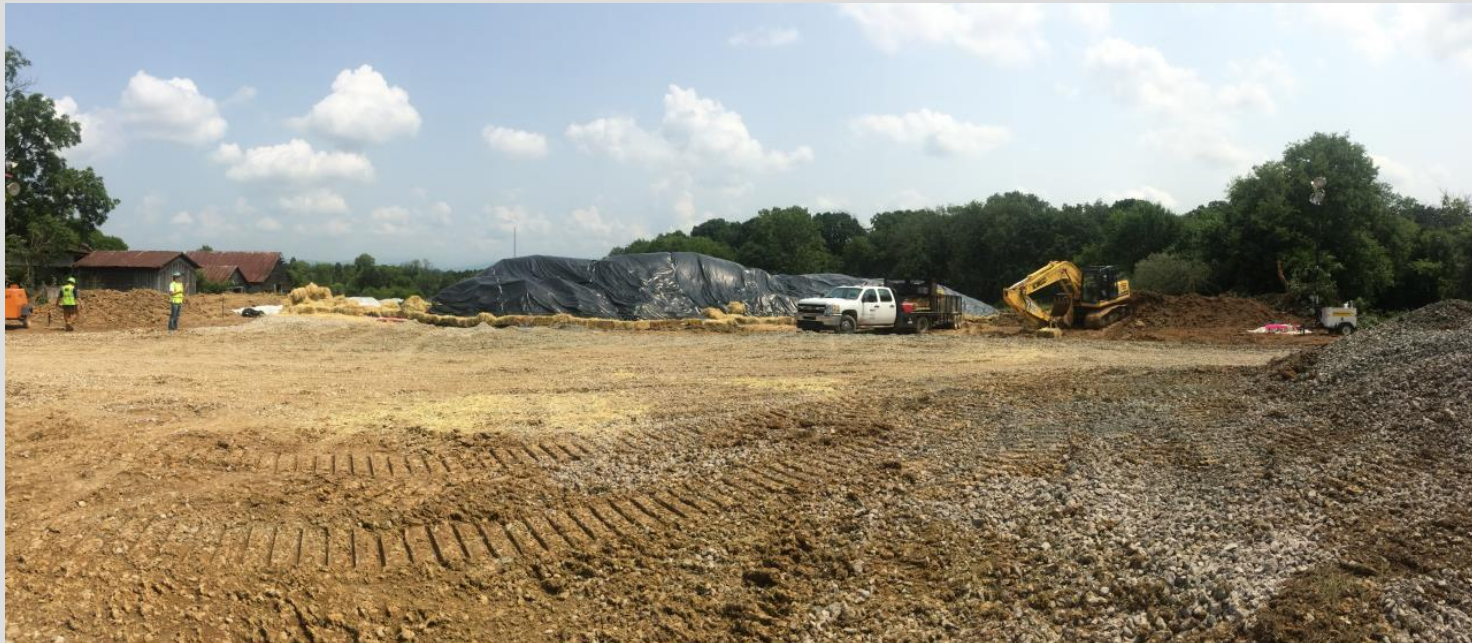
Ground Water Contamination

- On the final day of the response, groundwater sample results from an on-site well, indicated elevated concentrations of Acrylonitrile in the groundwater.
