8/9/2018

NYSWR

St. Rt. 17

Deposit

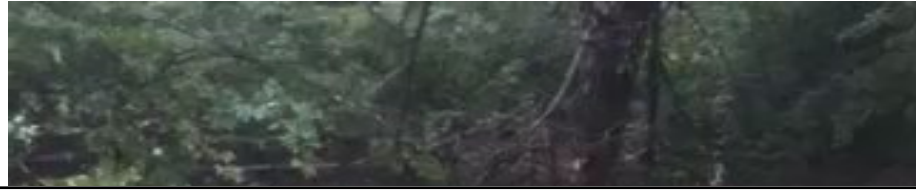
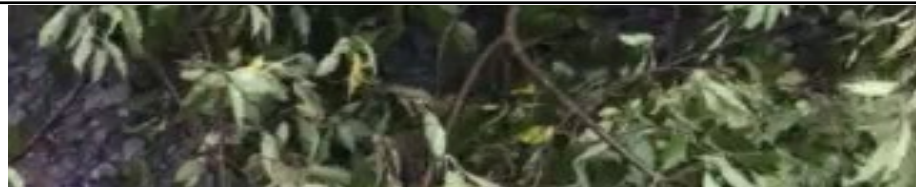
Engine video

Heavy rains in the area the night before

RR culvert was washed out

Train derailed as it crossed the culvert
